Geotechnical Investigations and Proposal for Stabilization and Recovery Slope on Highway BR-010 Stretch in Aparecida do Rio Negro to Goiatins, Tocantins, Brazil

Abstract. This article presents the results of geotechnical studies and proposals to stabilize embankments referring to cuts 16, 23, 25, 30 and 31 of the BR-010 referring to Aparecida do Rio Negro a Goiatins, State of Tocantins. The study consisted in the execution of a field incursions program for verification of geotechnical conditions along the indicated stretch, running lab tests, and stability analysis of embankments in order to indicate solutions to cuts made necessary for the completion of the highway. In terms of characterization of the problem, it presents part of the photographic survey conducted in November 2007 with the conditions of the most critical slopes. There is in the pictures that the side slopes to the highway were in the process of degradation and (or) progressive destabilization requiring urgent interventions aimed at mitigating the ongoing problems. In terms of geometry, the slope had heights up to approximately 35 m. To determine the parameters necessary to verify the stability of embankments using

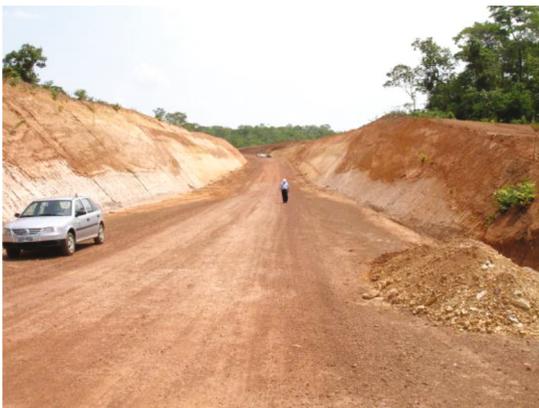
Fig. 1. General view of part of slope 16.

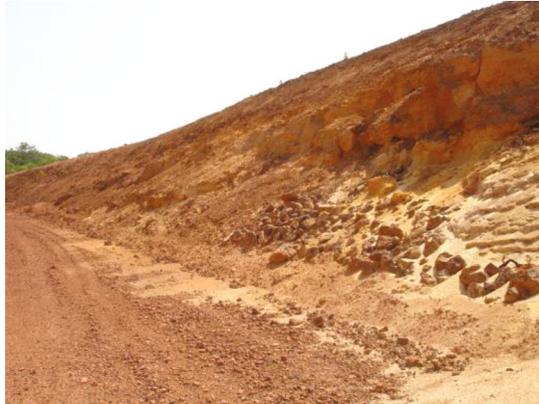
Fig. 2. General view of part of cut 16 with superficial erosion.

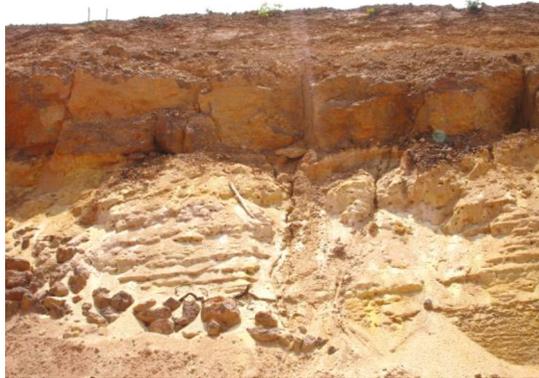
Fig. 3. General view of part of the cut 16 with superficial erosion.

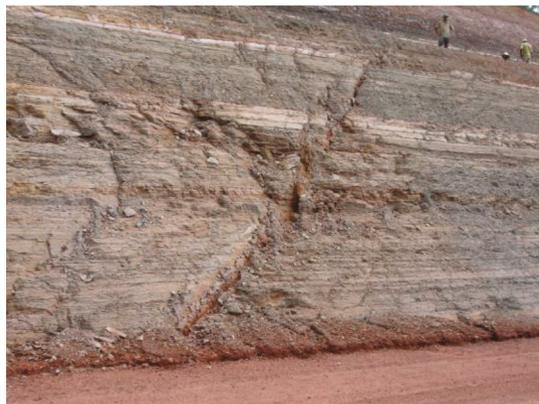
Fig. 4. View of the slope of cut 23.

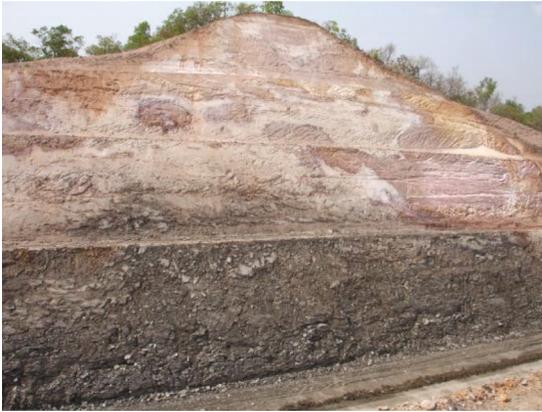
Fig. 5. Cut 25, still intact (September 2007).

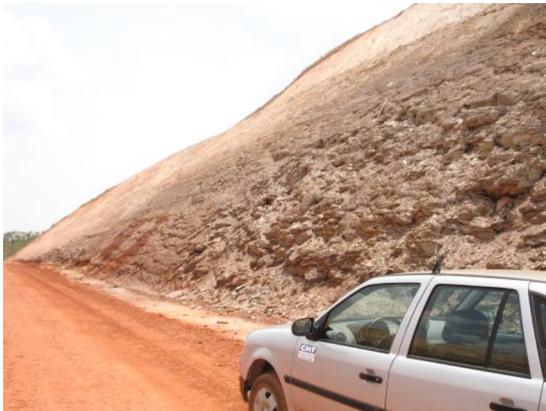
Fig. 6. Slope of cut 25 starting degradation process of slope.

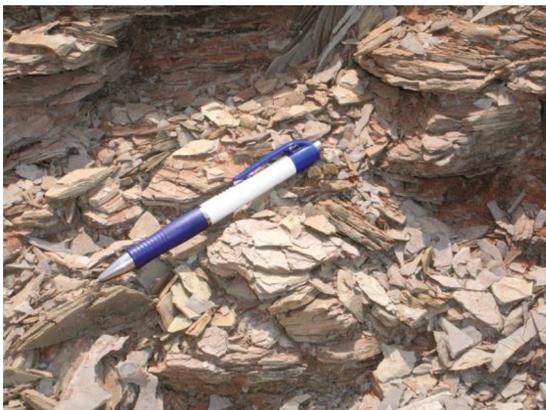
Fig. 7. Material of lower horizon of cut 25.

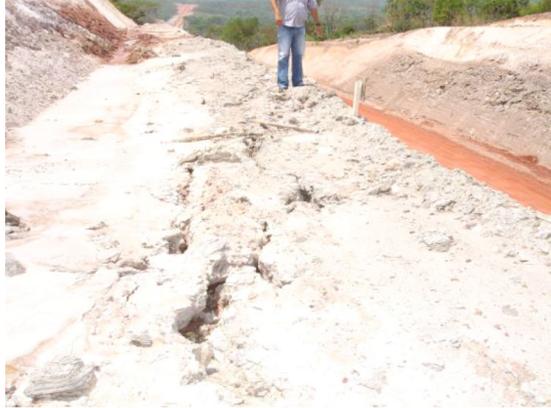
Fig. 8. Traction cracks in the berm slope of cut 25.

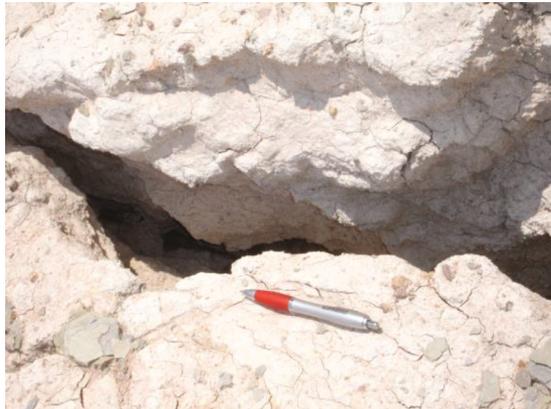
Fig. 9. Traction cracks on berm slope of cut 25.

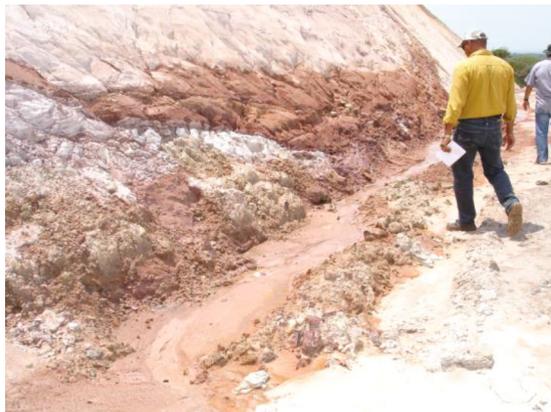
Fig. 10. Saturation from the slope basis in cut 25.

Another recommendation made was the draining mattress running on the highway over the cuts implemented in order to prevent possible upwelling of water that could compromise the surface layers of the highway, as the sub-base, base and coating, that the saturation finding the bases of slopes in the run cuts.

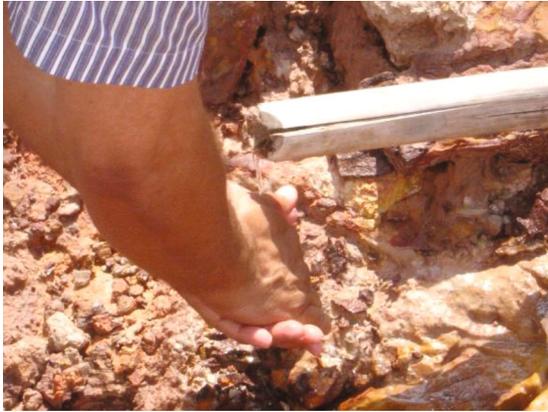
Fig. 11. Upwelling water in cut 25 slope.

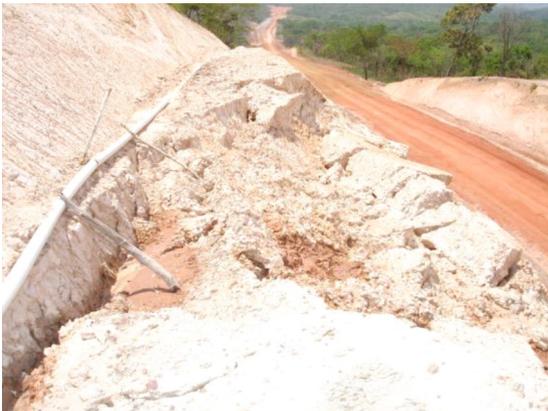
Fig. 12. Failure stretch in cut 25 slope.

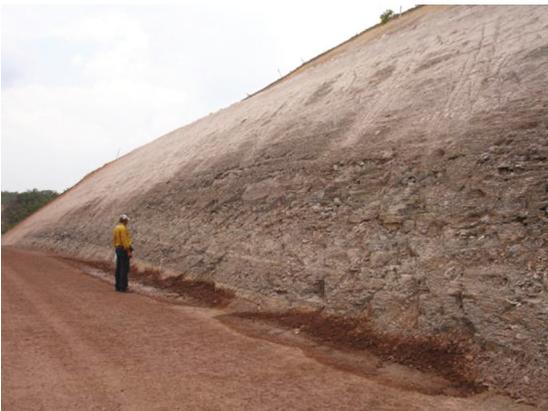
Fig. 13. Cut 31 (slope basis saturation).

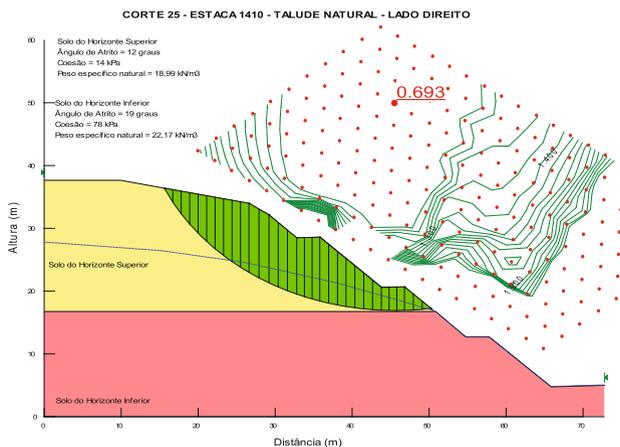
Fig. 14. Cutting 25 stability with lab parameters (FS = 0.693) – Stake 1410 (natural slope – right side).

Next, in Figs. 14 and 15, the stability analyzes are presented, with the strength parameters obtained in our laboratory for the cuts 25 on cuttings 1410 and 1411.

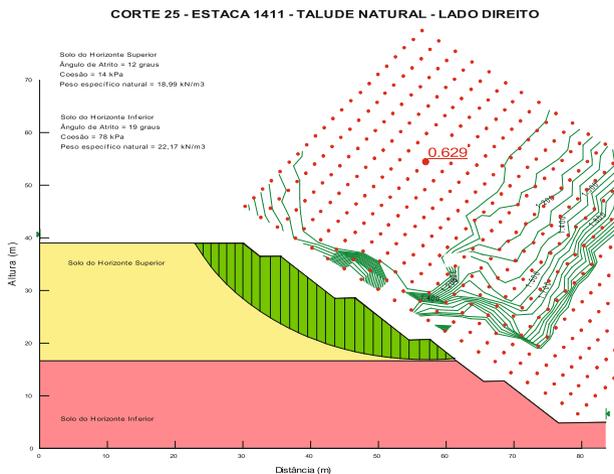
Fig. 15. Cutting 25 stability with lab parameters (FS = 0.629) – Stake 1411 (natural slope – right side).

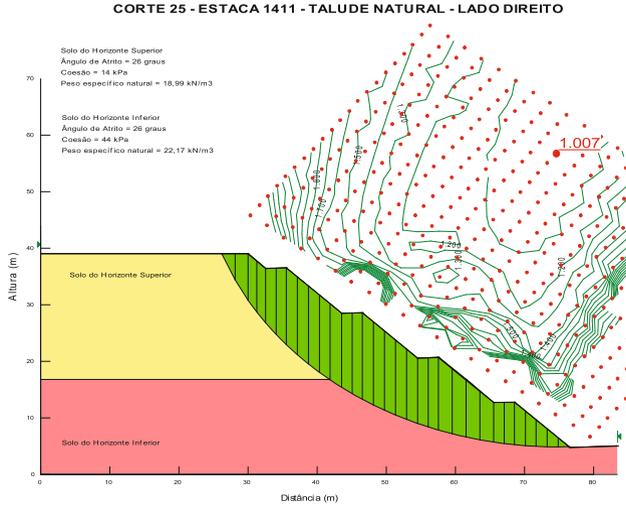
For cutting 25, broke up the natural slope safety factor equal to 1.007 (Fig. 16), with the implementation of retaludamento and introducing deep subhorizontal drains to relegation in N.A. within the massif.

Fig. 16. Cutting 25 Stability with fixed parameters – Estaca 1411 (natural slope – right side).

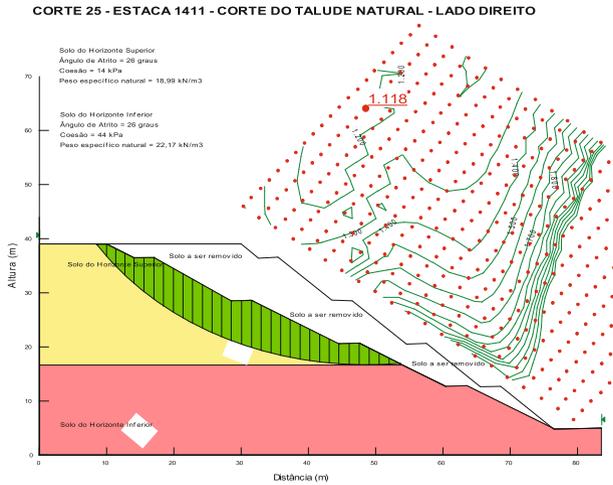
Initially, simulated an approximate cross-sectional area of 358 m² Stake 1411. In this situation, there was a need to move laterally out of the situation of the road - counting from the bottom up - the first edge in 5 m, second at 10 m, the third in 15 m, the fourth at 18.5 m and fifth in 20 m. Figure 17 shows such a situation where we got the 1,118 Safety factor that represents a low value for the stability of the slope in question.

Fig. 17. Cutting 25 stability with proposal remotion of soil – Stake 1411 (natural slope – right side).

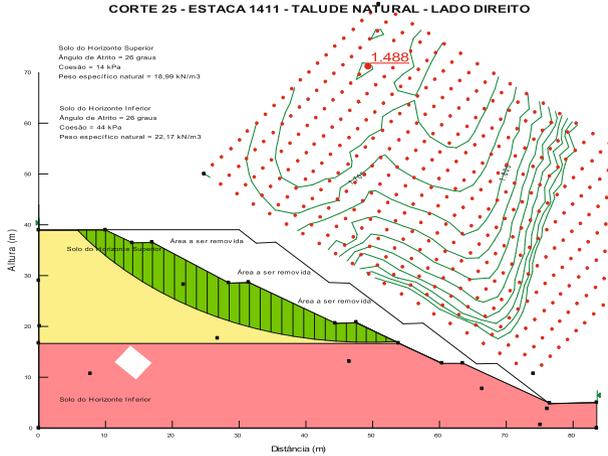
In addition to retaludamento, simulated to the lowering of N.A. inside slope which represents the introduction of the sub horizontal drains for the removal of excess water. In this situation it obtained the Safety Factor of 1.488, considered satisfactory for the type of work in question. Figure 18 shows the situation analyzed.

Fig. 18. Cutting 25 Stability – Stake 1411 (natural slopes – right side) – Low NA (introduction of deep subhorizontal drain).
