CUI Failure of a Hot Oil Line Due to Intermittent Operations

Abstract Insulated hot oil lines on high-temperature/intermittent duty are typically vulnerable to increased risk from corrosion under insulation (CUI) failure. This paper presents the results of an investigation into a CUI failure at an onshore natural gas-processing plant and also discusses the key issues affecting intermittent duty. The inadequate coating was degraded during high-temperature duty (up to 240 °C) followed by water ingress through degraded insulation mastic and sealant and resulting in (up to 3 mm) chain (coalesced) pitting during ambient temperature downtime, at damaged coating locations from the 2 to 10 o'clock locations. Several recommendations are proposed for addressing the underlying technical and systemic causes of the failure.

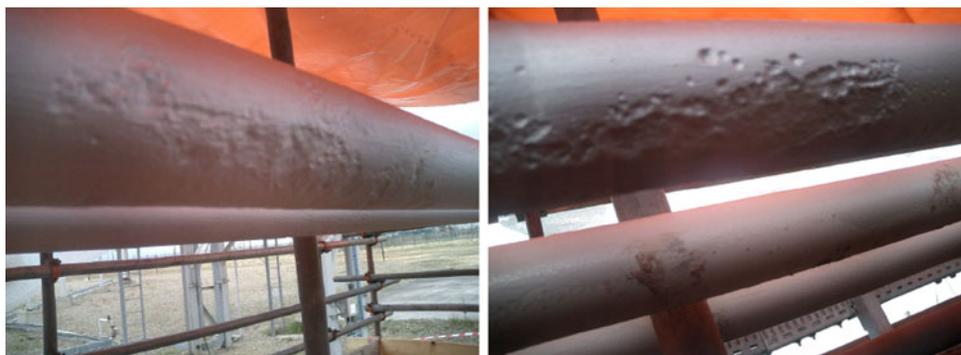
Subsequently, both lines were fully stripped and slurry/grit blasted in preparation for ultrasonic thickness (UT) and pit depth measurement. The thickness of the inlet line pipe wall was determined to have been reduced by pitting corrosion from 4 mm to a minimum of 1 mm, at multiple sites. The pitted sites were joined together to give a chain pitting presentation (Fig. 2). There was no loss of containment. If undetected for much longer, hot heating oil could have leaked unto the unbonded ground.

The source of the water under insulation is thought to be rainfall which entered through degraded mastic and sealant. Poorly sealed claddings were recorded by the pressure

Fig. 2 CUI degradation on hot oil lines showing multiple coalesced pittings from 2 to 10 o'clock positions

continued service at the operating pressures, since the 1-mm minimum allowable wall thickness (MAWT) still exceeded the 0.3 mm threshold. As a result, a number of temporary repairs were considered but were found to be impractical or not cost effective. Given that the plant's retiral thickness threshold is 2 mm, it was eventually decided that the line should be completely replaced, painted, and thermal insulation replaced with caged protection to protect personnel from hot surfaces.
