# Research on the Common Causes of Defects and Their Prevention Measures for RCF-Type PCB Mills Production

**Abstract.** Blade-type error, edge collapse cutaway, micro missing, four kinds of defect for RCF-type PCB mill production are deeply analyzed and their preventions measures are given detailed according to the author's many year's practice. These measures have been practiced and achieved good results. The research results can increase pass rate of such tools in the production and reduce production costs obviously, and owns with a special important using values and widely promoted significance.

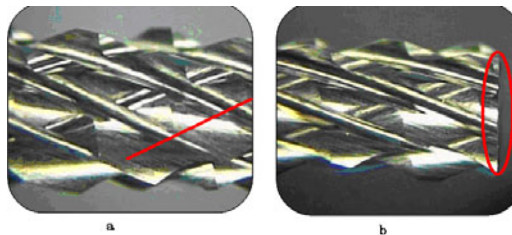
Blade-type error refers to the milling edge geometry and the geometric shape of drawings required exist one or several differences [3]. As shown in Figure 2 (a), the difference between the milling cutter and the drawing is that the former is less a L-edge, the drawings require RCF milling cutter has six Left- edges, but only has five Left-edges in the actual process of production, which must cause the milling cutter to waste product. Similarly, there exists such phenomena that the milling cutters are less one or several Right-edges, or while both on the left and right edges are less one or several edges in the milling cutters production, or vice versa. As shown in Figure 2 (b), the milling cutter has no fish tail, which would also cause it to waste product.

Fig. 2. Blade-type errors with (a) Less a left spiral edge and (b) Without fish tail

The main reasons for this defect are as follows: First, the operators are not strictly implemented the technological process of production, for example the technology workers look at drawings with mistakes cause to count the wrong edges, and then lead to set the wrong edges parameters of programs. Second, the machine operators have not checked the products, the milling cutters, carefully by themselves. Besides, the quality inspection workers have not timely feedback the defects to production sites,

which lead a lot of such defect to occur. Finally, the technical personnel who did not perform their duties at the production site, they did not comply with the related requirements of production process, not strictly random in proportion to the production machine products, leading to these defects are ignored. However, the milling cutter has not the fish tail because of programmers forgot to compile the fish tail program, which causes CNC machine does not carry out the production process.

First, all the programmers, the technical personnel and the production operators must master the production drawings thoroughly and review them carefully, especially should rigorous review and check each parameter of the trial products. If there were parameters not comfort to the drawings, then the corresponding correction should to be done immediately, and eliminate such defects in the bud state effectively. Second, the machine operators and production technology workers should check the some proportion products made by machines randomly in accordance with of the production process. If any parameter surpasses the tolerance range, an immediate correction to the processing program parameter, to eliminate the edge flaws of products.

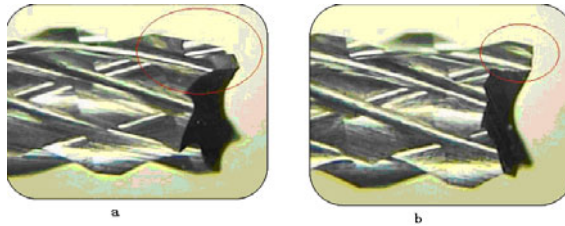
**Fig. 3.** Edge collapse with (a) Front end edge collapse and (b) Fish tail edge collapse

Edge collapse means a edge gap is greater than or equal to  $1/2$  values of the edge depth or edge width, or the fish tail has the phenomena of serious damage and many edges missing.

Through analyzing, we know that the carbide is a common tool material, and its major shortcoming of mechanical property is brittle, if there is little impact or vibration, it would prone to cause the destruction phenomena of break off, flaking and collapse[4]. Therefore, the edge collapse defect is produced mainly by the following several reasons:

- (1) Due to the unloading robot and the yard lumber holes beyond the tolerance range in the horizontal direction during the robots of CNC grinding unload mills to the yard lumber, resulting in a collision causes mills produce edge collapse defect.

- (2) It is very easily leads to serious collision among mills, or with other objects while workers are taking, attiring or checking mills during all the production processes.
- (3) The cutting grinding wheel edge has bumps lacks, which causes mills load uneven forces and thus produces edge collapse in machining the spiral grooves process.
- (4) The grinding wheel surface is blocked by chips, which can increase friction force between the grinding wheel and the mills.

### 3.2.2 Preventive Measures

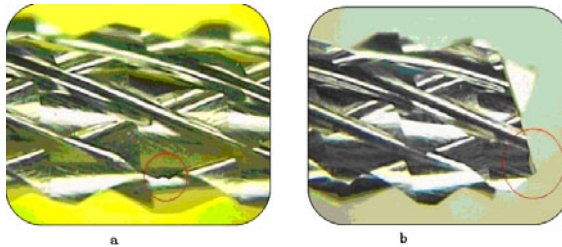
**Fig. 4.** Missing angle with (a) Middle edge missing angle and (b) Fish tail edge missing angle

Missing angle means a edge gap is more than  $1/4$  and less than  $1/2$  values of the edge depth or edge width. The extent of this defect is much slither than the edge collapse defect. However, its causes are identical with the edge collapse. Therefore, its preventive measures are consistent with the edge collapse.

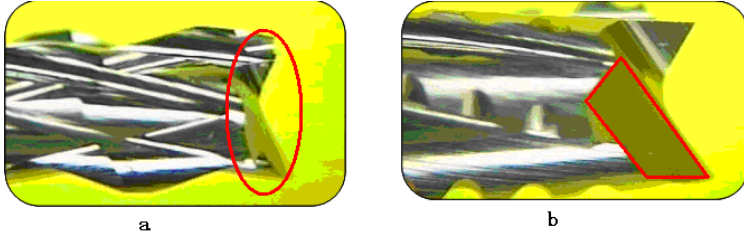
**Fig. 5.** Irregular fish tails with (a) Fish tail is asymmetry and (b) Moon surface arc

Fish tail is the most critical part to determine mill to process, and its geometric size and shape can directly affect the quality of PCB products and the life of itself. The judgment standards include the fish-tail's shape asymmetry and the moon surface arc and so on.

The main cause of this defect as follows: First, the aperture grinding wheel has not located in the fish-tail axis center while processing, which can make the fish-tail edge points exist a height difference and the geometry size is asymmetrical [7].
