Failure Analysis of Cracks Formed at Extrados of Bend Pipe of API 5L X65M Grade

Abstract A metallurgical and root cause analysis was performed on hot induction bent pipes that exhibited cracking at the extrados. The bent pipe of 1016 mm (40 in.) diameter by 18.5 mm wall thickness was API 5L X65 PSL2 line pipe containing a longitudinal submerged arc weld. A metallurgical cross section was removed at a crack on the bent pipe extrados to document the crack morphology using optical microscopy. In addition to the cracking, golden-yellow streaks were visible at the extrados of the bent pipe. The composition of the streaks was examined using scanning electron microscopy with energy dispersive spectroscopy.

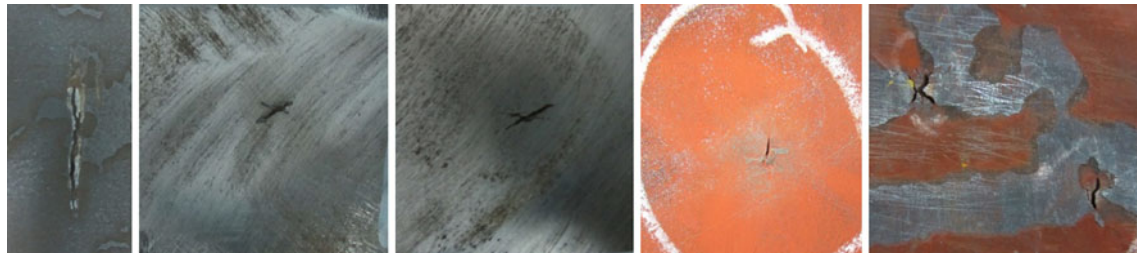
Sixteen bends out of 139 bends of 1016 × 18.5 mm, X65, and 3D radius have been observed with cracks at the extrados. The cracks were observed perpendicular to the bend/pipe axis (Fig. 1). Tables 1 and 2 give a gist of the chemical composition and process parameters of bends

which have failed during bending operation in two bending machines. After UT inspection of the cracks, a depth of approximately 10–15 mm was found with a length approximately in the range of 2–10 mm. The cracks were observed on bends formed at both bending machines.

Fig. 1 Crack photos observed on the extrados portion of the bend

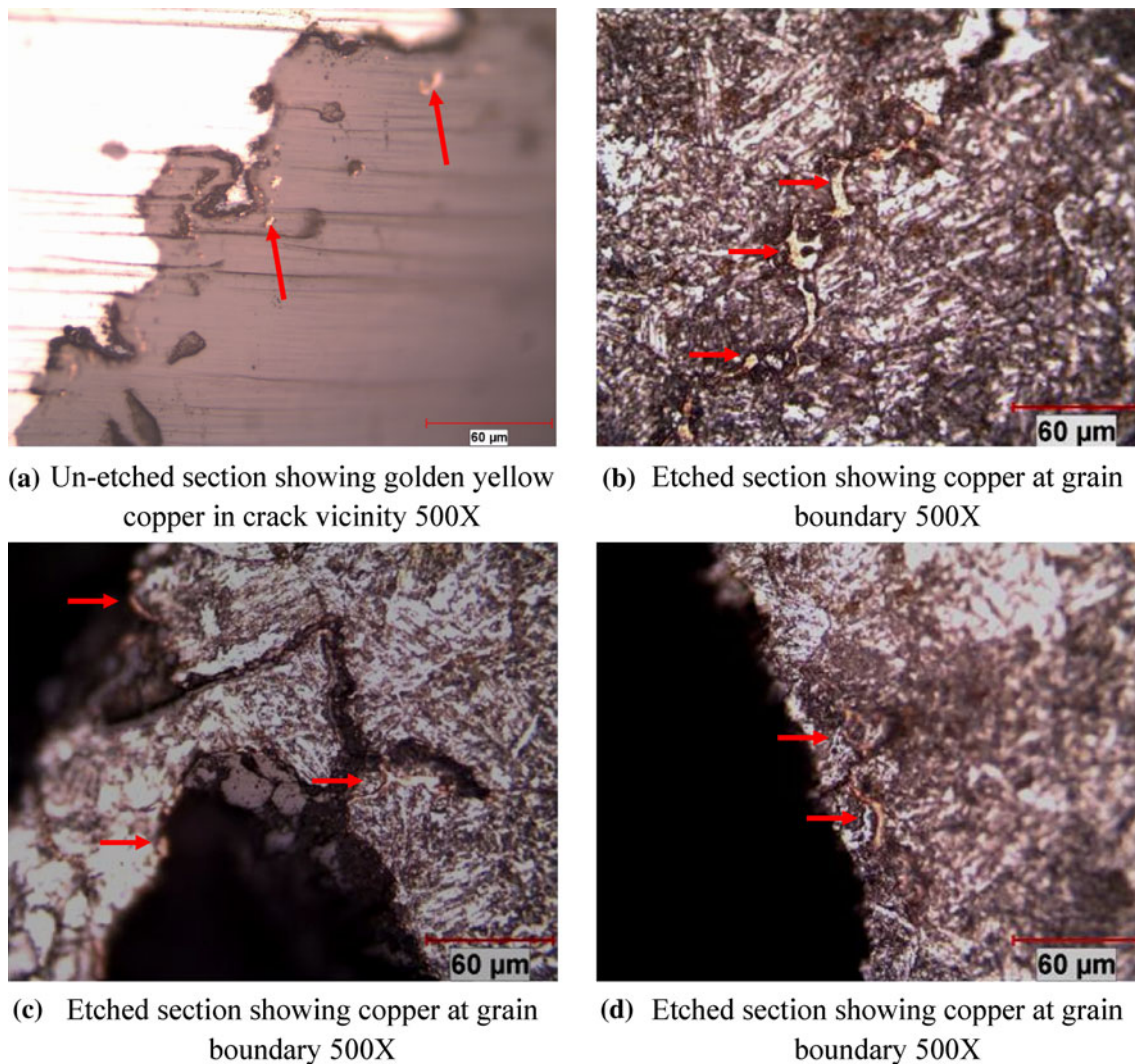
A couple of bend samples were taken for metallographic analysis as a representing one for the cracks formed on the bends at the extrados location. The cross section of the crack was microscopically analyzed in the unetched and etched conditions. The clear presence of golden-yellow color particles seen in the unetched condition indicates the entrapment of the foreign particles in the crack vicinity. After etching the sample, the presence of copper is observed at the grain boundary. This shows the possibility of copper diffusion during pipe bending at high temperature (Fig. 2).

The golden-yellow color particles could be either copper or a copper alloy as shown by the optical and SEM microphotographs. The diffusion of copper (melting point 1080 °C) in to the grain steel boundaries was the reason for the cracks on the bend extrados surface. Copper diffusion weakens the austenite grain boundary at ~980 °C (bending temperature). The weak austenite grains are no longer strong enough to sustain the tensile forces experienced by the bend extrados and hence a generation of cracks mostly transverses to the pipe axis. These cracks get opened up during subsequent stress-relieving heat treatment of the bends. A change in the

Fig. 2 Microphotographs of cracks in unetched and etched conditions

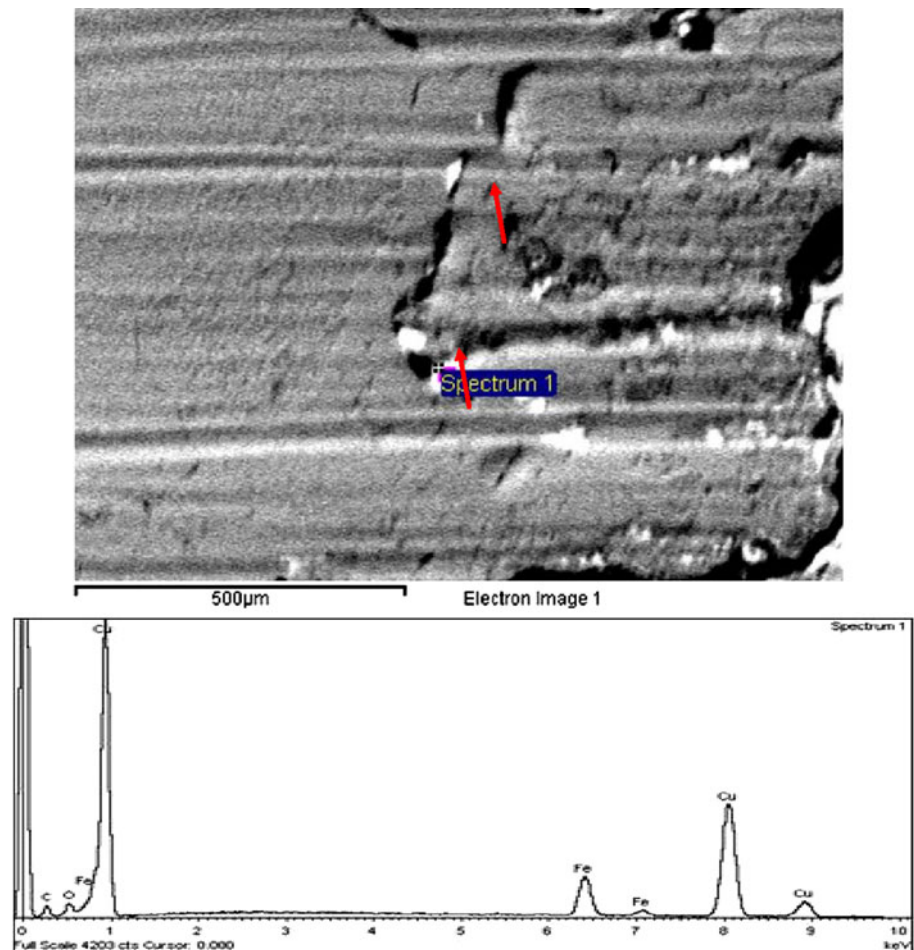
The crack samples were subjected to SEM–EDS analysis to insure the presence of copper at the grain boundary (Fig. 3). EDS spectra show the prominent peaks of copper entrapment at grain boundaries in the cracked region. The white particle shows the presence of copper at the grain boundary in the crack vicinity. An SEM image has been taken in the backscattered image mode in order to resolve the copper presence.

Fig. 3 SEM and EDS microphotograph (backscattered image mode) (white particle of copper in matrix of steel and its oxide)

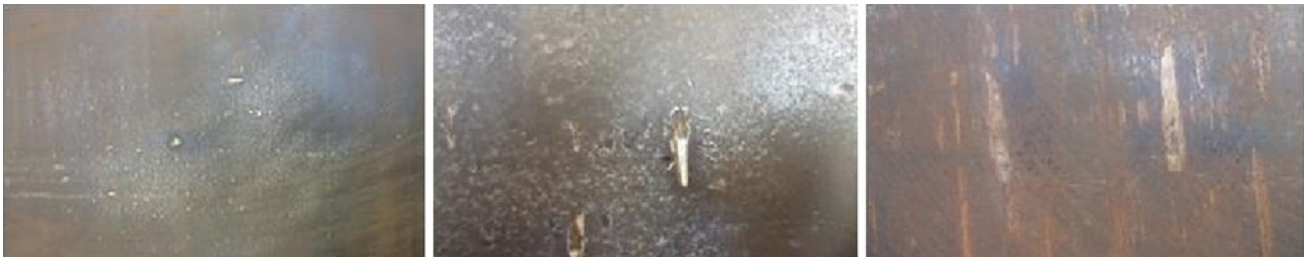
The pipes received from the LSAW plant were thoroughly inspected and the copper-alloy streaks were found on the

pipe OD surface in the transverse direction mostly and occasionally in the longitudinal direction of the pipe axis (Fig. 9).

The pipe received from the LSAW plant with Cu-alloy streaks on the pipe OD surface has led to the copper diffusion at the grain boundary during HIB operation at $\sim 980^\circ\text{C}$. The copper being a low melting point metal weakens the austenite grains which get disintegrated in the form of transverse cracks due to hot shortness and tensile

Fig. 9 Golden-yellow color copper-alloy streaks on pipe OD surface

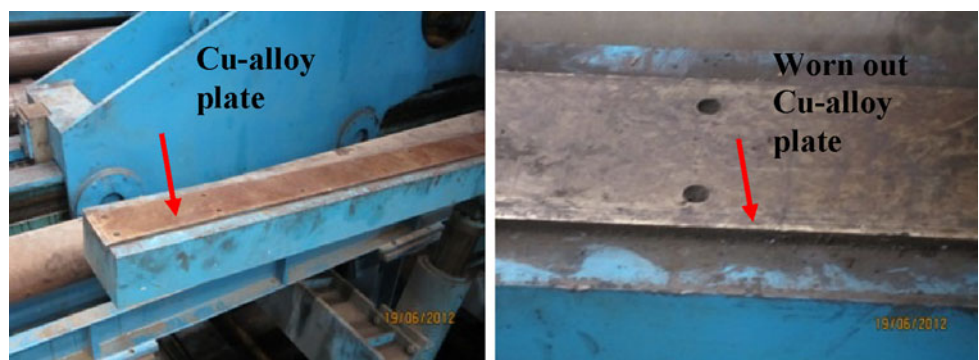
mill. The Cu-alloy plates used in the JCO mill were also found in wear condition as shown in Fig. 10. The presence of oil/ grease on these plates will help the small pieces of Cu-alloy to get stuck on the plate surface. These small pieces of Cu-alloy will get pressed in and embedded during pipe forming and appear as Cu-alloy streaks on the pipe OD surface.

Fig. 10 Cu-alloy plates in wear condition at JCO mill

The use of hard lubricated Teflon pads as shown in Fig. 11 is a better option in place of Cu-alloy plates used at the JCO mill to avoid any copper entrapment. After adopting hard lubricated teflon pads at the entry side skids, bends were manufactured from the LSAW pipes and no cracks developed during bending operation.

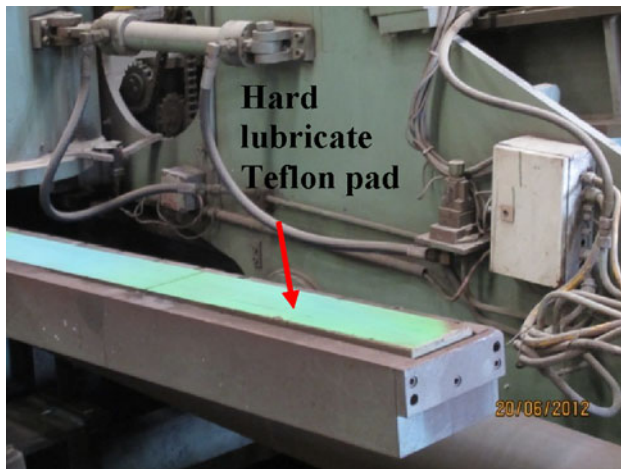
Fig. 11 Hard lubricated teflon pads
