Manufacturing Induced Hydrogen Embrittlement of 52100 Bearing Steel Outer Ring

P. Roffey

Submitted: 12 November 2014 / Published online: 4 December 2014
© ASM International 2014

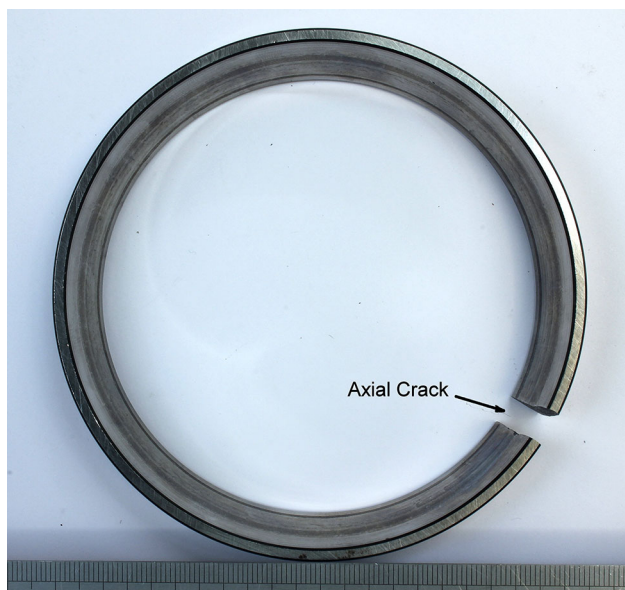
The failed roller bearing had been used on a tractor wheel axle. Each of the components, the outer ring, inner ring, cage and rolling elements, was examined in detail using stereomicroscopy. Although all of the components showed some form of damage, the most distinctive feature was the full width axial crack observed on the outer ring, Fig. 2. The crack was oriented perpendicular to the raceway and

Fig. 2 Overview of cracked outer ring

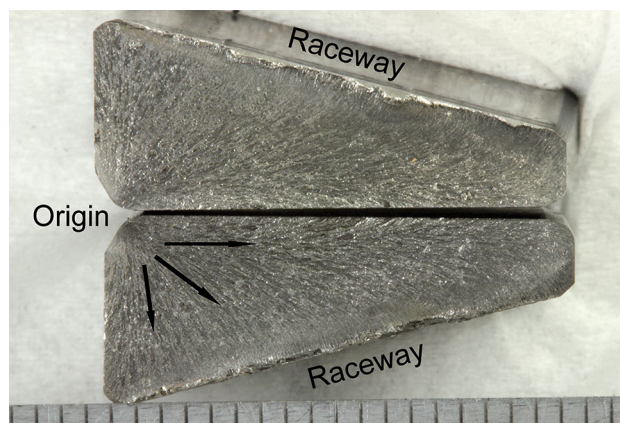
showed clear evidence of origination from the machined corner near to the outer surface at the thicker diameter, Fig. 3.

Fracture direction could be identified due to propagation marks from the origin towards raceway surface. The surface possessed no coarse, jagged final overload region with only high-cycle fatigue observed across the whole section. The fracture surface had suffered limited post fracture

Fig. 3 Overview of fracture surface on outer ring following sectioning

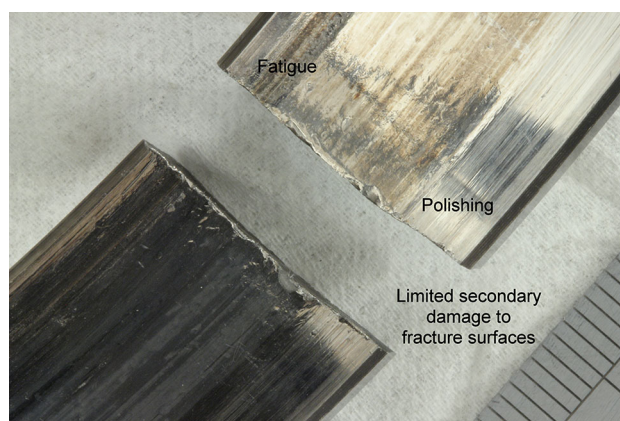
Fig. 4 Crack edges on running track indicating recent failure

damage which often impedes fractographic analysis. Light polishing and a narrow band of fatigue damage were identified on the outer ring raceway although no material loss had occurred, Fig. 4. The outer surface of the ring, which mated with the housing, had small patches of light fretting but no corrosion or mechanical damage near to the fracture origin, Fig. 5.

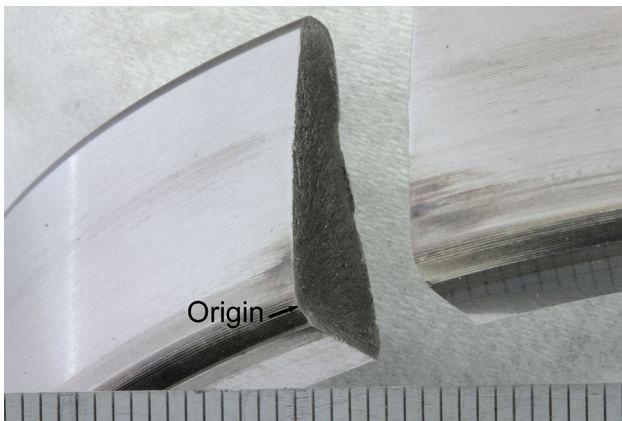
Fig. 5 Fracture surface of crack showing origin from abutment face on outer surface

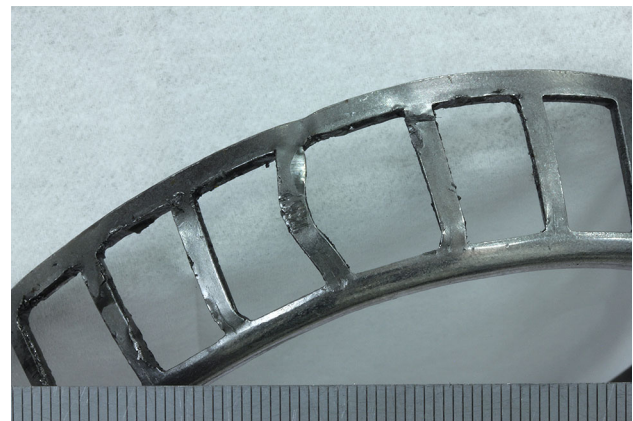
Fig. 7 Fractured cage arm, possibly due to roller seizure

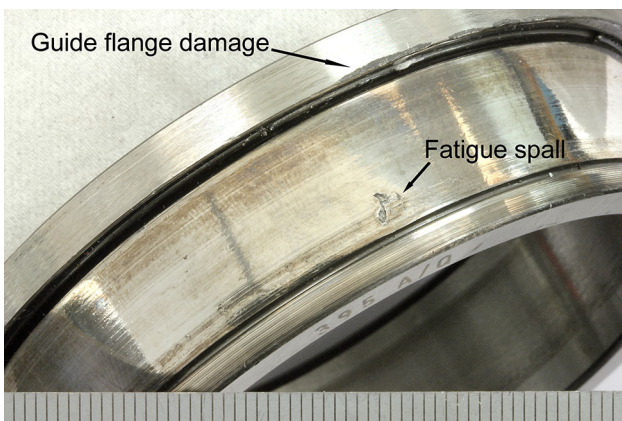
Two fatigue spalls were present on the raceway of the inner ring, along with polishing and secondary mechanical damage on the guide flange, Fig. 6. The cage was intact but had undergone some plastic deformation, Fig. 7. Several of the rollers had catastrophically failed, although the majority remained in relatively good condition with slight indentation damage from entrained debris, Fig. 8.

Fig. 6 Fatigue spall on inner raceway close to guide flange

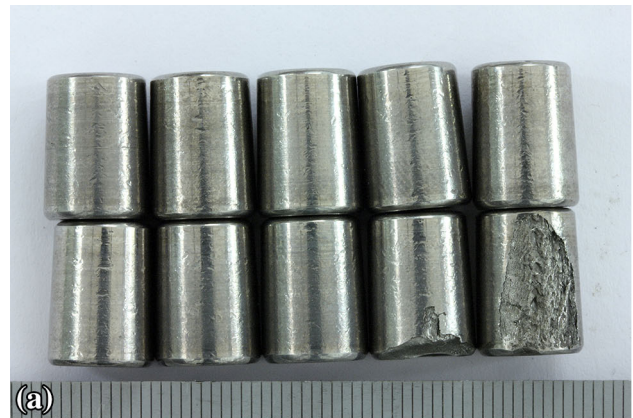
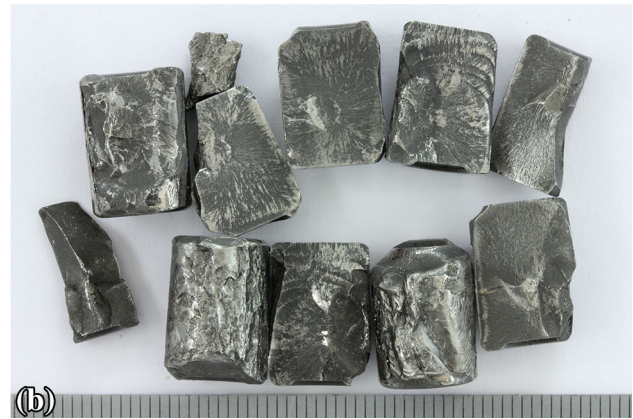
Fig. 8 Overview of rolling elements either intact or catastrophically failed

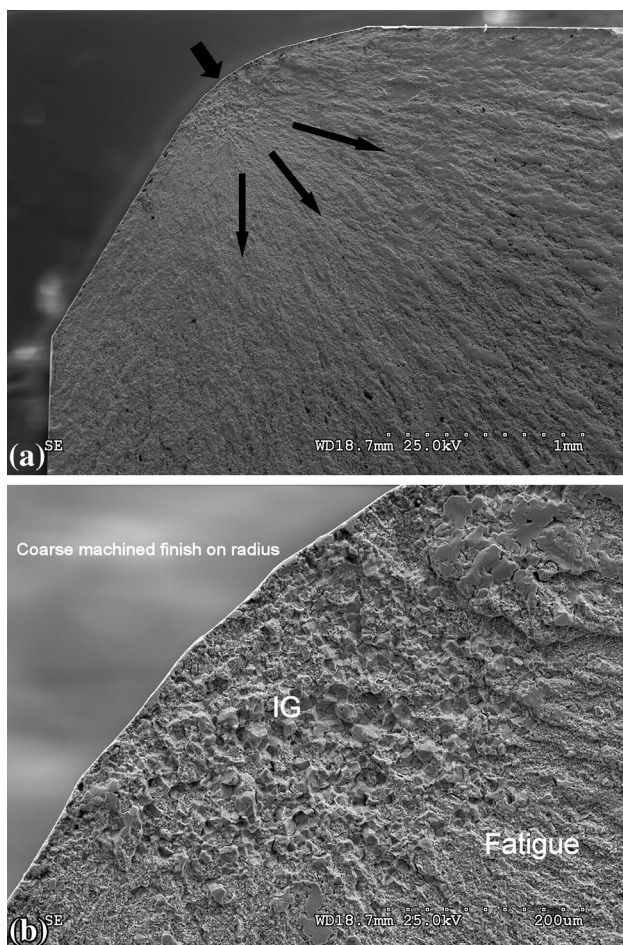
High-magnification imaging was performed on the outer ring using scanning electron microscopy (SEM). The fracture origin at machined radius possessed a 300 μm intergranular (IG) crack, Figs. 9 and 10. IG cracking in bearing rings is typically associated with environmentally assisted cracking (EAC), i.e. corrosion related. Examination of the external surface close to the origin however showed no indication of corrosive attack, either general corrosion or pitting corrosion, Fig. 11. A small impact mark was identified adjacent to the origin; this however was not directly at the point of fracture and was more likely a result of the bearing removal process following failure. The remainder of the fracture surface showed a high-cyclic fatigue propagating towards the raceway with no final overload region present, Fig. 12.

Fig. 9 (a) Overview of fracture surface—crack origin at radius on outer surface of ring and (b) fracture origin—intergranular (IG) fracture region at surface—depth $\sim 300 \mu\text{m}$

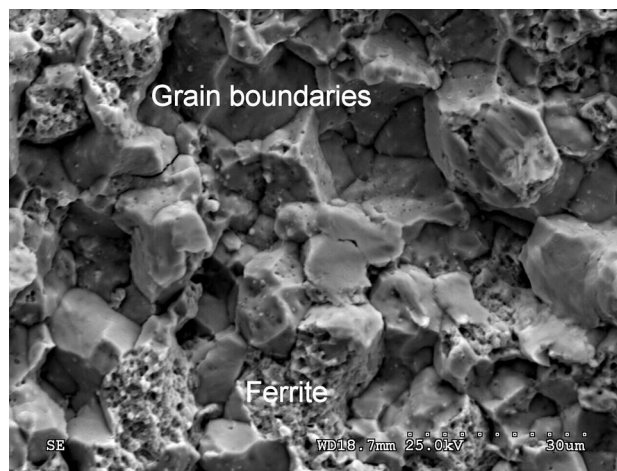
Fig. 10 Detail of IG cracking mechanism with grain boundary separation and propagation through the ferrite phase

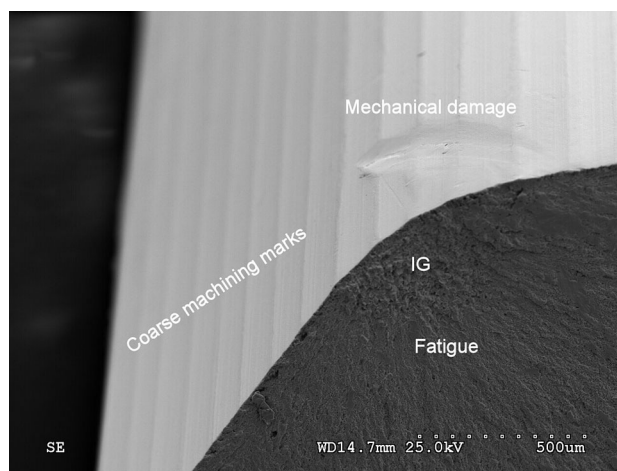
Fig. 11 Coarse machined radius close to fracture origin—note mechanical damage close to fracture but no corrosive attack

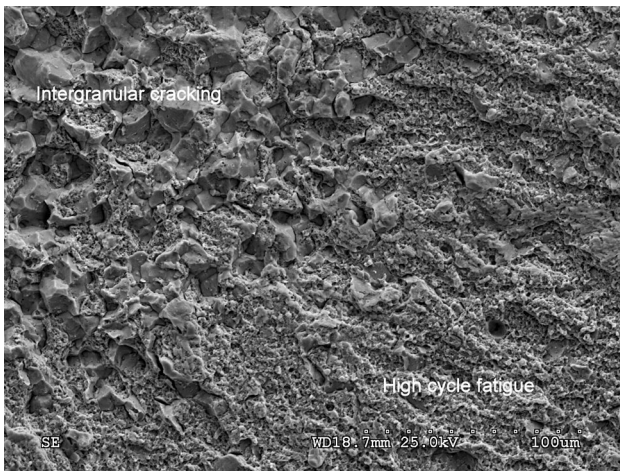
Fig. 12 Boundary between IG crack and fatigue propagation

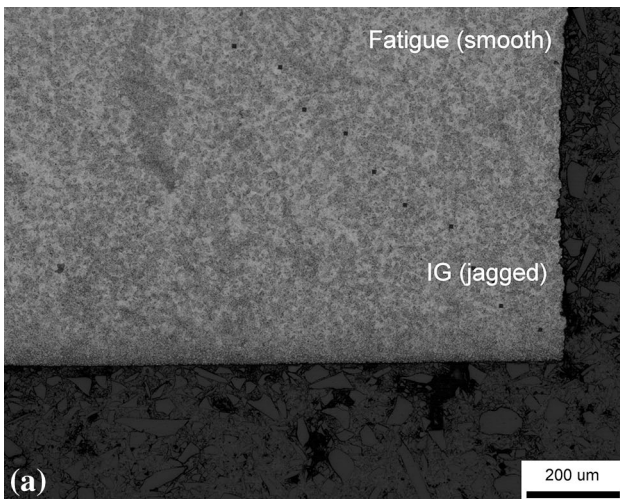
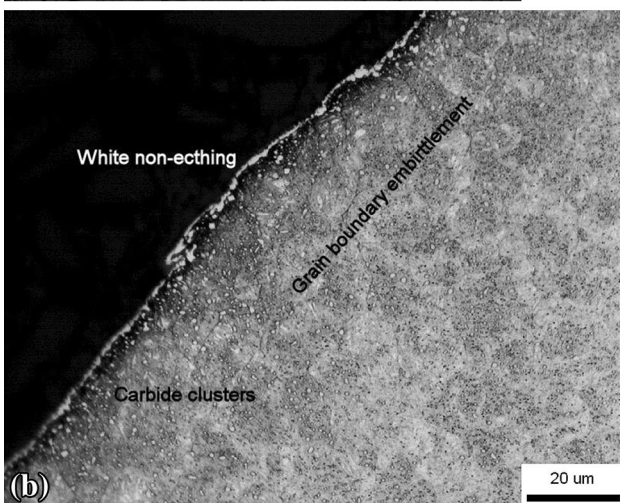
The IG propagation when viewed in cross-section revealed a coarse morphology with no branching; this was followed by the relatively smooth fatigue propagation, Fig. 13(a). The microstructure was mottled bainitic with

prior austenite boundaries visible; the mottling is the result of localised variations in composition. High-magnification examination of the machined radius surface revealed evidence of IG embrittlement along the entire length with a high distribution of grain boundary carbides, Fig. 13(b).

Fig. 13 (a) Cross-section through fracture surface with coarse IG crack followed by ‘smooth’ fatigue propagation (b) detail of embrittled surface with high carbide distribution at grain boundaries

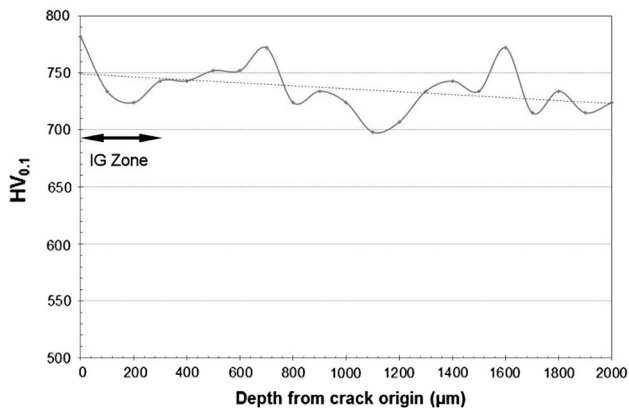
Hardness testing was performed on polished microsections using a Vickers indenter (HV) and a load of 100 g ($\text{HV}_{0.1}$). A profile obtained from the origin to a depth of 2 mm is plotted in Fig. 14. The average hardness was measured at 736 HV with no large increases or decreases within the embrittled region.

Fig. 14 Hardness profile from outer surface near fracture origin on outer ring to a depth of 2 mm

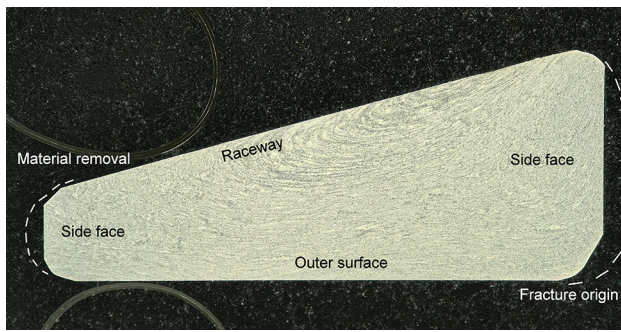
Fig. 15 Overview of etched transverse microsection through outer ring showing forged structure. Dashed lines indicate most likely forging shape prior to machining

The initial shape of a forged bearing ring means that the rounded edges on the side faces require a greater amount of material removal from these locations to achieve tolerance and surface finish. Likewise, the outer surface and raceway will undergo substantial material removal, with the raceway being finished to a polished surface. The corners of the ring, or radii, however require less strict tolerance and can be left with a relatively coarse machined finish, Fig. 15.

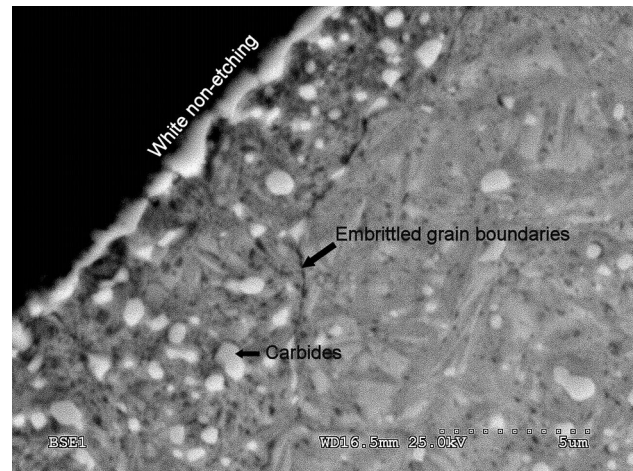
Fig. 16 SEM micrograph showing IG embrittlement, carbide clustering and white non-etching material on the machined surface

A common form of material embrittlement during the manufacturing stage is hydrogen diffusion into the structure, i.e. hydrogen embrittlement (HE), particularly for materials above the 320 HV threshold. Thus, heat treatments should be performed correctly to avoid hydrogen diffusion. The diffusion of the hydrogen follows the path of least resistance along ferrite grain boundaries, through the ferrite phases and along the interface between the ferrite and pearlite phases resulting in the loss of ductility and tensile strength. Grain boundary separation and separation through the ferrite phase were observed on the fracture surface, Fig. 16.

To allow the steel to effuse the hydrogen and avoid embrittlement, baking processes can be carried out to components. This process however may be only applicable to certain material and may affect the materials properties, thus it should be performed to the correct parameters.
