# Failure and Fracture Analysis of Austenitic Stainless Steel Marine Propeller Shaft

G. Pantazopoulos · S. Papaefthymiou

**Abstract** A fractured in-service ship-propeller shaft (50.8 mm, i.e., 2-inches nominal diameter) was examined to determine the causes of failure and to recommend preventive measures to minimize the risk of recurrence. The findings of the failure analysis investigation suggest strongly that the shaft failed due to rotating bending fatigue initiated from the surface and close to the keyway area. The origin is located on a surface flaw (recess or dent) of approximately 100  $\mu\text{m}$  depth, which could have probably been caused either during installation, operation, or maintenance. In addition, scoring lines formed due to friction-related processes and found on the journal surface were considered as stress raisers acting as potential sites for fatigue crack initiation. Careful review of the shaft service conditions and the implementation of suitable inspection procedures adapted to the vessel planned maintenance are recommended as necessary corrective actions for failure prevention.

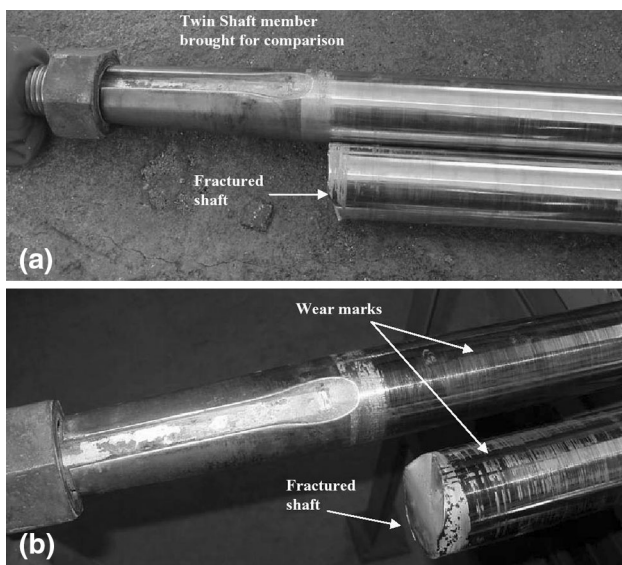
A single part of the broken shaft (50.8 mm; i.e., 2-inches nominal diameter), along with one being still in operation, is shown in Fig. 1. The matched piece (2nd half) of the fractured shaft was not available (probably sank after fracture). Both shafts were driven by a dual heavy duty ship engine ( $2 \times 720$  HP), transmitting rotational motion to the propellers, and they have been in service for almost 14 years. Shaft fracture, during navigation, led to significant loss of engine power and temporary loss of vessel stability, without any additional safety-related consequence. A simplified drawing that shows a general layout of the shaft and the related components along with the fracture location is shown in Fig. 2. The above incident led to the activation of a failure analysis procedure in order to evaluate the cause of failure and recommend preventive measures to minimize the risk of recurrence.

**Fig. 1** Macrograph showing the fractured propeller shaft and the unbroken twin member shaft (as received condition)

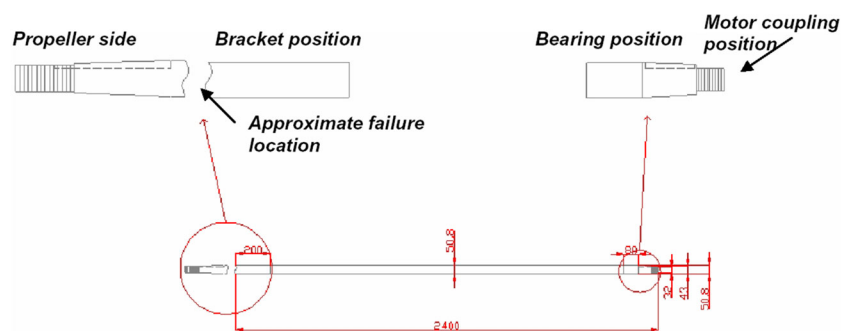
**Fig. 2** Simplified drawing of the propeller shaft and the fracture location

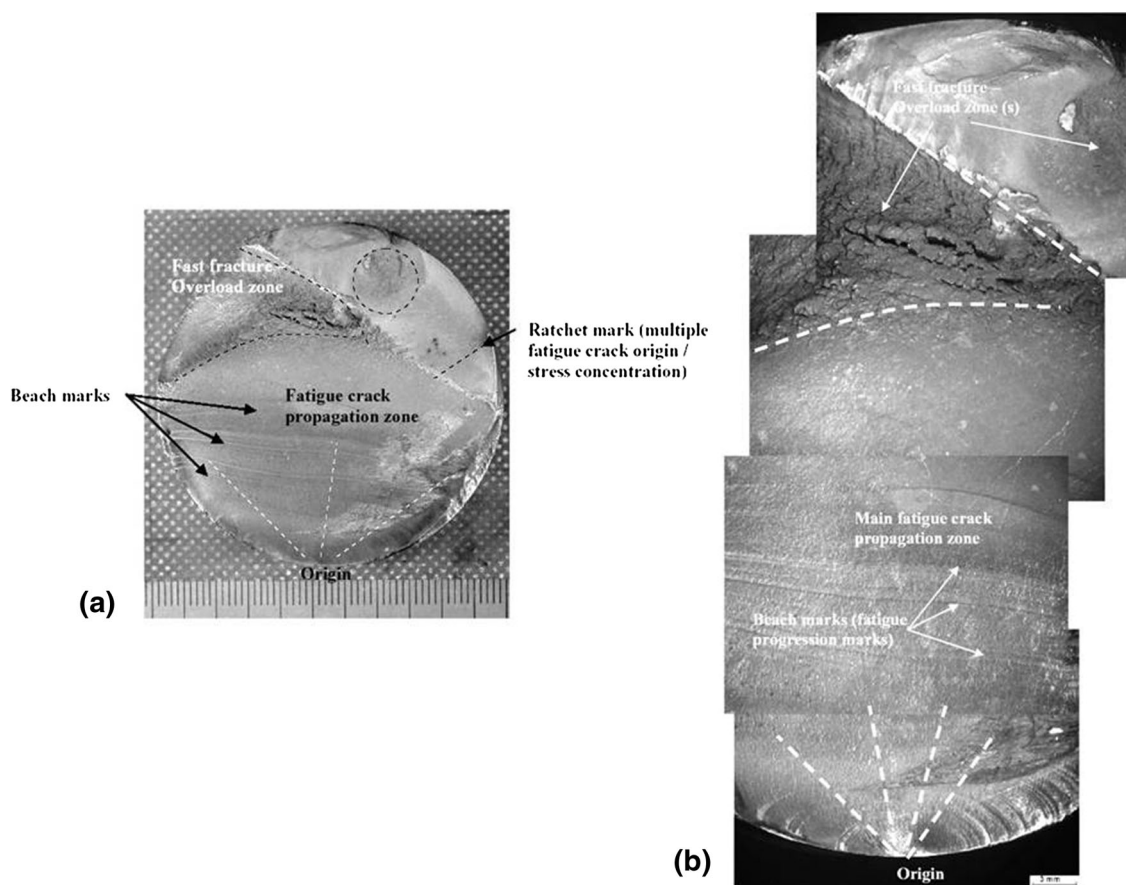
Signs of distortion due to potential shaft misalignment were not identified during rotation. Macrofractographic investigation showed clear evidence of the occurrence of

fatigue failure mechanism (Figs. 3 and 4). No visible shaft distortion and essentially flat fracture surface indicated the operation fatigue caused under complex rotational/in-plane/reversed bending loading mode [2, 3]. Industrial machine elements and engine components, subjected to various complex stress states, such as transmission of rotational motion or behaving as cantilever beams sustaining high bending moments, suffered from torsional overload and fatigue failures [4–9].

**Fig. 3** (a) Macrograph of the fracture surface and (b) macrofractographic image showing a close-up view of the fracture surface (“collage” made by superposition of specific areas) outlining the distinct fracture zones

Fast or instantaneous fracture occurred when the residual cross-sectional area reached a critical size, becoming unable to support the operating load. Final fracture surface, accomplished via overload, showed a rough morphology, having a triangular and a off-center circular shape (slightly projected out), while its extent indicates low operating stress

level (Fig. 3). The dominant type of the ultimate failure mode is dictated by the material properties and on the other hand by the existing service conditions (e.g., temperature, strain rate, local constraints). Areas that resemble to “quasi-cleavage steps,” formed as a result of brittle transgranular overload, were observed in the final fracture area (Fig. 5d).

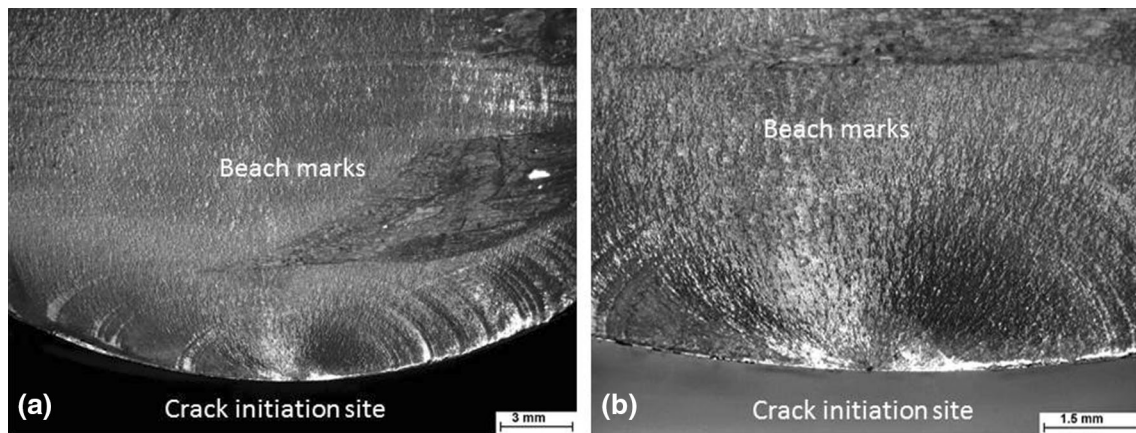
Fatigue crack in the present case is clearly initiated from shaft circumference and propagated to the interior forming a characteristic macroscopic smooth surface pattern. Surface topography displays evidence of clearly defined *beach marks*, which evolved as concentric rings (Fig. 4). Beach marks or crack arrest marks constitute crack front progression marks that formed due to intermittent loading and/or development of compressive stress state ahead of the crack tip. Surface flaws, such as pits, grooves, dents etc., serve as crack initiation sites since they cause increase of local stress concentration factor ( $K_t$ ). Ratchet marks are also another fatigue characteristic feature (see right part of Fig. 3a), indicating the presence of multiple crack initiation sites and high stress concentration, see also Ref. [5]. Furthermore, triangular shape ratchet areas may also indicate the occurrence of complex stress state including torsional loading mode.

**Fig. 4** (a) Optical stereomicrograph of the fatigue crack propagation zone (FCP), showing the presence of beach marks indicating the initiation site; (b) detail of (a)

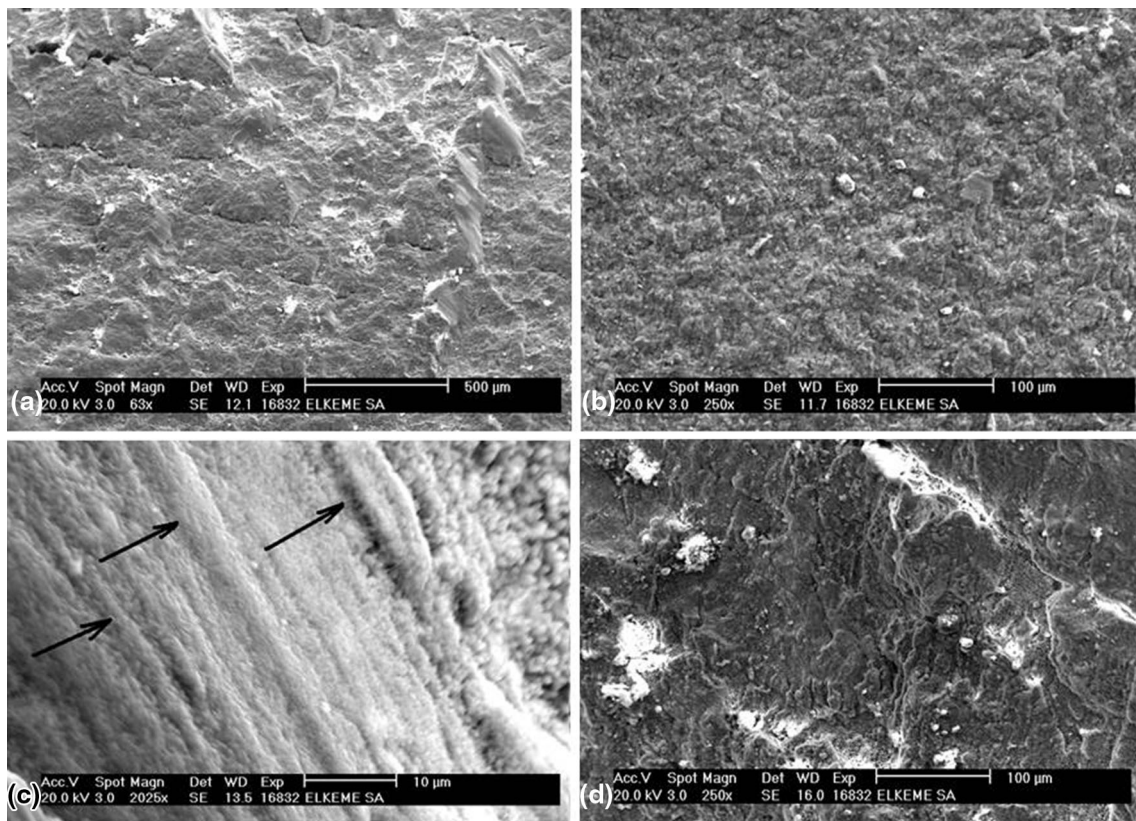
Secondary electron imaging (SEI) micrographs showed at a higher magnification the morphology of the various fracture zones on the shaft fracture surface (Fig. 5). The fatigue zone revealed mainly smeared areas from friction between crack mating surfaces with extensive secondary cracking (Fig. 5a, b). Moreover, poorly resolved striations were shown in isolated areas as depicted in Fig. 5c. *Fatigue striations*, a surface feature of fatigue crack propagation zone, constitute a microscopic fingerprint of the operation of cyclic loading. Striation pattern is formed by blunting and re-sharpening of the crack tip during stress cycling. Mean striation spacing corresponds to the average advancement of fatigue crack per load cycle. General aspects of fatigue fractographic features and the corresponding formation mechanism are also reported in Ref. [10].

**Fig. 5** SEM micrographs showing details of fracture surface topography: (a) fatigue crack propagation zone (FCP), (b) detail of (a), (c) poorly resolved fatigue striations; the arrows show the direction of crack propagation. The actual striation spacing corresponds to the local crack advancement rate per load cycle ( $da/dN$ ); (d) the rough overload area showing quasi-cleavage features

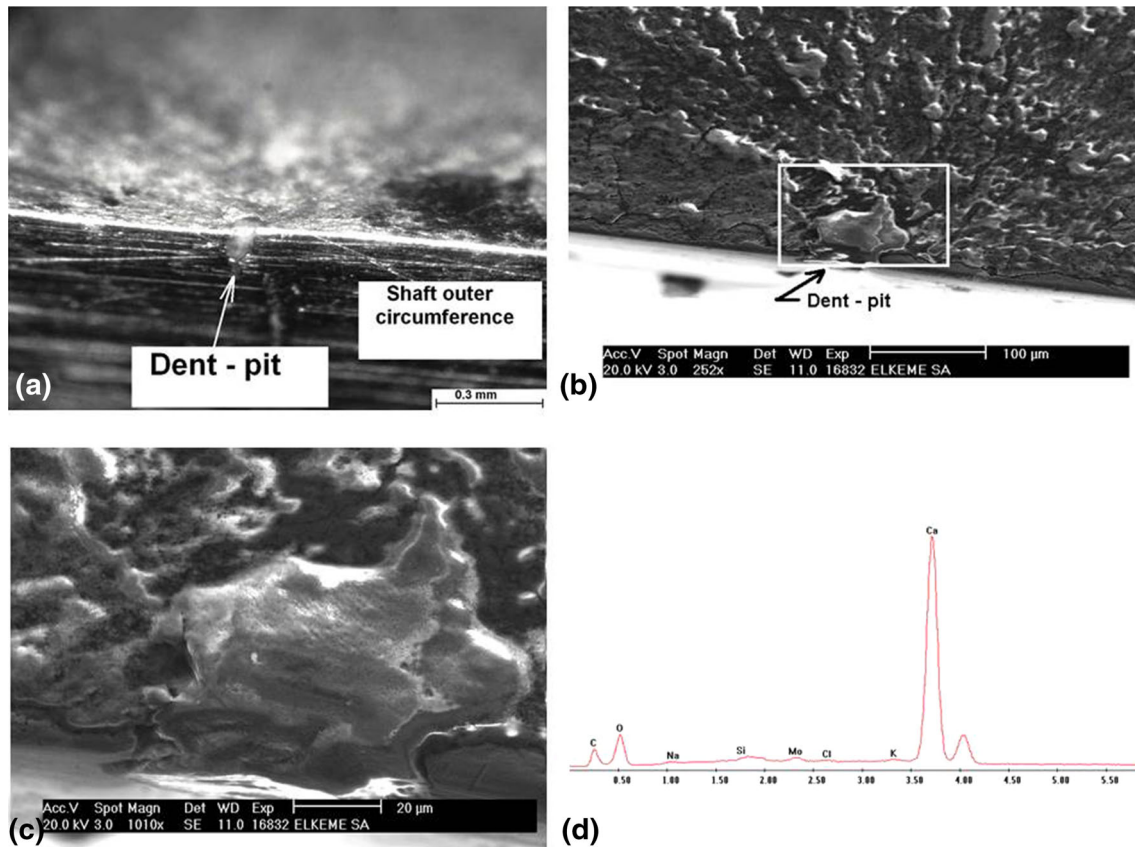
**Fig. 6** (a) Optical stereomicrograph of the fatigue origin showing the presence of localized dent contaminated with salt deposit; (b) SEM micrograph showing the fatigue origin at higher magnification and (c) details of boxed area are presented in (b); (d) EDS spectrum performed on the salt deposit found on fatigue origin area

Fatigue crack initiation area was viewed under low power stereomicroscope and under SEM (Fig. 6). The fatigue origin is located on a dent/pit coming most probably from mechanical damage during operation or handling/maintenance (Fig. 6a). The recess was filled with a wedge-shaped hard scale salt deposit (matched approximately to  $\text{CaCO}_3$ ) analyzed by means of energy dispersive x-ray spectrometry (EDS), see Fig. 6b, c and d. Selected area elemental analysis indicated severe and relatively uniform surface contamination resulted from hard scale deposits (carbonate related) that might address shaft journal cooling and operation issues. No other structural abnormality or foreign body inclusion that could be connected to the failure was identified during the fractographic study.

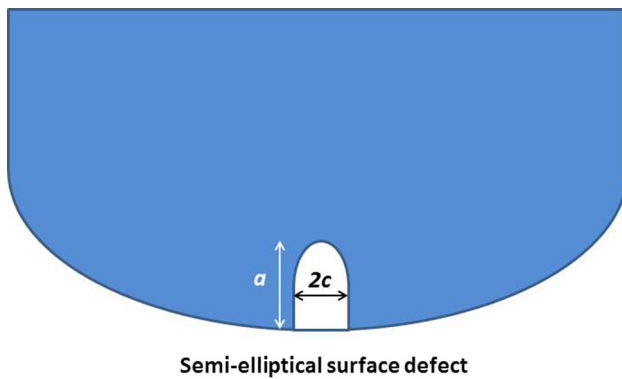
From Eq 1, the critical threshold stress range which can give rise to fatigue crack growth from the observed surface defect of semi-elliptical shape ( $\alpha = 100 \mu\text{m}$ ,  $c = 25 \mu\text{m}$ ) is deduced (Fig. 7):

**Fig. 7** Simple schematic of the geometry of semi-elliptical surface defect on the shaft's circumference

This value of stress range ( $\sigma_{r,th}$ ) equals to the threshold tensile stress, over which a fatigue crack growth could be potentially induced from such surface discontinuity (Eqs 1–3).
