CASE HISTORY—PEER-REVIEWED

# Grade P110 Tubing Shredded by Downhole Detonation

**Abstract** A failure analysis was performed on a length of API 5CT Grade P110 tubing that failed while being used in a drilling operation. Approximately 10 feet of the tubing was shredded by axial slits, and there were collapsed zones above and below the failure. The slits were at 45° to the tubing surface and showed very fine microvoid coalescence. Metallographic examination showed that the slits had formed along adiabatic shear bands. The presence of adiabatic shear bands indicated an extremely high strain rate. That, combined with the orientation of the slits, indicated that the failure was caused by a detonation of gasses in the annulus surrounding the tubing. Well operations responsible for the detonation will be briefly addressed.

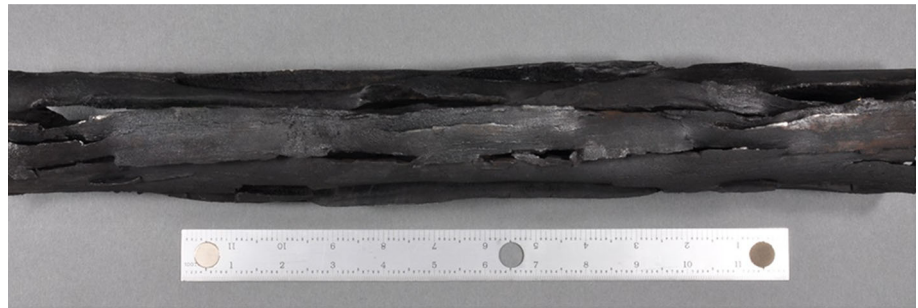
to have been shredded by a large number of axial slits, as shown in Fig. 1. The shredded tubing was approximately 15 lengths above the bottomhole assembly.

**Fig. 1** A portion of the shredded tubing, after cleaning. Scale is in inches

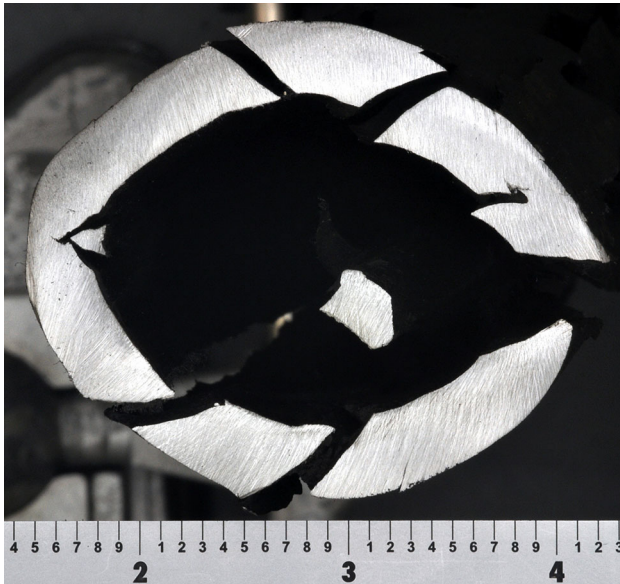
The slits were axial, but were oriented at approximately 45° to the outside surface of the tubing, as shown in the cross section of Fig. 2.

**Fig. 2** A cross section of the shredded portion of the tubing. Scale is in inches

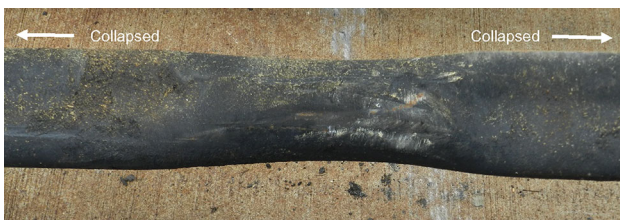
Approximately 10 feet of tubing above and below the shredded portion was collapsed, and there was an interval in the middle of each collapsed zone where the tubing retained a round profile, as shown in Fig. 3.

**Fig. 3** Intermittent collapse

The appearance of the collapse damage above and below the shredded portion of the tubing also suggested impulsive loading. In upset tubing, a collapse failure caused by excessive external pressure typically initiates at a single point and propagates rapidly in both directions until it arrests at the thicker upsets at each end, or until the deformation causes the tubing to leak, allowing the pressure to equalize. If the tubing is ductile enough that it flattens without rupturing, additional lengths of tubing above and below it may collapse as well. Because a collapse propagates so rapidly; however, it is unusual to have two separate collapsed zones in a single length of tubing, as was observed in both the damaged length and the length above it. The unusual appearance of the collapse damage thus suggested it was caused by a pressure wave rather than by sustained external pressure.

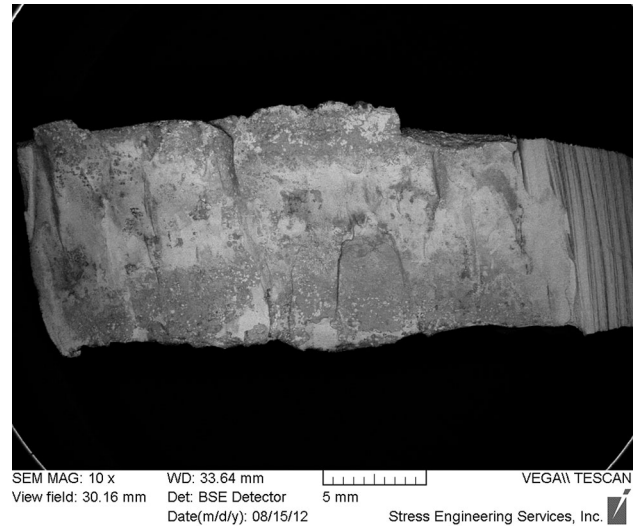
A portion of the fracture surface created by one of the slits, shown in Fig. 4, was examined using a scanning electron microscope. Although much of the surface was covered with an adherent oxide, the exposed portions of the fracture were very flat, but showed a fine microvoid coalescence fracture, as shown in Fig. 5.

**Fig. 4** SEM backscattered electron image of a fracture surface

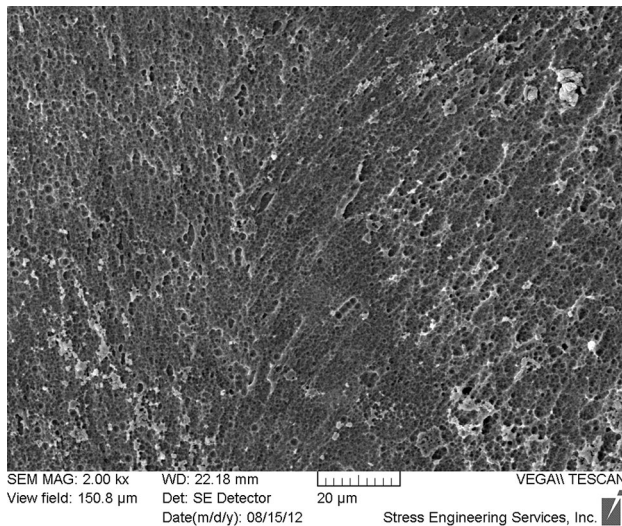
**Fig. 5** SEM secondary electron image, showing fine microvoid coalescence fracture. Original magnification:  $\times 2000$

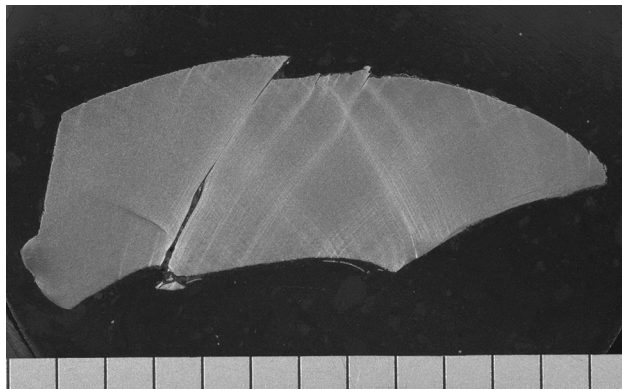
A metallographic specimen, shown in Fig. 6, was prepared from a transverse section of a strip created by two of the slits. The specimen was criss-crossed with slip bands at  $45^\circ$  to the surface, parallel and perpendicular to the orientation of the slits. The slip bands were associated with surface relief, but did not necessarily extend through-wall. At higher magnification, it was evident that the fractures occurred along highly localized shear bands that were

**Fig. 6** Metallographic specimen, showing shear bands. Nital etch. Scale increments: 0.1 inch

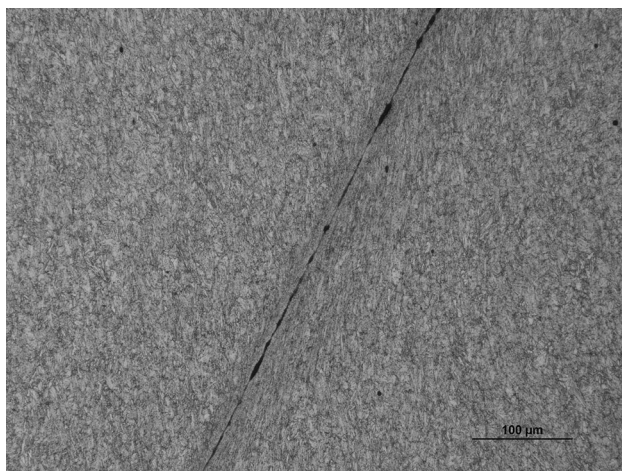
characteristic of adiabatic shear bands, as shown in Fig. 7 (For a comparable image of an adiabatic shear band in carbon steel, see Wright [1]). Apart from the deformation associated with the shear bands, the microstructure was uniform tempered martensite, typical for API 5CT Grade P110 tubing.

**Fig. 7** Fracture along adiabatic shear band. Nital etch
