Investigation and Recommendations on Bottom-Dented Petroleum Pipelines

Erik Mueller · Xiaohu Liu · Ravindra Chhatre · Adrienne Lamm

Abstract On September 21, 2015, the National Transportation Safety Board responded to a petroleum leak from a transmission pipeline in Centreville, VA. A small through crack was found leaking at a dent on the underside of the pipe, located away from any welds. The investigation found that corrosion fatigue could initiate at small dents, typically caused by impingement. While top-side dents from excavation and servicing have well-been documented and regulated, bottom-side dents, deemed acceptable per regulations, were found to be susceptible to stress corrosion and fatigue cracking. This investigation explored multiple and fundamental aspects of cracking in steel pipe dents, including nondestructive inspection, electron microscopy, finite element modeling, and long-term cyclic loading tests to characterize the cause of this pipeline accident.

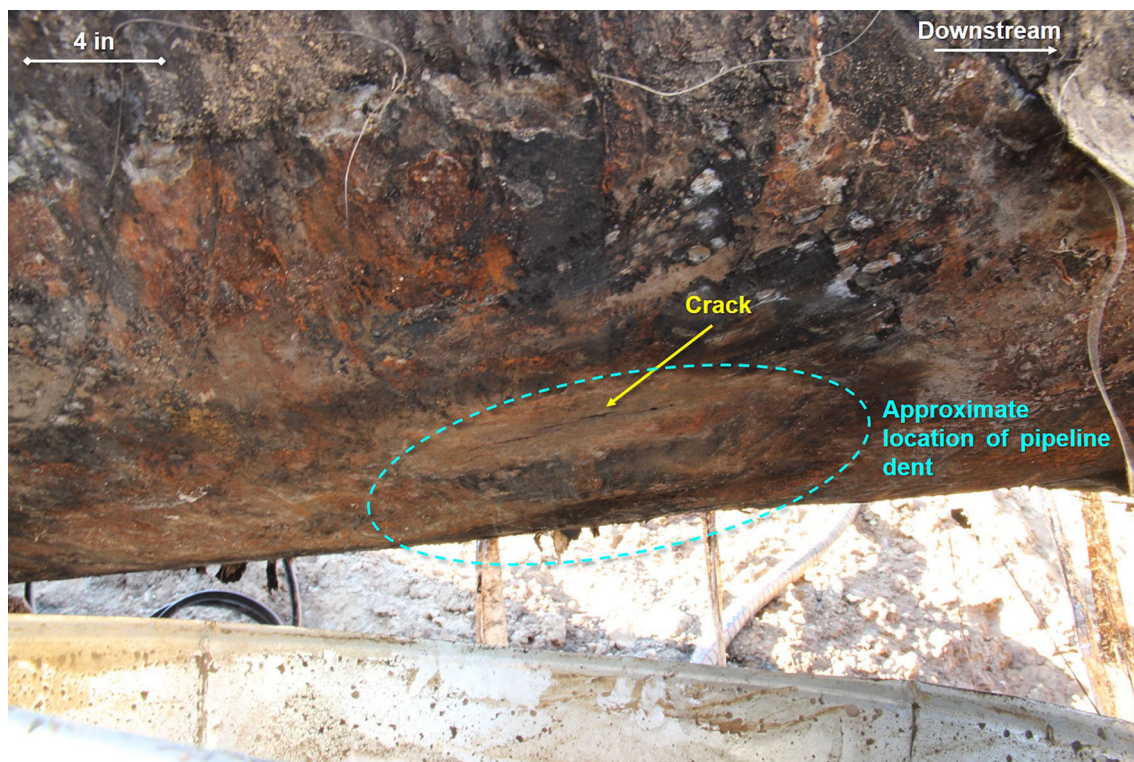
The crack was located within an inwardly dented section of the pipeline, as illustrated in Fig. 1. During the initial excavation, there was no rock or other object in direct contact with the pipeline. Reports from a prior excavation in 1994 stated that a rock had been in contact with the pipeline, but it had been removed. The enamel asphalt coating was found compromised at the leak location on the bottom of the pipe.

Fig. 1 The 6 o'clock position of the upstream portion of the pipeline from underneath, showing the crack and dent

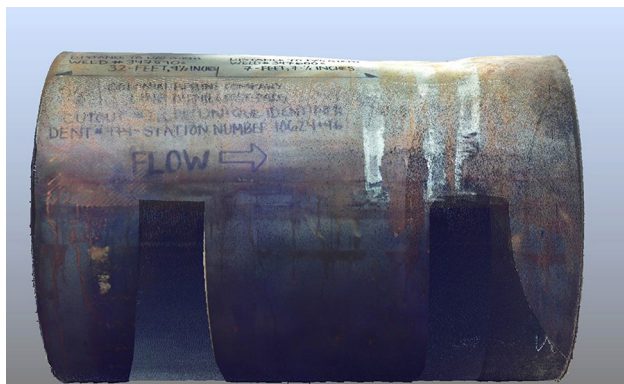
Figure 2 illustrates a rendering of the laser scan data from the cracked, dented pipe section. This dent depth was calculated as being 2.3% of the pipe diameter, and the uncracked dented pipe segment was measured a 1.9%.

Fig. 2 Rendered data representation of the dented, cracked pipeline from laser scanning, showing the pipe from the side, and the degree of material deformed at the dent

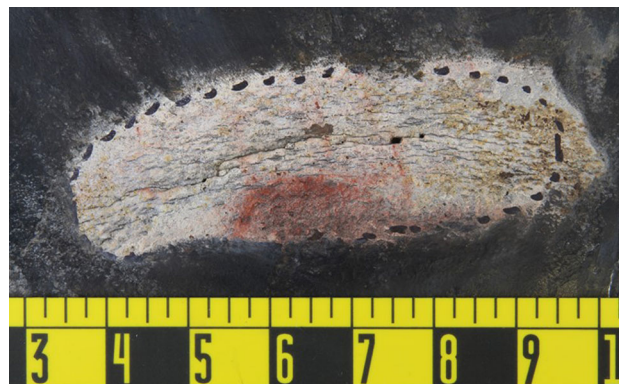
The area surrounding the cracked dent was cleaned using a wire wheel offset grinder, revealing small pits on the surface (Fig. 3). A colony of cracks parallel to the through-wall crack was present, aligned with the longitudinal direction of the pipe. The through-wall crack was backcut and intentionally overstressed (laboratory fractured). Figure 4 shows one of the mating sides of the opened crack face or fracture surface. The oxidized crack measured 5.970 inches long (152 mm) on the outer pipe surface and 4.518 inches (115 mm) on the inner. Adjacent to the crack location, the pipe thickness varied between 0.266 and 0.270 inches (6.76–6.86 mm). The nominal thickness of the pipe was 0.281 inches.

Fig. 3 View of the outside surface of the cracked pipe segment, after sectioning, showing the parallel crack colony about the through-wall crack in the white region

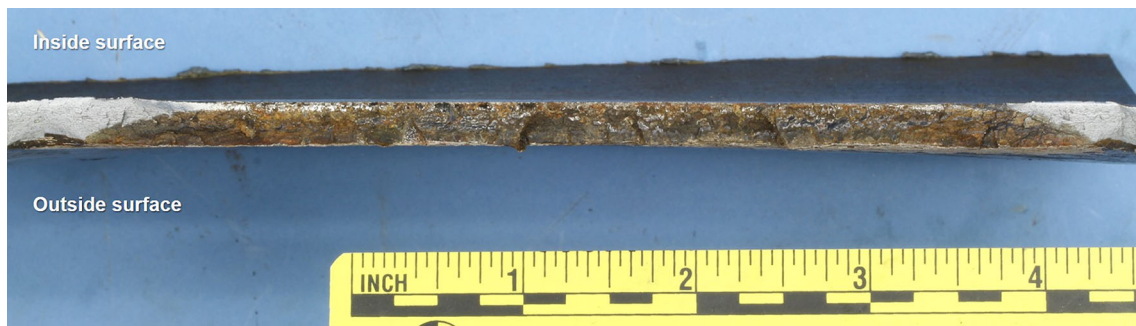
Fig. 4 View of one of the faces of the main crack after laboratory fracture and crack opening

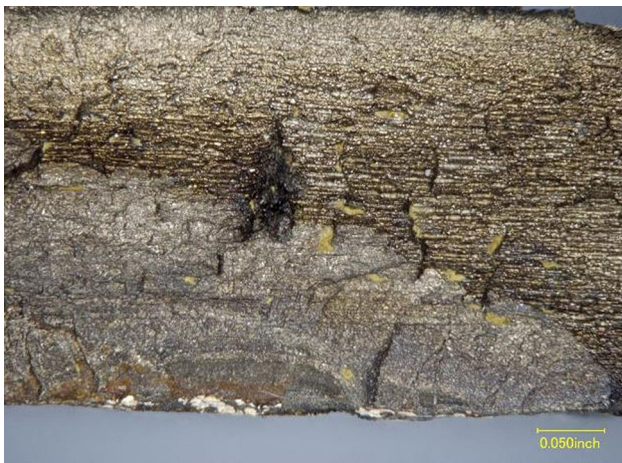
Fig. 5 View of the right edge of the through-wall crack from Fig. 4, showing crack arrest and ratchet marks, consistent with progressive cracking

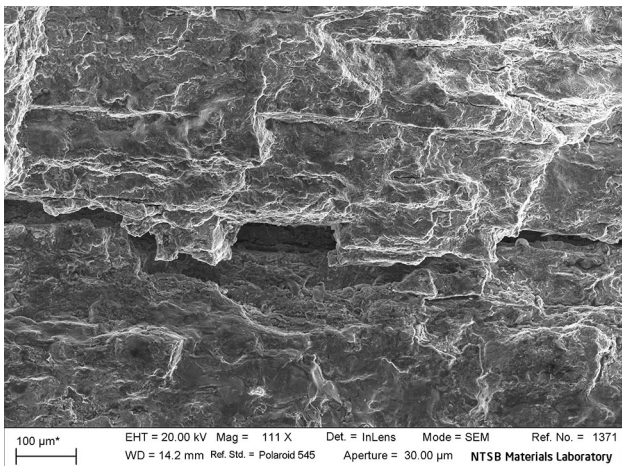
Cleaning of the fracture surface oxide also revealed an underlying faceted morphology, as illustrated Fig. 6, consistent with grains of the microstructure. A mix of fracture features, including fine dimple rupture and faint fatigue striations, was observed along the facets, consistent with a compound propagation mode such as corrosion fatigue. While most of the fracture surface exhibited a general orientation perpendicular to the outer surface of the pipe, secondary cracking perpendicular to the fracture surface was documented (Fig. 6).

Fig. 6 Secondary electron (SE) micrograph showing branched secondary cracking into the fracture surface at the end of the crack

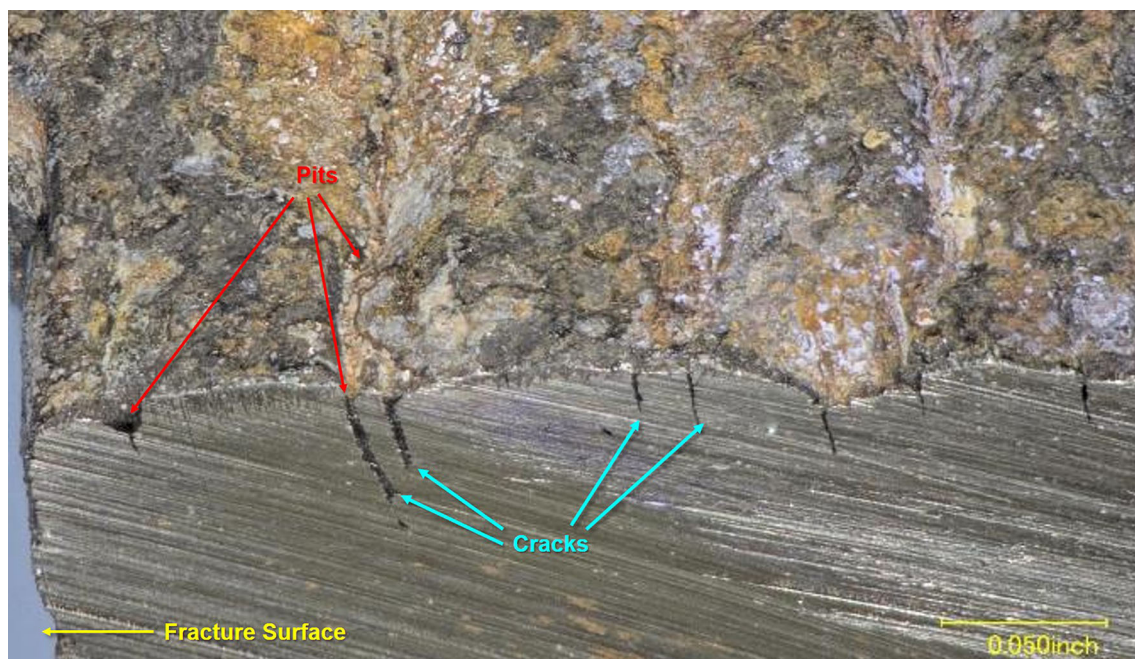
Fig. 7 Angled view of a cross section of through-wall fracture surface, showing parallel cracks propagating from pits on the outer pipe surface

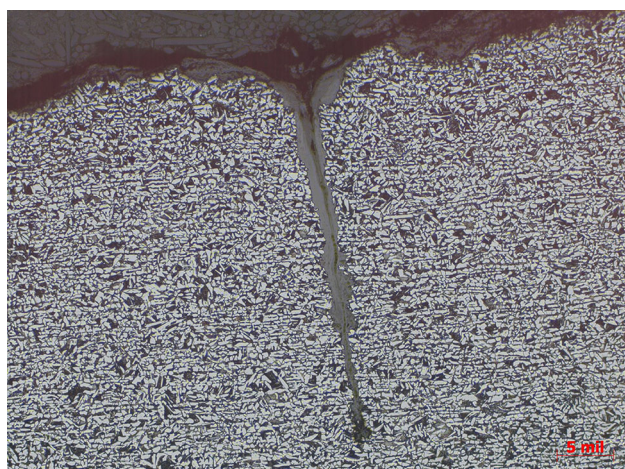
Fig. 8 Bright-field optical micrograph showing oxidation in a crack emanating from a corrosion pit, after etching with 2% Nital solution ($\sim 100\times$)

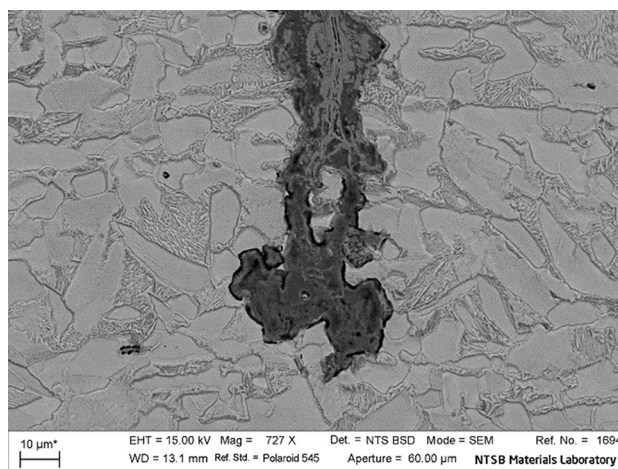
Since the initiation sites of the opened primary crack were obliterated by oxidation, the parallel cracks were examined. These cracks were observed propagating from exterior surface pits (Fig. 7). Both the pits and crack interiors exhibited material consistent with iron-based corrosion products (Fig. 8). The cross-sectioned cracks were generally consistent with transgranular propagation, but some perpendicular secondary cracking was observed. These secondary cracks tended to intersect pearlite colonies in the microstructure adjacent the main crack. Figure 9 shows the tip of the largest cross-sectioned crack. The

crack contained compounds consistent with iron oxide, as well as detectable levels of magnesium and silicon. The “darkest” areas of the crack tip oxide also contained silicon, phosphorus, sulfur, and chlorine.

Fig. 9 Backscattered electron (BE) micrograph of the crack tip from Fig. 8

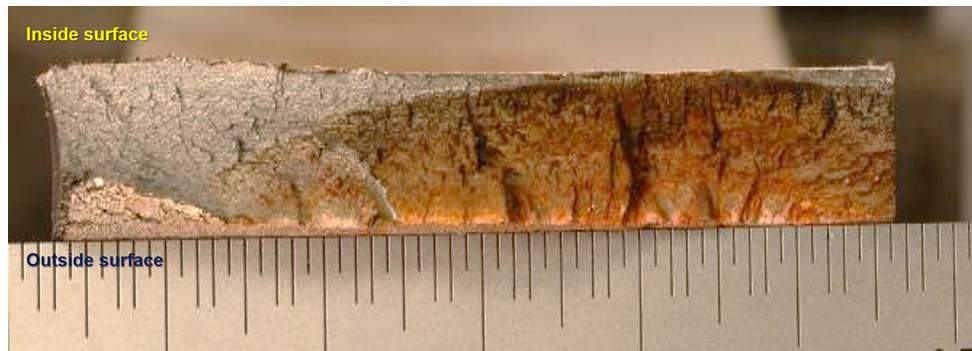
One end of this through-wall crack was cross-sectioned for metallographic inspection, and the other laboratory fractured. The opened crack face revealed a thumbnail-shaped crack that exhibited crack arrest marks and ratchet marks, consistent with the fatigue crack propagation from cyclic loading during the test (Fig. 10). The opened crack exhibited some rust, consistent with contact with the internal pressurized water.

Fig. 10 Opened fatigue crack from the dented pipe after cyclic hydraulic testing

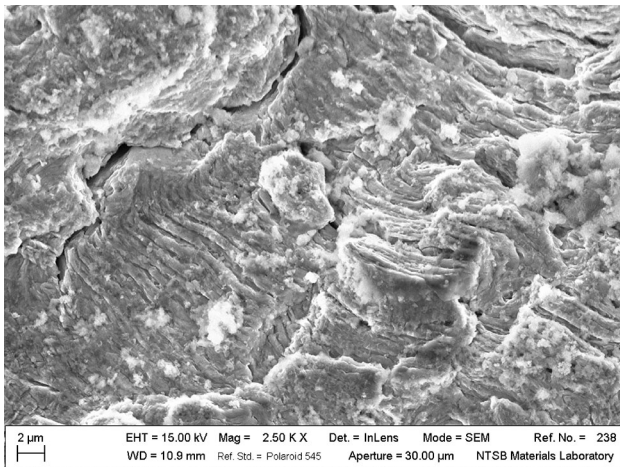
Discernible fatigue striations were observed throughout the cyclic-tested pipe fracture surface (see Fig. 11). In contrast to the accident crack fracture surface, the striations had not been obscured by oxidation, and there was no evidence of other fracture features such as grain boundary facets.

Fig. 11 SE micrograph of fatigue striations at mid-distance of the opened crack in Fig. 10

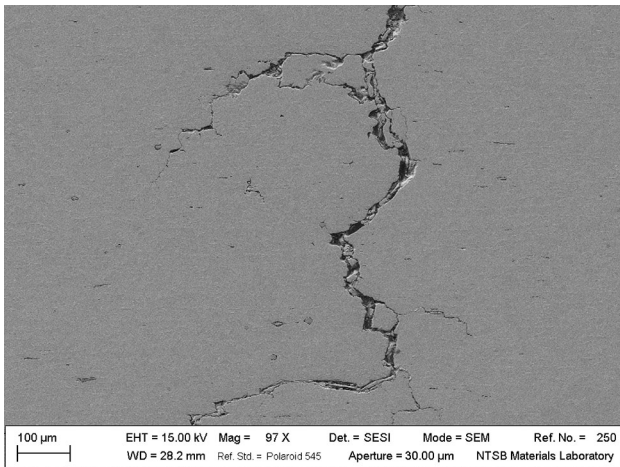
Toward the end of the fatigue crack, secondary branched cracking was present. This was observed in the metallographic cross sections, which revealed branched cracking in a parallel crack (Fig. 12). The branching occurred approximately 4 mm deep from the outer pipe surface. Closer examination of the crack did not find any propagation preference along prior austenite grain boundaries, between pearlite and ferrite, or other features.

Fig. 12 BE micrograph of a cross section of a crack parallel to Fig. 10, exhibiting crack branching
