LESSONS LEARNED

The Alexander L. Kielland Disaster Revisited: A Review by an Experienced Welding Engineer of the Catastrophic North Sea Platform Collapse

E. J. France

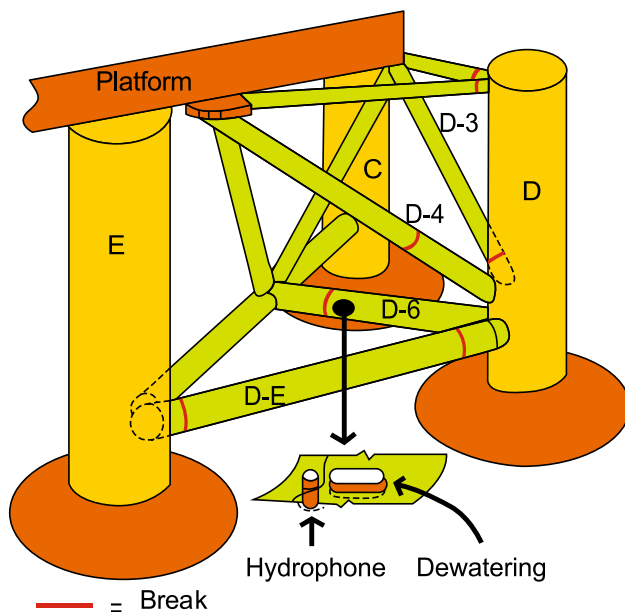
A brief examination of the fatigue characteristics defines the site of crack initiation at and around the inserted hydrophone tube, in the brace D-6. The site of the primary progressive fracture together with the later plastic failures is shown by the circumferential red markings in Fig. 1.

Fig. 1 Position of the fatigue fracture on brace D-6, marked in red

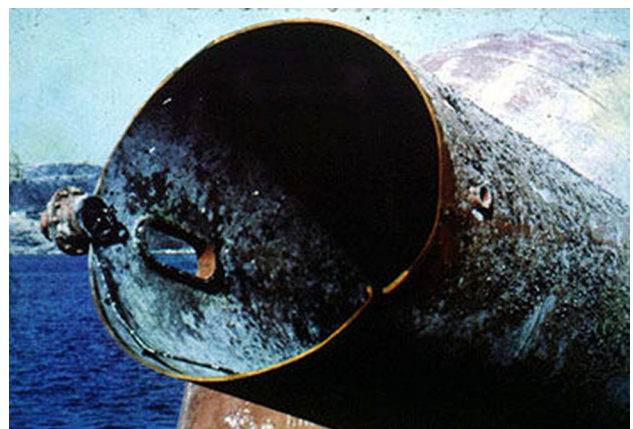
The primary fracture path is defined in Fig. 2 with the inserted hydrophone tube remaining in place beside the drainage port.

Clearly, part of the insert weld remained integral since the components are still rigidly attached after some 3 years of service. The entire surface fracture characteristics were scrutinized to establish, unequivocally, the changing mechanisms of fracture along this path, Fig. 3. The results of this study are conclusive, with two fatigue fracture initiation sites (I and II see Fig. 3), at diametrically opposite points within the overall fracture plane. The cyclic fatigue crack paths were characterized by “clam shell” markings which arise from minor changes in the direction of the crack tip during progressive crack extension. These pathways were approximately 312 cm (II) and 113 cm (I) in lengths, prior to the more rapid crack extension by both ductile fibrous tearing and latterly by brittle fracture shown by the chevron markings. In total, the fatigue crack components represented about 53% of the crack surfaces. Investigators reported the presence of paint layers within the intended weld bead, which confirmed the defective weld condition before the structure entered service. The lifetime of the brace D-6 is significant; it also confirms and identifies that the quality of the steel used in its fabrication was appropriate.

Fig. 2 Fatigue crack propagated part way round the insert and then the brace

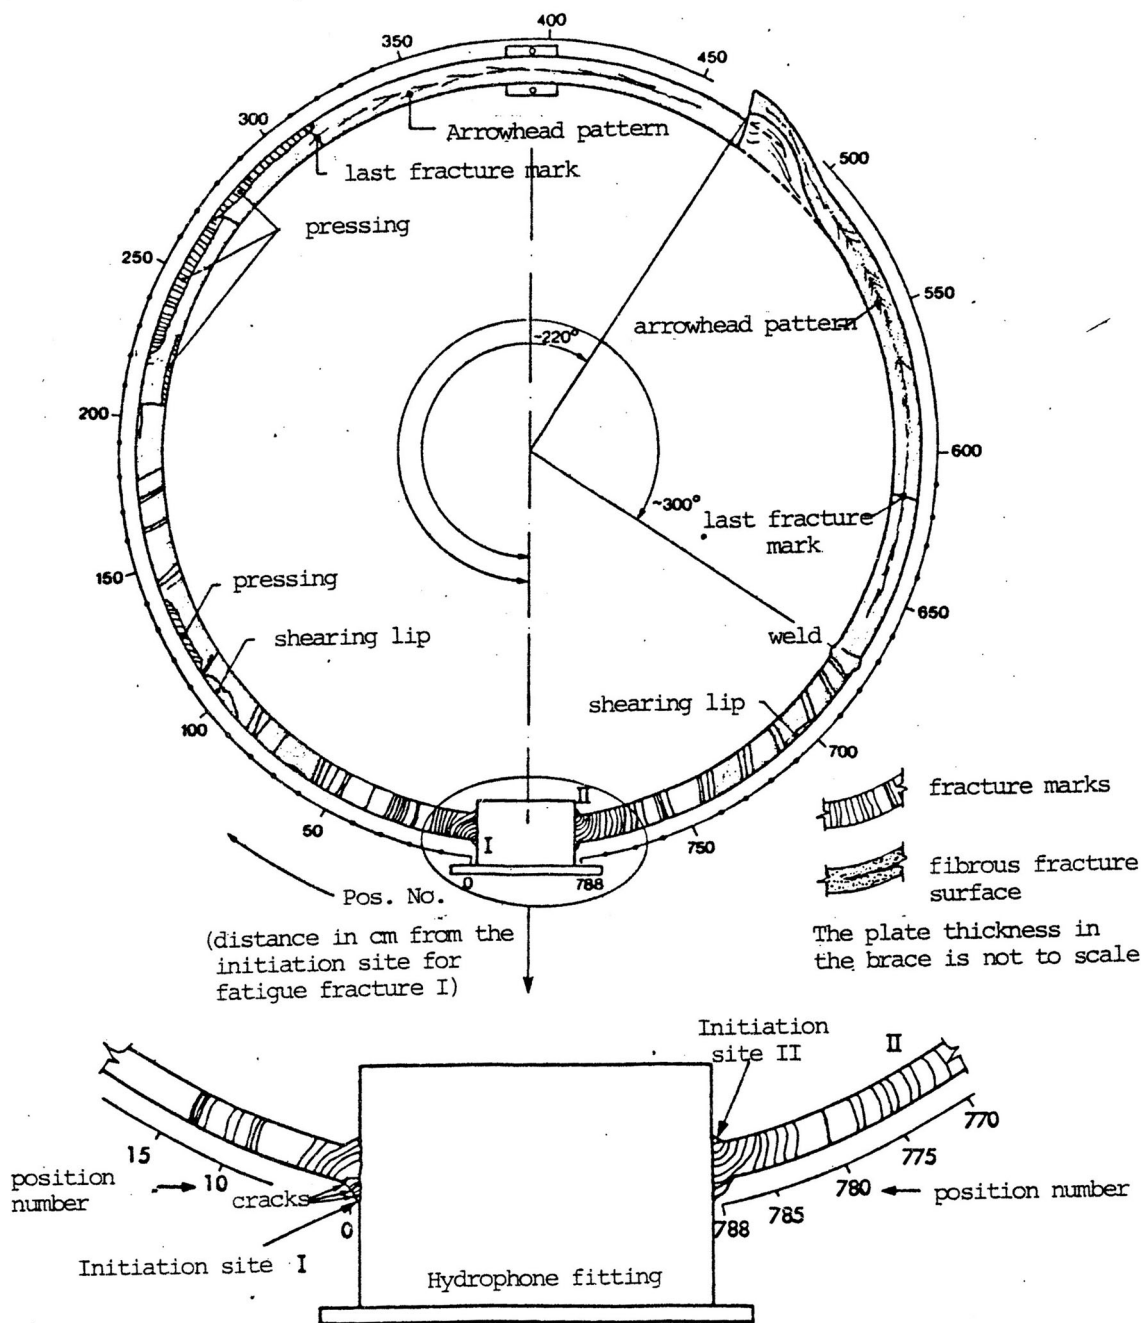
Fig. 3 Schematic representation of the fracture surface around the hydrophone tube taken from the accident report [1, p 338]

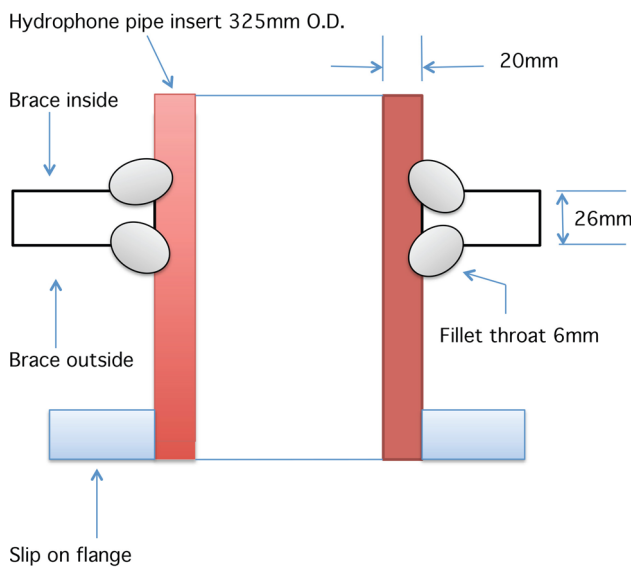
At this point in the review, a welding engineer would demand a detailed study of the weld design and welding protocols. It was and remains a fact that the weld was produced in a zone of designated and low nominal stress level, using materials which met the required chemical and mechanical property specifications. The hydrophone support was inserted and welded into the brace as a “set through, pipe to pipe, double sided fillet, branch weld”. The dimensions of the intended joint configuration are shown in Fig. 4.

The welding engineer would regard the joint as a point of difficulty and would not have recommended a simple fillet weld between thick wall components, which involved inserting a large circular hole into the brace, i.e. a cavity of 325 mm diameter. The weld protocol requested a 6 mm throat thickness fillet, alternatively expressed as an 8 mm leg length fillet weld, when estimated by a weld gauge. It was known that the thick-walled brace had been manufactured with both longitudinal and circumferential “full thickness penetration butt welds” and had been inserted into the fabrication as such. Why was the hydrophone insert tube not required to also have full penetration butt welds, perhaps with the reinforcement as indicated in Fig. 5?

Fig. 4 Dimensions of hydrophone insert joint

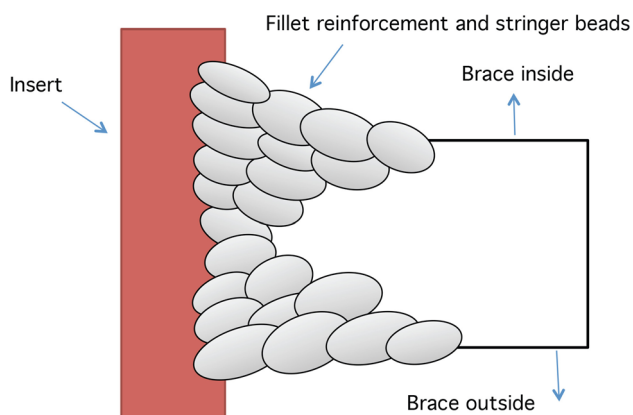
Fig. 5 Schematic representation of an insert full penetration butt weld

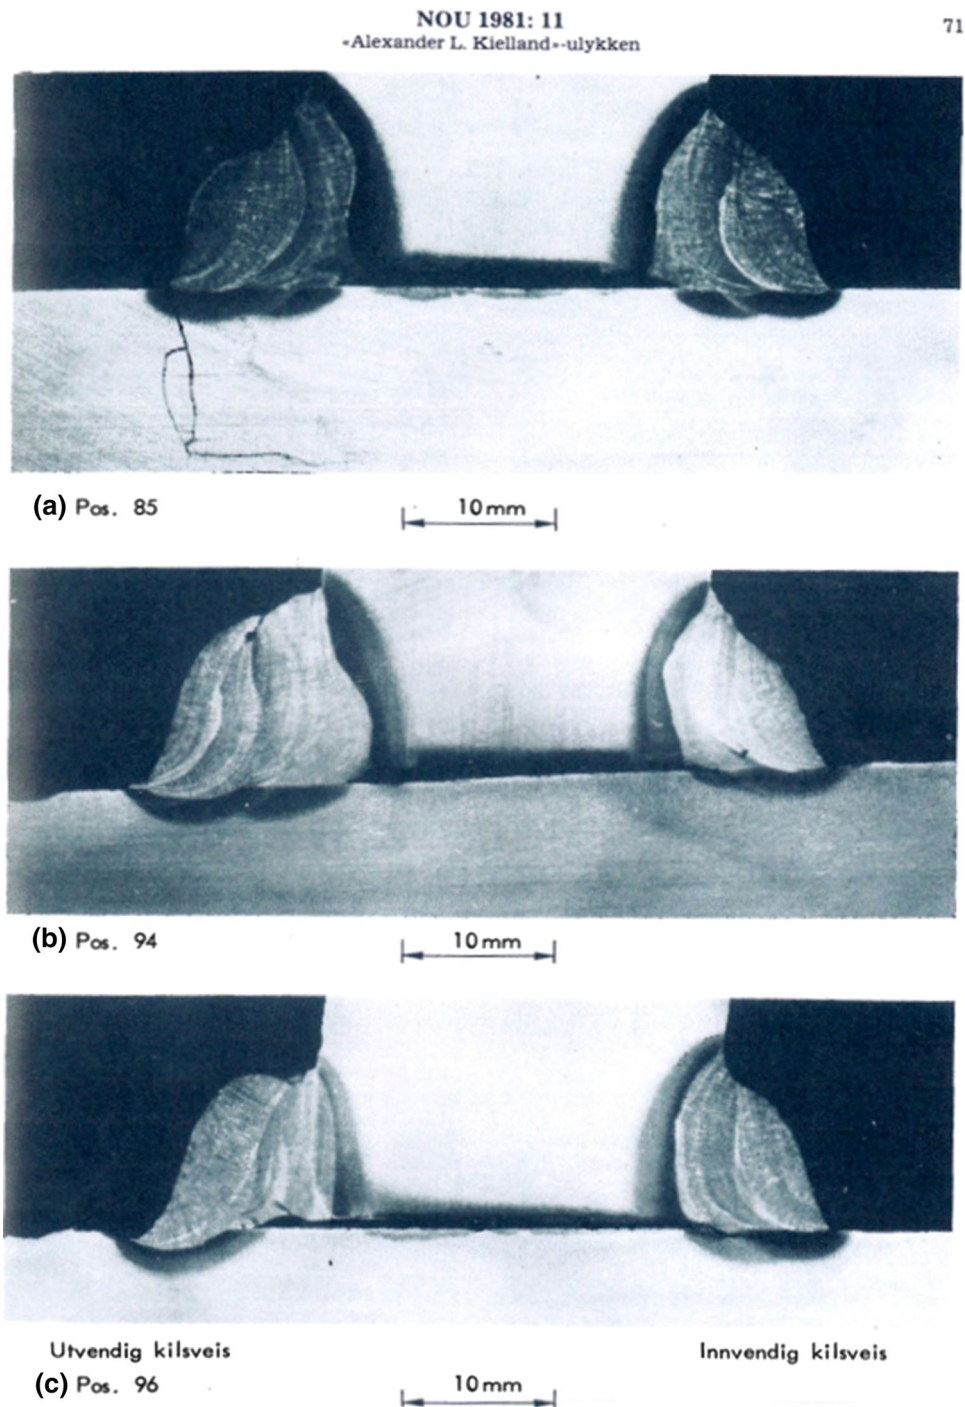
Fig. 3.1.9. of the accident report, these are the etched macrostructures at three different positions, positions P-85, P-94 and P-96, taken from the circumference/regions of hydrophone attachment remaining in place to the brace D-6, reference pages 339 Fig. 3.1.5. and 345, Fig. 3.1.15 again from the accident report. On these macrographs, the vertical plates represent the brace material and the horizontal plate being the insert tube.

All three images possess features defining the inadequacy of the welding protocol, listed as;

- Inadequate penetration of the weld into the insert tube.
- Grossly different leg lengths on opposite sides of the brace plate.
- Evidence of excessive weaving of the electrode in an attempt to generate a sufficiency of fused weld material.

Position 85—imperfections

- Hydrogen induced cracks originating at the toe of the fillet and propagating into the insert plate material. The source of this hydrogen would be moisture on the surface of the joint, inadequate baking of the electrodes and poor control of arc length or a combination of these factors. The fusion and penetration characteristics of the weld deposits with the insert tube are low in comparison with the brace material, further identifying the application angle of the electrode which was predominantly perpendicular to the brace and only parallel to the insert. This feature of the application of the welding process by the welder resulted in unequal leg lengths of 12 mm on the brace and 8 mm on the insert tube.

Position 94—imperfections

- The welder continued the electrode weaving strategy and the same electrode application strategy generating unequal leg lengths and inadequate fusion profiles. On the left side weld weaving has induced the false nature of apparently four electrode passes where in reality it is from a single pass.

Position 96—imperfections

Fig. 7 Macro-sections from around the remaining insert at pos. 85, 94 and 96

- The application angle of the electrode is so exaggerated that there is complete lack of root fusion and significantly no horizontal insert sidewall fusion. The weld structure on the left side is due to two passes of the electrode compared with the right side deposit. By chance the fillet leg lengths are seen to be equal, creating the illusion that the joint is satisfactory. In reality the joint was poorly fused generating a potential point of failure.

All of the observed weld imperfections were a result of the manner in which the welder had applied the SMAW weld process. Clearly, this earliest evidence in the investigation confirms the failure to conduct a proper and acceptable weld procedure. The authors of the official report ignored the obvious deficiencies in weld production, seeking a mechanical property test study of the parent carbon steel plate. The mechanical testing of parent carbon

Fatigue cracking usually emanates from a surface at points of highest stress and in fillet welds often at the toe sites. The toe profiles of the fillet in positions P-85, P-94 and P-96 are not blended correctly and could be preferred sites for crack initiation and propagation; the most likely site candidate, however, would be the hydrogen crack at P-85. The fact that the fatigue crack propagated from the fillet weld establishes the cyclic stress applied to the joint in service, due to imposed wave loading.
