Metallographic Investigations of the Premature Corrosion Failure of Steel Seam-Welded Galvanized Cold Water Pipes

Abstract A premature corrosion failure in seam-welded galvanized steel cold water pipes was reported to occur after just 18–24 months in service. The aim of the present work was to investigate the causes of this premature corrosion of pipes, through metallographic investigations. This work comprised chemical analyses, visual examination of internal surfaces of pipes and microstructural examinations of the corrosion perforation regions (pitting corrosion areas) using optical and scanning electron microscopy with energy-dispersive x-ray analysis. The investigations showed that failures resulted from incorrect installation—pipes were installed with yellow brass ball valves. When mixed with yellow brass, galvanized steel triggers dezincification and results in electrolytic action when combined with nonferrous metals, such as copper and brass.

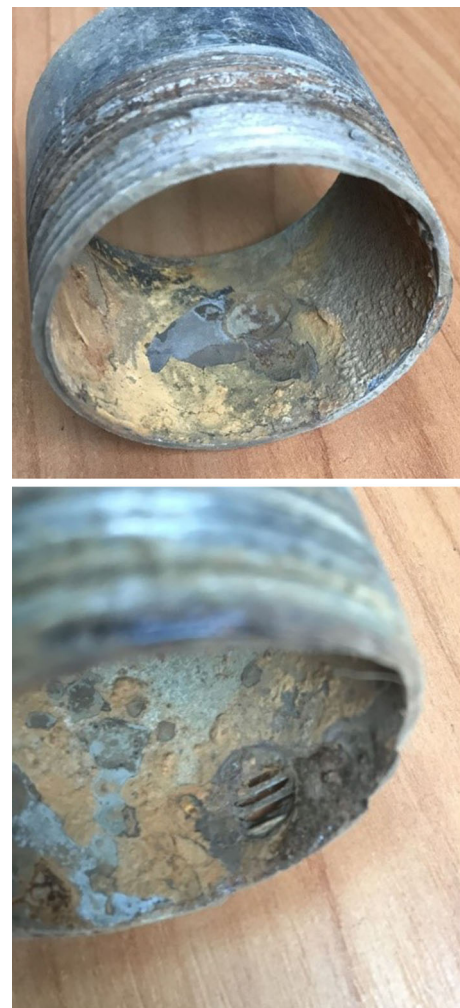
The chemical composition of the base steel as given in Table 1 meets the standard requirements for S195T steel. Typical macroscopic pictures of samples cut from the two perforated galvanized steel are shown in Figs. 1 and 2. The area marked in red in Fig. 2 was in close proximity to the screw connection pipe valve.

Fig. 1 Macroscopic view of samples of the 60.3-mm pipe

The bright, silvery gray areas present in the vicinity of the pits (Figs. 1, 2) on the inner surface of galvanized steel pipes were also observed by other authors [14], but were apparently not thoroughly examined. In [14], only macro-images of such areas were shown.

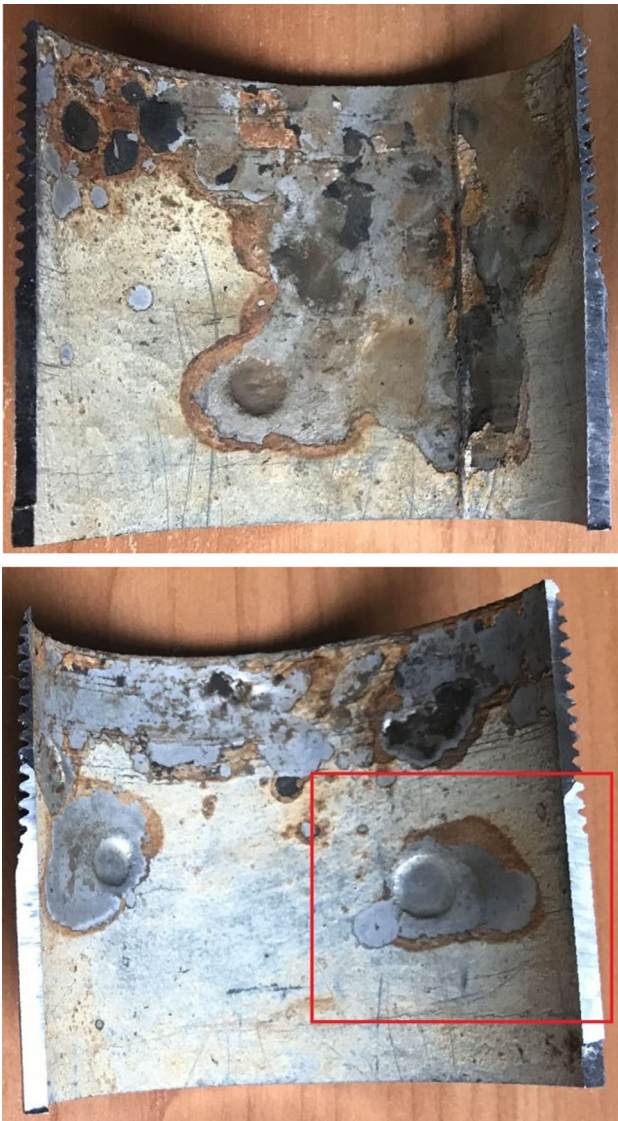
Fig. 2 Macroscopic view of samples of the 76.1-mm pipe

As shown in Fig. 2, pitting in the examined cold water galvanized steel pipes occurred only in close proximity to the screw connection pipe valve. According to information obtained from the installation user, the examined cold water pipes were installed with yellow, in contrast to the hot water galvanized steel pipes where the nickel-plated brass ball valves were installed.

The use of yellow brass valves in direct electric contact with the galvanized steel pipes is a significant installation error, and it was the cause of the premature corrosion failure of the cold water zinc-coated steel pipes. The phenomenon called contact corrosion (bimetallic corrosion) occurs when two different metals are attached to one another (in this case, galvanized steel and yellow brass) and contact an electrolyte (flowing water). This results in different electrode potentials in the two metals with respect to the electrolyte. The base metal (zinc layer on the steel) is transformed into an anode, and this leads to the accelerated corrosion of that metal and inhibits the corrosion of the other, more noble metal (yellow brass), which is transformed into a cathode. This is what happened in the cold water galvanized steel pipes in the failed water supply system. When mixed with brass, galvanized steel triggers dezincification, and it results in electrolytic action [9, 10].

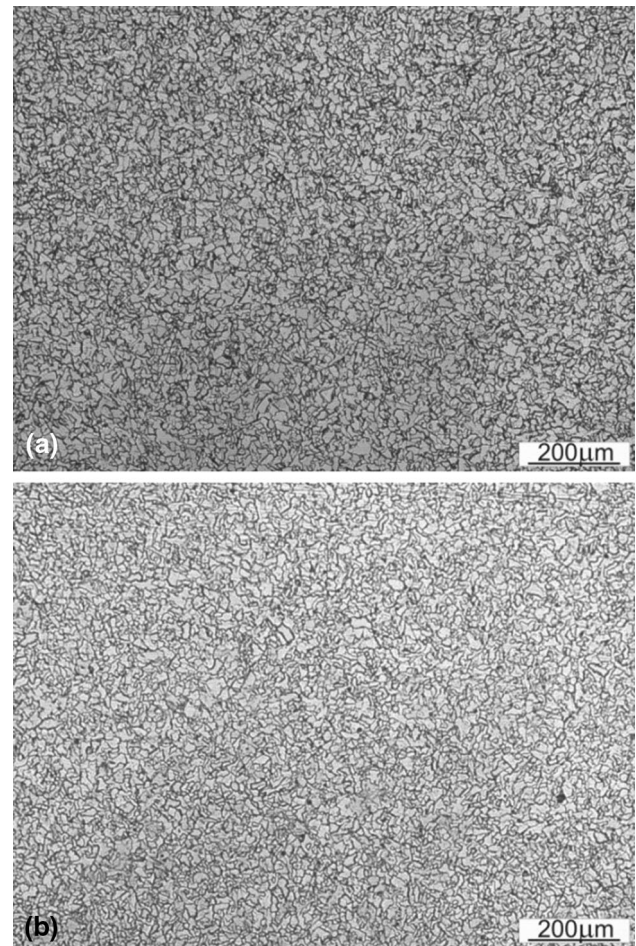
The microstructure of the base material of pipes is presented in Fig. 3 and is proper, typical for such steel grade (cross section near the pitting area). Metallographic examinations (not reported here) on transverse and

longitudinal specimens did not reveal any metallurgical defects or other irregularities in the microstructure.

Fig. 3 The microstructure of the base material: (a) 60.3-mm pipe, (b) 76.1-mm pipe

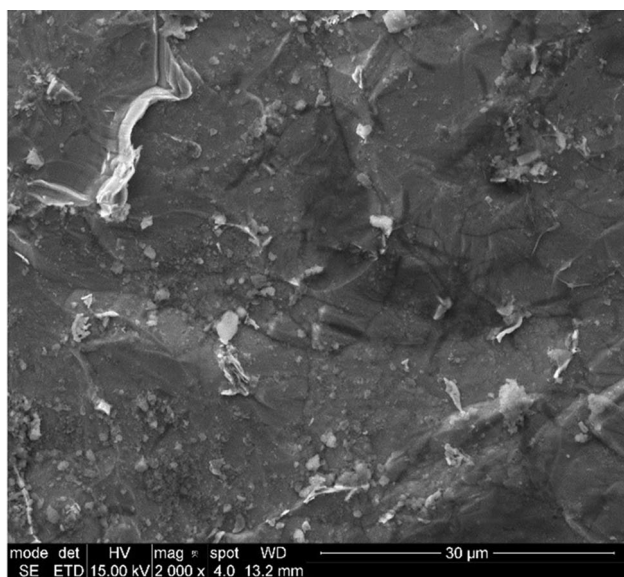
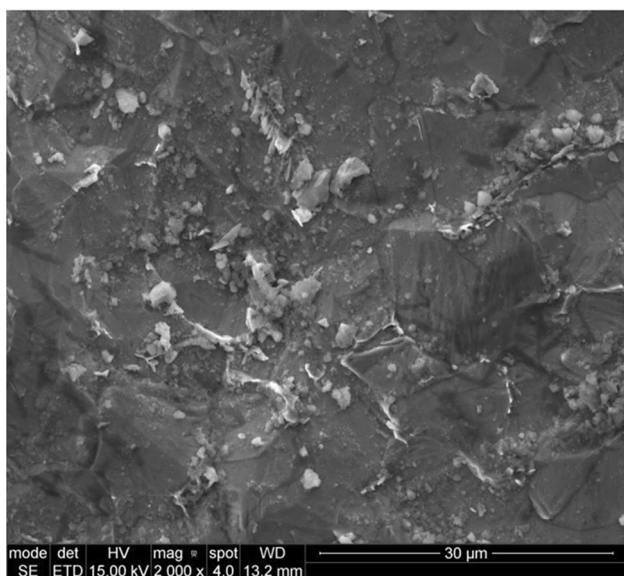
The tested galvanized steel pipe inner surface samples (pitting area) were clean and almost free of corrosion products (oxides). Figure 4 shows a scanning electron micrograph of the sample shown in Fig. 2b and shows that in this section of the pipe, near a yellow brass valve, pitting and shiny, silvery gray areas were observed in the vicinity of corrosive pits and in other examined sections. This demonstrates the purely galvanic nature of the formation of corrosion perforations in the studied pipe sections (so-called contact corrosion).

Fig. 4 Surface morphology of the pitting area of Fig. 2b: (a) pit, (b) vicinity region

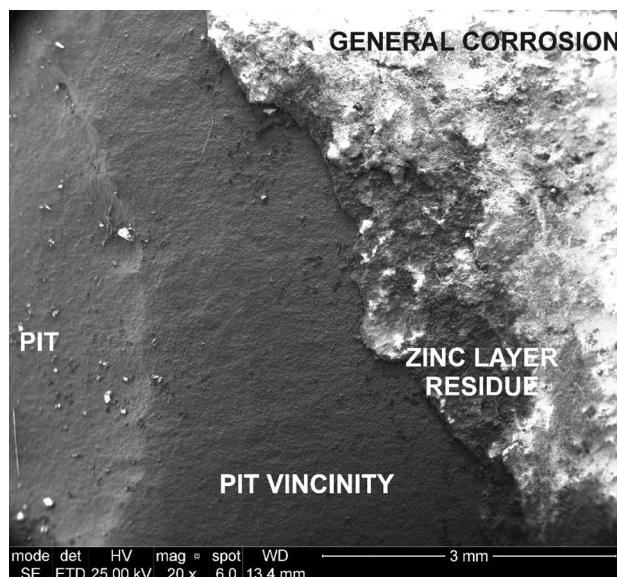
The galvanic nature of the formation of corrosion perforations was confirmed by EDS X-ray microanalysis; the results are shown in Figs. 5, 6, 7 and 8. In the area of pitting (Fig. 6), the analysis revealed the presence of elements contained in the steel, practically without the presence of zinc. Similarly, for the pit vicinity area, only trace zinc content was revealed. The thin layer, visible at the bottom right of the micrograph (Fig. 7), is a residue from the original galvanized layer (iron–zinc), while further away (right side of the micrograph), there are general corrosion products (iron oxides, Fig. 8).

Fig. 5 The area of EDS microanalysis

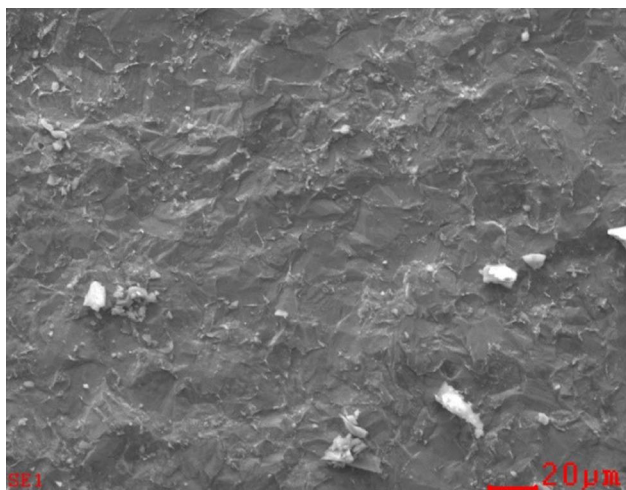
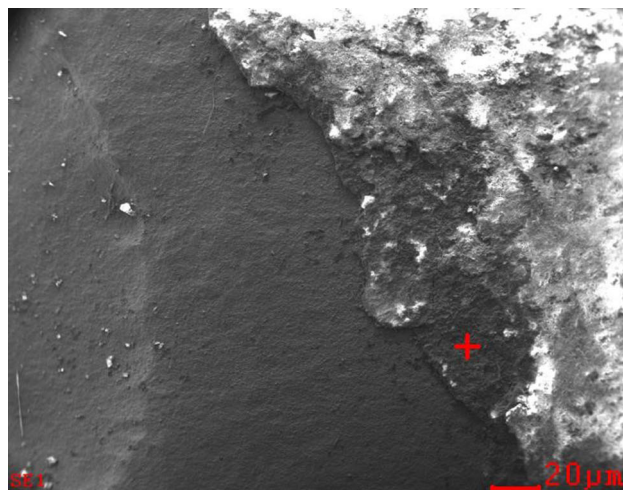
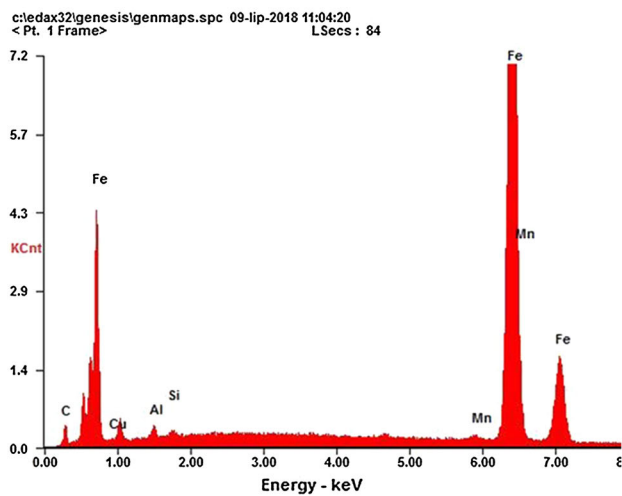
Element	Wt%	At%
CK	05.48	20.95
CuL	01.46	01.06
AlK	01.23	02.10
SiK	00.49	00.81
MnK	00.61	00.51
FeK	90.72	74.58
Matrix	Correction	ZAF

Fig. 6 The results of EDS microanalysis in the pit

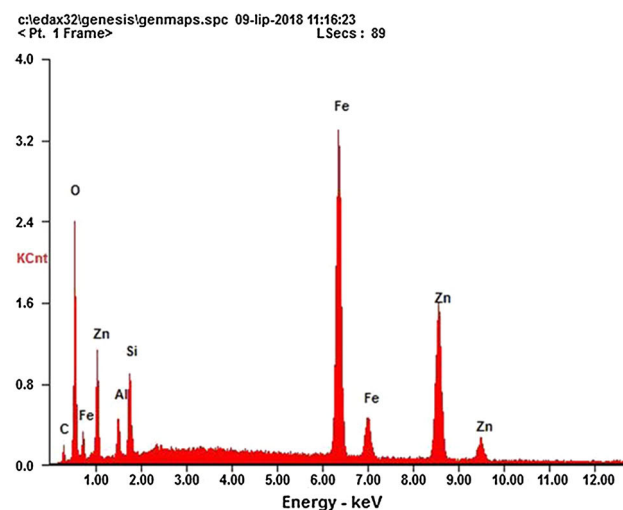
Element	Wt%	At%
CK	04.33	12.29
OK	17.95	38.22
AlK	03.12	03.94
SiK	05.37	06.51
FeK	33.31	20.32
ZnK	35.92	18.72
Matrix	Correction	ZAF

Fig. 7 The results of EDS microanalysis in the zinc layer residue

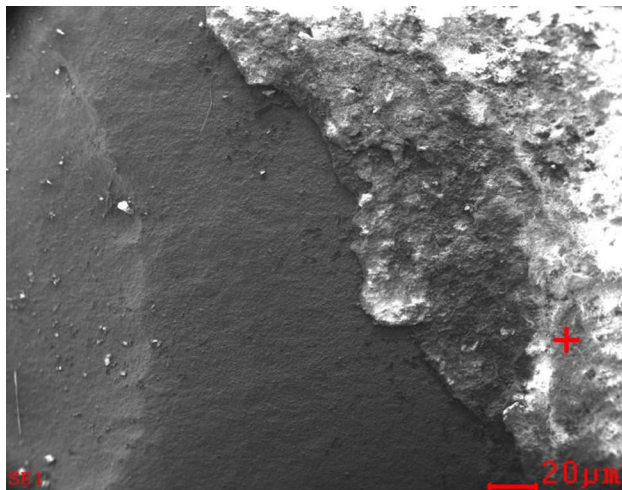
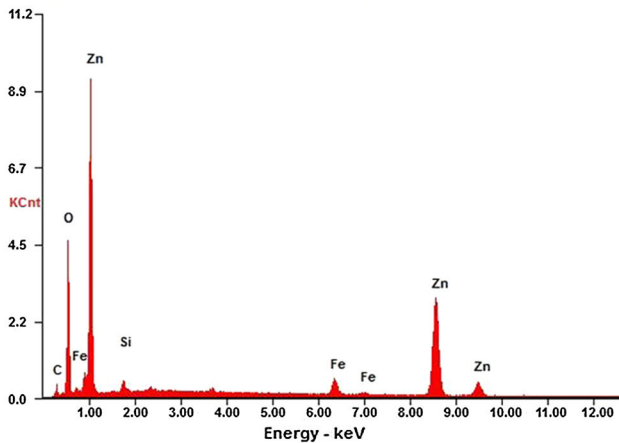
Element	Wt%	At%
CK	06.97	16.49
OK	31.07	55.21
SiK	01.88	01.91
FeK	03.63	01.85
ZnK	56.45	24.55
Matrix	Correction	ZAF

Fig. 8 The results of EDS in the general corrosion area
