PROJECT AZORIAN BACKGROUND

BRINGING PROJECT AZORIAN TO THE CLASSROOM

FRESH INSIGHTS INTO A 40-YEAR-OLD MYSTERY

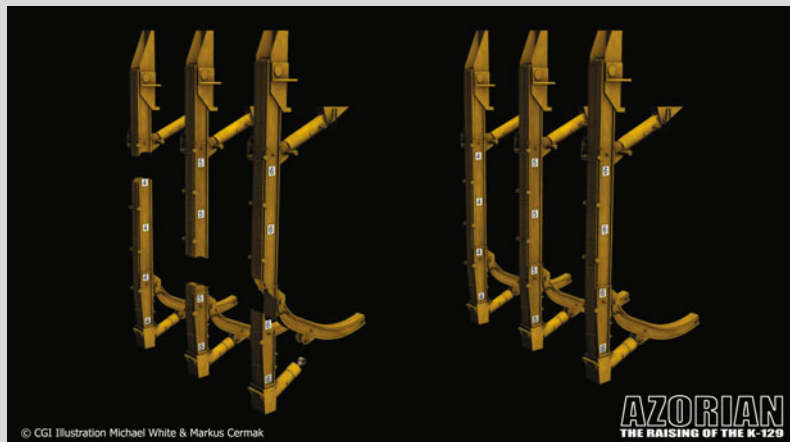
Figure 3. CGI illustration of the failed CV tines (left) and the CV tines prior to use. Note that the fractures occurred in different locations and the fractures do not appear brittle (i.e., straight). The fractures in all of the three fractured tines appear quite tortuous. Tine #4 failed on the ocean bottom and tines #5 and 6 failed during the final phase of the lift operation. Courtesy Michael White.

that involved a company owned by the colorful American business magnate and aviator, Howard Hughes, and the development of deep ocean mining technology. A specialized ship, the *Hughes Glomar Explorer*, was built for the sole purpose of picking up the submarine—referred to as the target object (TO)—the 4 million pound CV, and 8 million pounds of pipe string. During the attempt in the summer of 1974 to raise the submarine off the ocean bottom and into the massive well area of the *Hughes Glomar Explorer*, several of the CV’s eight “fingers” (Figure 3), or tines—each con-

sisting of a beam and a davit—failed and a significant portion of the submarine fell back to the ocean bottom. The forward 38 feet of the submarine was successfully brought to the surface and examined by the CIA (Figure 4). The results of that target exploitation for intelligence purposes are still classified, as are many other elements of the AZORIAN operation.

It should also be noted that computer generated images (CGI), derived from actual videos taken during the recovery operation and used in White's book and documentary, do not appear to be flat, straight fractures typical of embrittled steel. Instead, the fracture surfaces appear quite tortuous, which would be typical of ductile maraging steel. Therefore, it seems unlikely that the failure of the tines was related to materials selection or embrittlement.

hours while holding the *K-129*. The designers of the CV never anticipated the need for it to remain on the ocean floor with the four million pound submarine cradled in the tines for a prolonged period of time. It was during these anomalous "bottom operations," as they have become known, that the #4 tine failed and fractured. The broken beam was later photographed standing up on the ocean bottom. In addition, review of the video from the bottom operations indicated that cracks had formed in several other tines. However, the cracks in these tines did not result in immediate fracture, as would be expected if the material was embrittled as suggested by some of the metallurgists on the Tiger Team.

Two additional tines, #5 and #6, also failed during the lift operations to bring the submarine and the CV to the surface, although these tine failures did not occur until the submarine had been raised a significant way from the ocean bottom. The fact that these tine failures did not occur immediately at the ocean bottom, but probably occurred during shifting of the submarine in the CV during the lift, indicates

that the failures were not due to a materials problem, such as hydrogen embrittlement.
