I-495 in Wilmington, Delaware USA – The Leaning Towers; Lateral Squeeze Effects on Pile Supported Bridge Piers Due to Mudwave; Emergency Response and Retrofit

Abstract. In 2014, the Delaware Department of Transportation was notified of a potential problem with a bridge that was part of the interstate system. After preliminary investigation it was determined that a stockpile located adjacent to the bridge piers caused lateral squeeze effects deforming the pile groups and causing the bridge piers to tilt and displace laterally. Because of the importance of this bridge, an emergency plan was established to enable removal of the stockpile, geotechnical investigations, and design to occur simultaneously. Instrumentation of the bridge was critical to provide real-time monitoring of the existing structure and to modify construction and design decisions. Geotechnical investigation and analysis, design, and construction were completed sufficiently by August 23, 2014 to safely open both directions of the interstate.

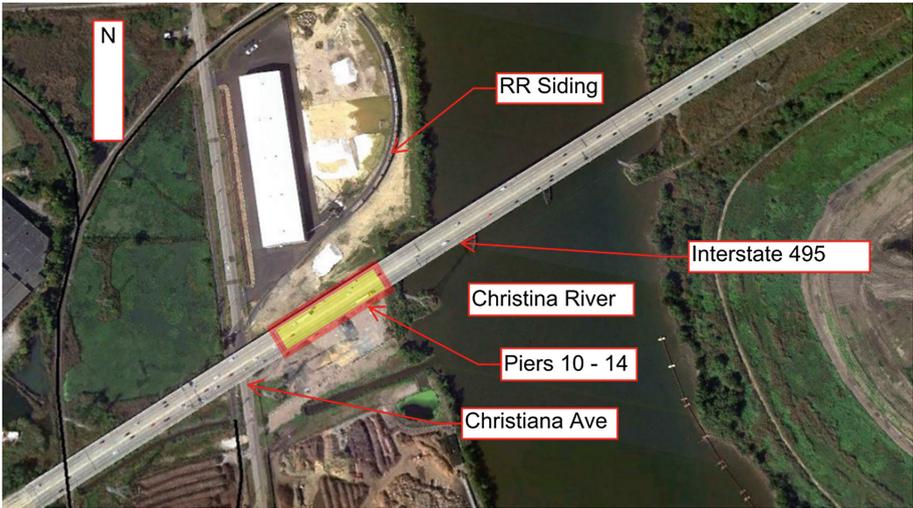
Fig. 1. Impacted area of bridge

The impacted section of the bridge, highlighted in Fig. 1, is within the floodplain of the river. It consists of parallel structures supported by pairs of single shaft, hammerhead pier columns founded on groups of battered and plumb steel H-piles, approximately 140 ft long.

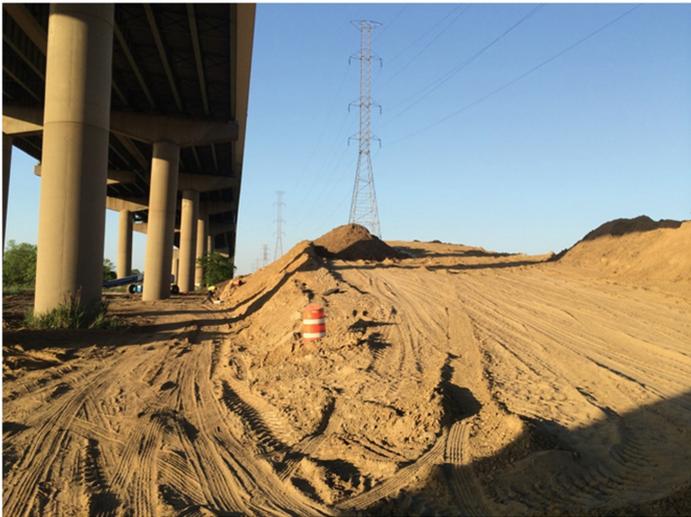
Fig. 2. Impacted bridge piers with soil stockpile in foreground

DelDOT arrived on site on June 2, 2014 and responded by closing the bridge to traffic. DelDOT contracted with AECOM to assist with developing a remediation strategy and designing a retrofit to re-open the bridge as quickly as possible. It was determined soon after that a stockpile adjacent to the piers (Fig. 2) induced lateral deformation and

produced a mudwave through the saturated clay layer. Multiple activities began concurrently, including removal of the stockpile, geotechnical investigations, contractor selection, and design.

Work began immediately to remove the soil stockpile to unload the surcharge on the compressible clay layer to stop any additional movement of the bridge. Inclinometers and sensors were installed in the bridge foundation to monitor structure movement during stockpile removal. Work continued 24 h a day until all of the soil had been transported offsite and the area under the affected piers was restored to original grade. Over 50,000 tons of soil was removed in 10 calendar days.

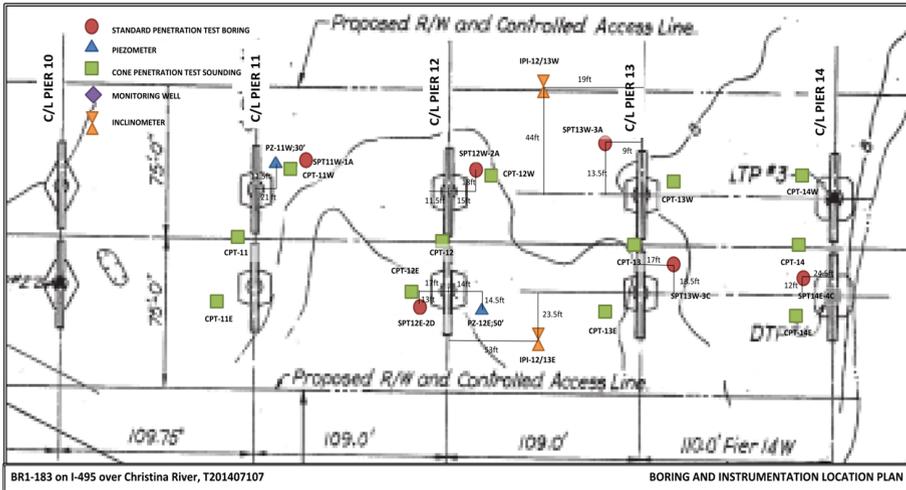
Fig. 3. Boring location and instrumentation plan

The subsurface investigation began on June 5th, 2014 and was performed within the affected area to measure soil disturbance, confirm foundation conditions, and define a competent bearing stratum for the impacted pier foundations. The investigation included test pit excavations at ten pier footing locations (Pier Nos. 10–14); 12 cone penetrometer test (CPT) soundings; six Standard Penetration Test borings with rock coring; installation of four open-standpipe piezometers with drop-in transducers; and installation of three inclinometers with dedicated probes (Fig. 3). In addition to subsurface instrumentation, the bridge piers were instrumented with tiltmeters to measure movements of the superstructure. All of the instrumentation was connected to a data logging hub that uploaded real-time readings to a centralized website.

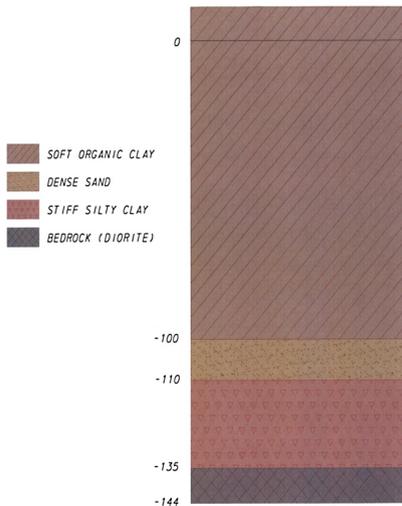
Fig. 4. Soft clay layer

One of the most significant findings of the investigation was the excess pore water pressure observations during the CPT soundings. The observed pore pressures exceeded a 1.0 psi/ft threshold in numerous locations throughout the entire soft clay layer under Piers 11 through 14 (Fig. 4). This is indicative of shear failure in clay soil. The pore water pressure values (Fig. 5) correlated to an equivalent soil stockpile height of 35 to 40 ft corresponding to the original height of the soil stockpile removed.

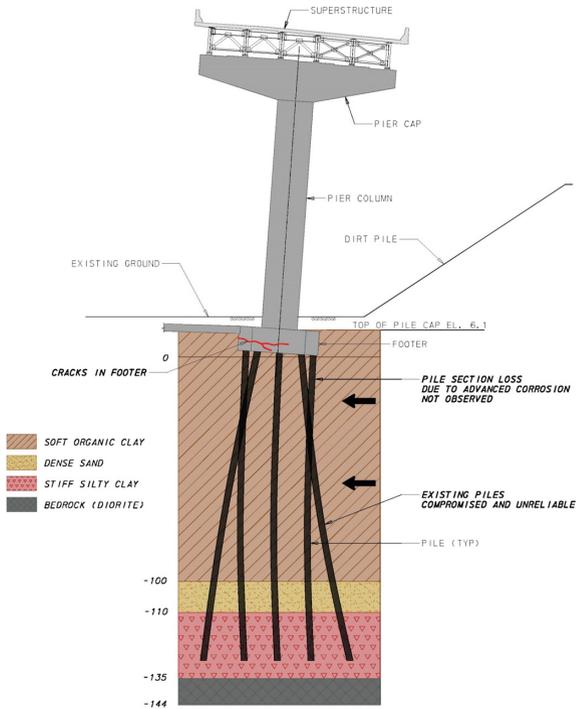
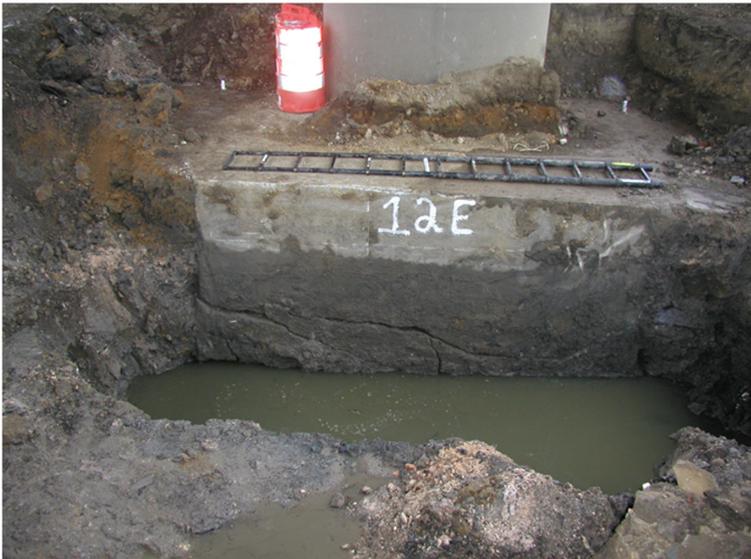
Fig. 6. A: Diagram of impacted pier cap at Pier no. 12E, B: Photo of impacted pier cap at Pier no. 12E

Significant cracking (Fig. 6A and B) was found during test pit investigations at each of the pile caps where deformation and displacement of the piers was observed. Exposing the pile caps revealed that each of the impacted pier column foundations were compromised at four pier locations (11 through 14) consisting of eight pile caps. Installation of new deep foundations to underpin and/or reconstruct the piers was required to restore the bridge to service.

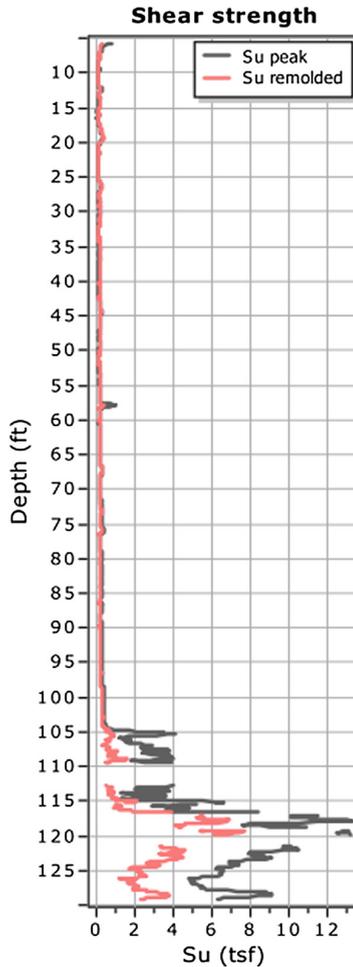
Fig. 7. S_u correlation from CPT C-12E

value of undrained shear strength (S_u) was developed that increased with depth based on correlated estimates of S_u provided by the CPT soundings (Fig. 7).

The S_u values were corroborated by subsequent S_u values produced in the laboratory triaxial testing program performed on undisturbed Shelby tube samples. Unconfined, unconsolidated (UU) tri-axial tests were performed. The significant thickness of soft, compressible marine clay was assigned very minimal S_u values ranging from 0 to 7 psi, increasing with depth. Excess pore water pressure was also accounted for as additional axial load on the drilled shaft using correlated pore pressure readings taken during CPT sounding when the soil surcharge was still in place. This would be considered the worst case scenario, since immediate removal of the soil stockpile resulted in the pore pressures dissipating significantly by the time the drilled shafts were constructed. However, to maintain a conservative approach the initial

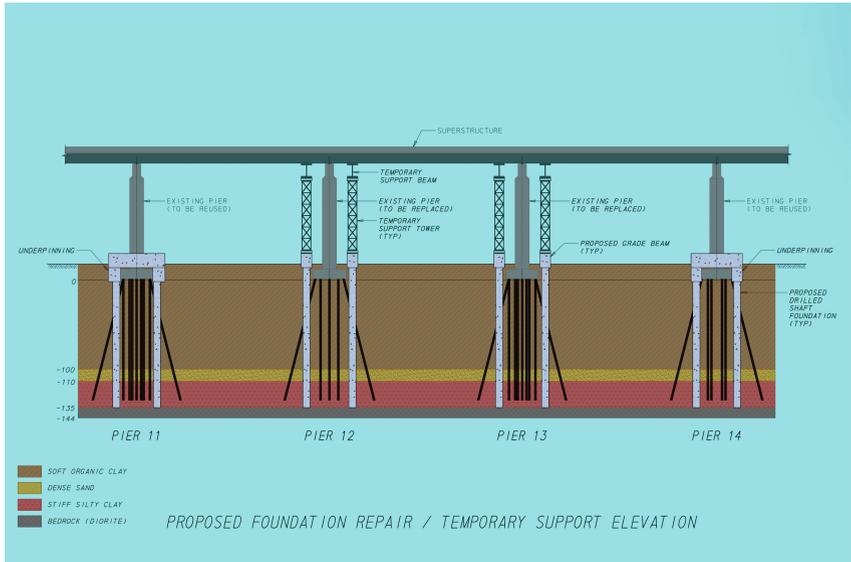
Fig. 8. Elevations of underpinning and new foundations for Pier nos. 11–14

The prime contractor selected for the project, J.D. Eckman, mobilized their caisson contractor, A.H. Beck of San Antonio, TX on June 12, 2014. A.H. Beck performed the caisson installation and another subcontractor, R.E. Pierson, began the installation of thirty-two drilled shafts (Fig. 8). The caissons were fully-cased for their entire depth and excavation was handled with low head, fixed-lead rigs using a ‘wet method’ with bentonite slurry (Fig. 9).

Drilled shafts bearing on bedrock were the selected preferred foundation due to their superior lateral and axial capacity compared to flexible H-piles. The drilled shafts were designed as end bearing on competent rock.

The caisson contractor's construction methods verified the perceived subsurface conditions by drilling through a weathered rock zone prior to encountering the competent gneiss bedrock. Four feet diameter drilled shafts were installed with an average shaft length of 150 ft, with the deepest shaft going over 165 ft. This was not considered possible with conventional low-head drill rigs and tooling. Permanent steel casing was installed for the entire depth to bedrock to eliminate soil loss during drilling and to minimize localized bridge settlement.

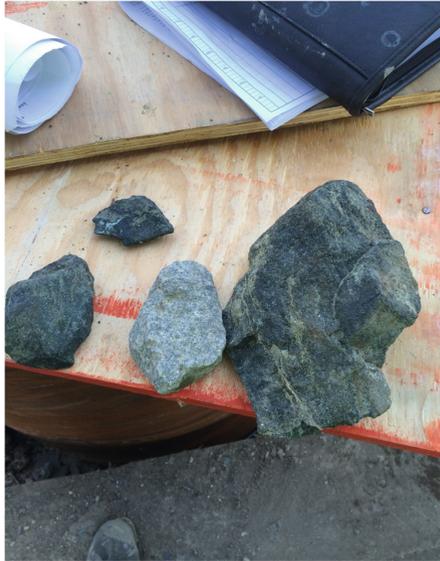
Fig. 10. Bedrock recovered from 1st drilled shaft to reach termination, note light gray Gneiss in center

A comprehensive Drilled Shaft construction specification was developed by DelDOT and implemented for the entire project. AECOM worked with A. H. Beck to develop termination criteria for each caisson based on the perceived depth to competent bedrock (Brandywine Blue Gneiss shown in Fig. 10) as determined from the existing subsurface profiles and the new borings.

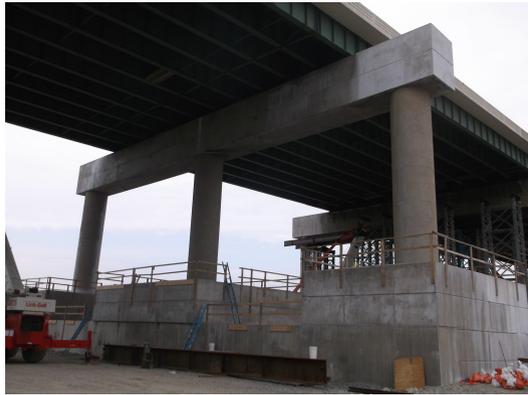
Fig. 11. Completed Pier no. 12 from March 24 2015

The last drilled shaft was completed on July 16, 2014; just 32 days after the drilling began (Fig. 11). That equated to a production of one shaft/day with an average length of shaft of 150 ft. This duration included the testing and acceptance of each of shafts with crosshole sonic logging (CSL).
