A Case of Aluminum Nitride Embrittlement of Heavy Wall Cast Steel

Abstract Weld cracking was observed in multiple heats of large-sized cast steel components. Fracture analysis, metallography, and mechanical testing indicated that the failure mechanism was aluminum nitride (AlN) embrittlement. Prevention of this type of embrittlement is achieved by controlling aluminum content, nitrogen content, and above all, cooling rate of the casting. A macro-etch procedure for evaluating large castings for AlN embrittlement has been available in ASTM A 703 for decades, and it was found to adequately predict embrittlement in this instance.

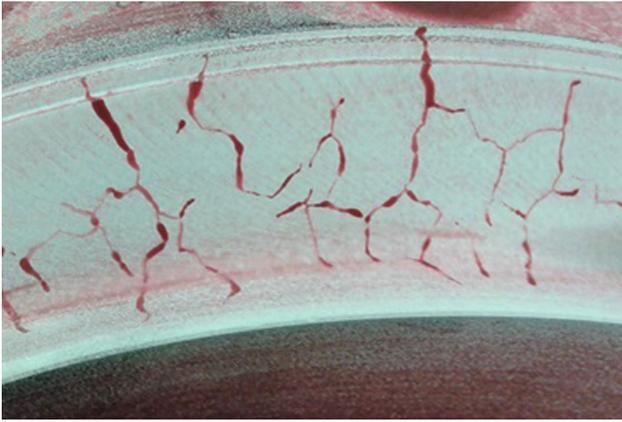
heavier and of greater wall thickness. The castings were on the order of 20–40 kg each. Major wall thicknesses were in the range of 25–75 mm. The details of the product and design are withheld for confidentiality reasons. A typical view of the cracking after welding and dye penetrant testing is shown in Fig. 1. Multiple crack paths are visible, relating to the thermal contraction and residual stress patterns of the weldment.

Fig. 1 Cracking identified by liquid penetrant testing

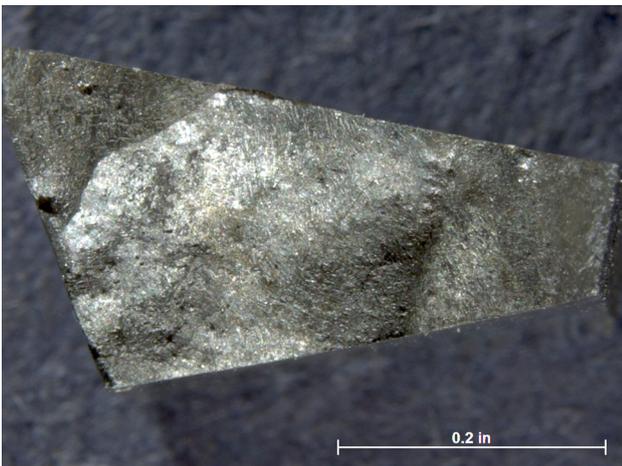
Typical castings were obtained, and areas of interest were sectioned from the castings. The fracture surfaces of the cracks were opened in the laboratory and examined with optical microscopy and scanning electron microscopy (SEM). The fracture surfaces exhibited large flat facets, on the order of 2.5–5 mm dimensions (Fig. 2.). The size of these facets is much too large to correspond to the prior austenite grain boundaries associated with the immediately preceding heat treatment or weld transformation, which would be on the order of 0.0045 mm for ASTM grain size number 6 [1]. The appearance of the fracture surface is typically described as “rock candy” and has been associated with aluminum nitride (AlN) embrittlement of steel castings in the past [2–7]. Therein, the large size of the grain facets is due to fracture along the original *primary* solidification austenite grains or dendrites (as-cast), not the immediate prior austenite grain boundaries. A typical tensile specimen fracture appearance is shown in Fig. 3; this sample exhibited nearly 100% brittle fracture appearance and is a good example of the rock candy fracture surface.

Fig. 2 Portion of the crack surface opened, showing rock candy fracture facets of large size

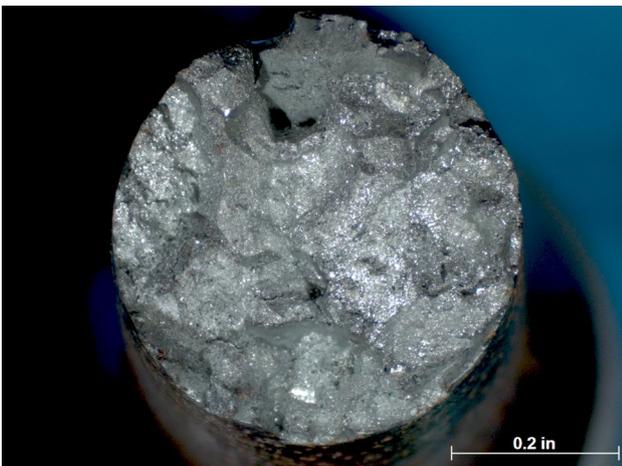
Fig. 3 Brittle tensile specimen fracture surface

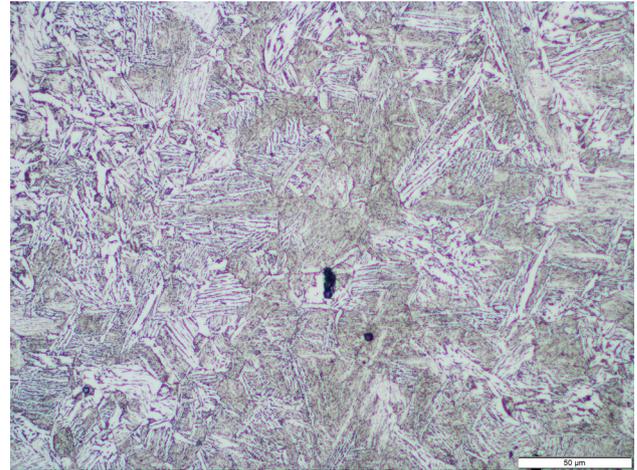
Metallurgical sections were prepared through several castings according to standard laboratory techniques. The core microstructures consisted of bainite/ferrite mixtures (Fig. 4), while the heat affected zones (HAZ) and weld

Fig. 4 Typical core microstructure of bainite and ferrite, Nital etchant

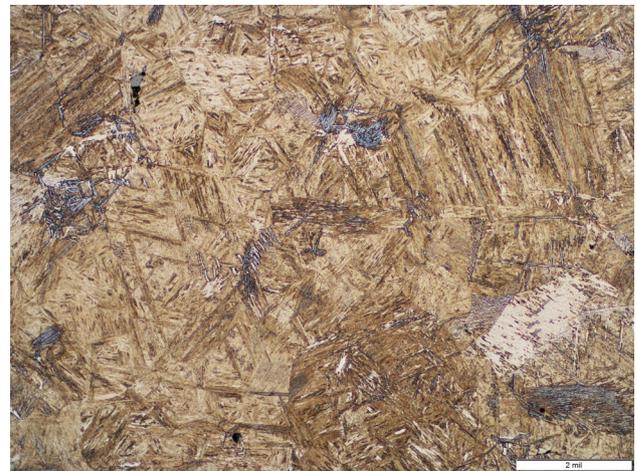
metals exhibited martensite with some bainite (Fig. 5). The cracks initiated in the weld metals or HAZ's and propagated in long straight paths into the base material (Fig. 6).

Fig. 5 Typical weld heat affected zone, exhibiting a martensitic microstructure with some bainite, Nital etchant

Martensite in the welds is almost always undesirable and indicates an unqualified weld was performed. This indicates other issues with the manufacturing process; however, it does not alone explain the rock candy fractures that extended into the base material. A martensitic microstructure is more susceptible to aluminum nitride embrittlement [3].

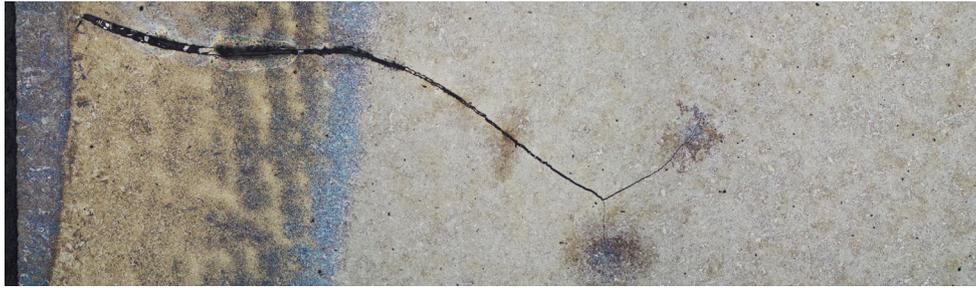
Fig. 6 Typical crack path from HAZ into the base metal, Nital etchant. This crack had a repair weld attempted (at left), which is the source of the additional HAZ and no crack at the surface. Original magnification 25×

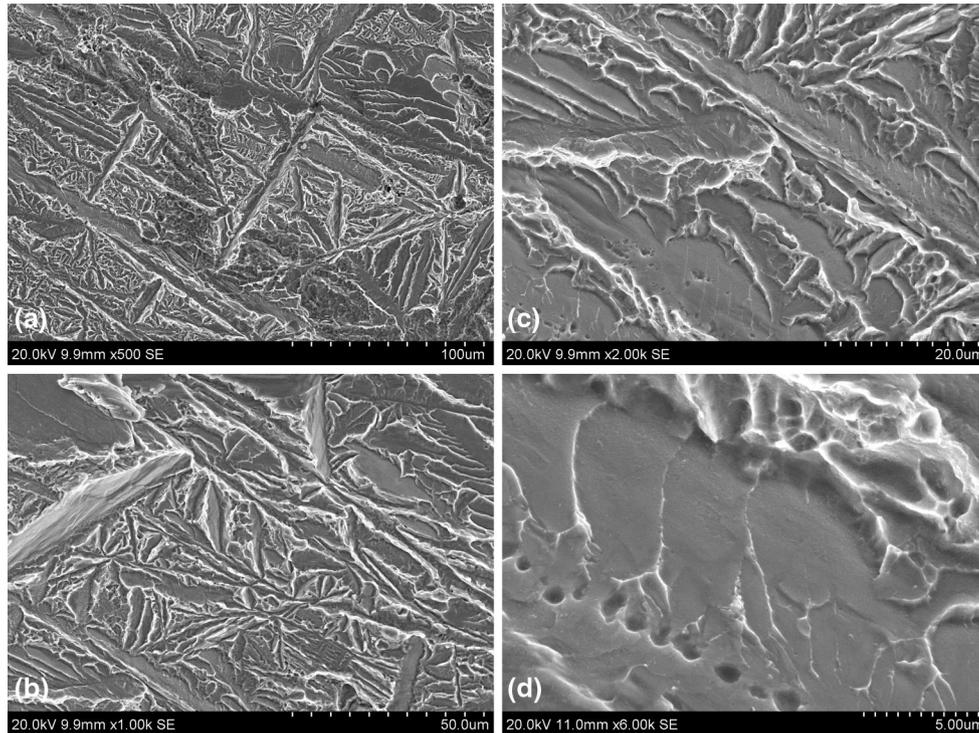
Typical casting fracture surfaces and tensile specimen fracture surfaces were examined at higher magnifications with a scanning electron microscope (SEM). A typical crack surface is shown at various magnifications in Fig. 7. The facets exhibited a characteristic pattern of cross-hatched platelet morphology. This is typical of aluminum nitride embrittlement [2, 6] and distinguishes it from other forms of embrittlement such as temper embrittlement, tempered martensite embrittlement, and hydrogen embrittlement [6], which would exhibit relatively flat facets. The

Fig. 7 Typical SEM images of a casting crack surface at various magnifications

platelets are due to the AlN particles that form a semi-continuous network along the primary austenite solidification grain boundaries [2–5, 7]. Micro-scale ductility in the form of small dimples was visible between the platelet locations. The tensile specimen fracture surfaces exhibited similar platelet morphologies (Fig. 8).

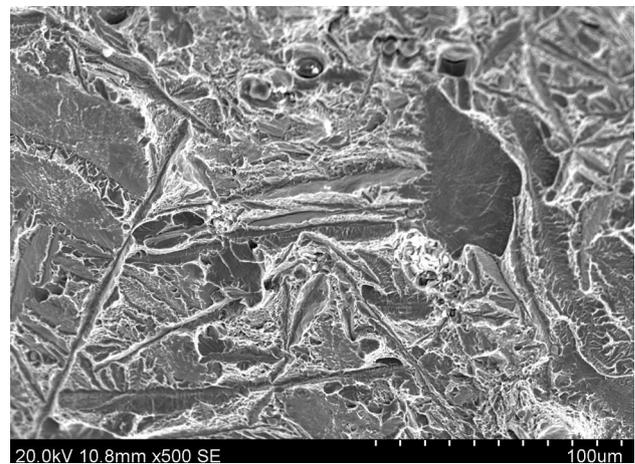
Fig. 8 Typical SEM image of a tensile specimen fracture surface

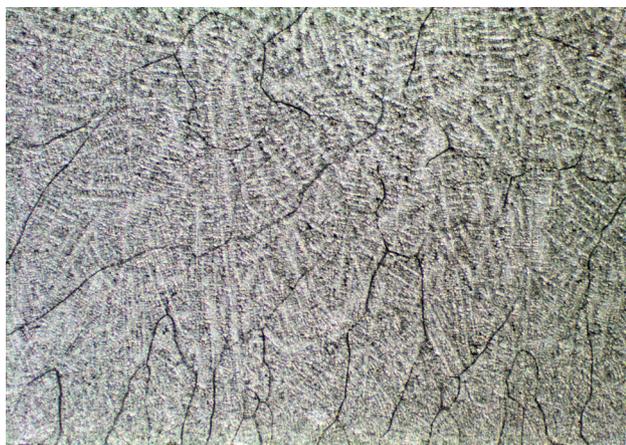
networking and width of the etched boundaries by comparison to reference images and a table provided in the standard [8]. A typical view of a severity level 5 macro-etch from the current work is shown in Fig. 9. The primary solidification dendrite pattern is clearly visible. Severity levels > 4 are considered suspect and must be evaluated further by mechanical testing; however, levels < 4 can still exhibit measurable lowered properties [5]. It should be noted that this ASTM A 703 supplementary requirement applies only to castings with > 0.08 wt.% aluminum and to “heavy section castings,” which are defined as a combination of ≥ 37 mm wall thickness and 455 kg. In the current work, AlN embrittlement was found in much smaller castings.

Fig. 9 Macro-etch specimen with severity level 5 using the ASTM A 703 procedure

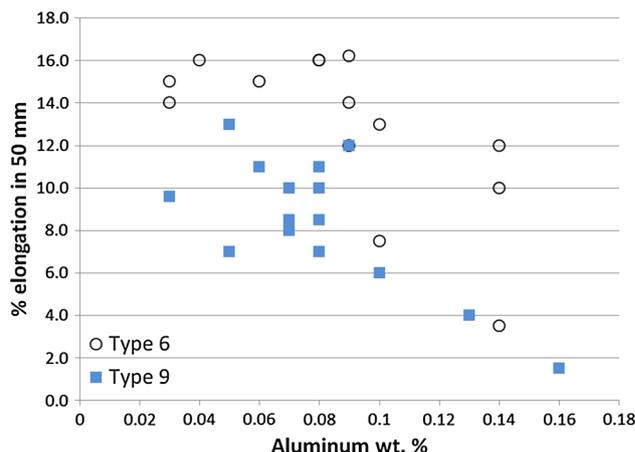
Figure 10 shows the elongation to fracture as a function of aluminum content. The plot shows a trend to lower elongation (higher brittleness) with higher aluminum content, especially above 0.08 wt.%, in agreement with the literature. This was especially true for the Type 9 heavier castings. Residual aluminum content for these heats ranged from 0.03 to 0.16 wt.%. There was no clear trend for nitrogen content (Fig. 11), which ranged from 60 to 100 ppm. There was a clear trend to lower elongation when plotted as a function of the macro-etch severity level, per ASTM A 703 (Fig. 12).

Fig. 10 Elongation as a function of aluminum content

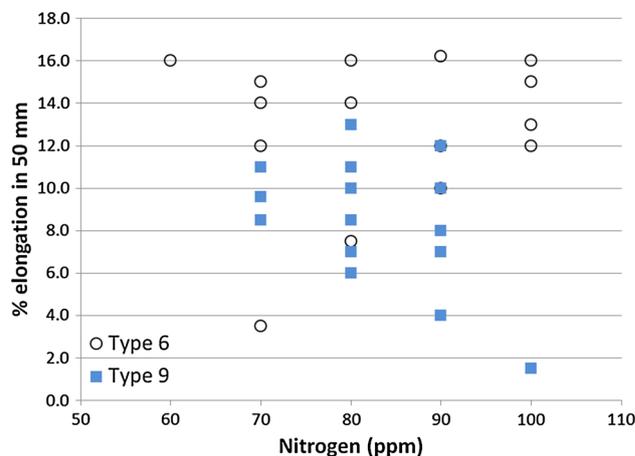
Fig. 11 Elongation as a function of nitrogen content

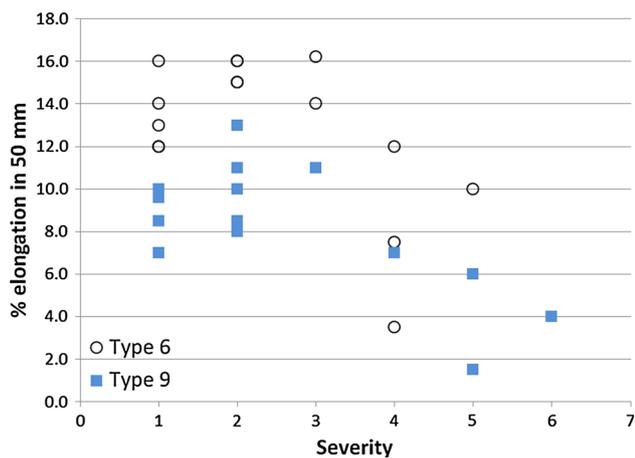
Fig. 12 Elongation as a function of severity level

The severity level illustrates the trend more distinctly since it combines the variables of aluminum content and cooling rate into one value; it evaluates the actual AlN networking present. The trend was significant at level 4 and above, consistent with the literature. Plots of brittle fracture appearance as a function of severity level were essentially identical to Fig. 12. It is interesting to observe that the same set of tests presented very little, if any, change in tensile strength as a function of aluminum content (Fig. 13). The scatter remained consistent, except for the heavier, Type 9, castings above 0.12 wt.% aluminum, where there was somewhat of a drop below the remainder of the scatter. This is again consistent with the literature reports.

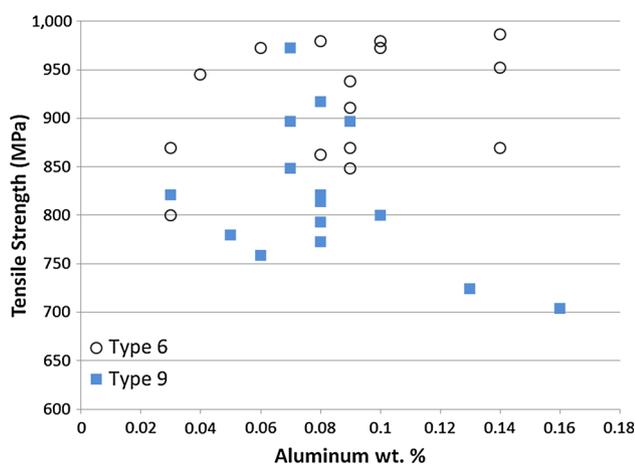
Fig. 13 Tensile strength as a function of aluminum content
