Repair of soda–lime–silica glass

Kyriaki Corinna Datsiou · Dominic Hall ·
Mauro Overend

Abstract Glass strength is very sensitive to damage accumulation during its service life. Repair methods for glass have been proposed over the last decades to volumetrically fill or remove existing flaws from the surface of glass. However, the lack of information on the strength recovery attributable to glass repair methods restrict their use to low consequence class applications in buildings thereby making replacement of damaged installed glass the only safe and practical solution when dealing with damaged glass. Repair methods involving volumetric filling of visible flaws with resins, removal of visible flaws with polishing and chemical repair with acid treatment of visible flaws are undertaken in this study to investigate the strength recovery in 60 artificially aged annealed glass specimens. It is found that the polishing provides the most promising strength recovery results showing a 132 and a 40% increase in design and mean strength whilst the acid treatment provides the worst performance. Polishing repairs are further investigated in this study to determine their efficacy in strength re

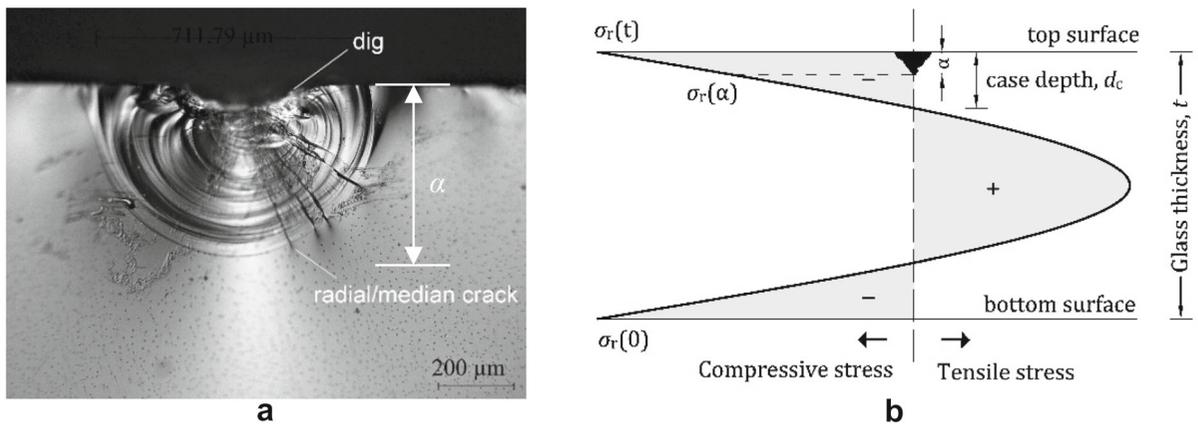
Fig. 1 Cross section of critical flaw in: **a** annealed glass (micrograph) and; **b** stress profile of fully toughened glass

Glass is an ubiquitous material, 87% of glass [52 million metric tonnes per annum (Nsg 2010)] is used in sheet form and is used extensively in vision and display panels in the automotive, aerospace and construction industry. Glass has many desirable properties, but it is very sensitive to damage accumulation; flaws (Fig. 1a) accumulate on the surface of glass during its service life and have a detrimental effect on its strength because: (a) they generate stress concentrations at the flaw tip that are several orders of magnitude higher than the nominal stress in the immediate vicinity of the flaw and; (b) they impose this stress concentration at a flaw depth α below the surface thereby reducing or removing the beneficial effect of residual surface compression induced by glass toughening processes (Fig. 1b).

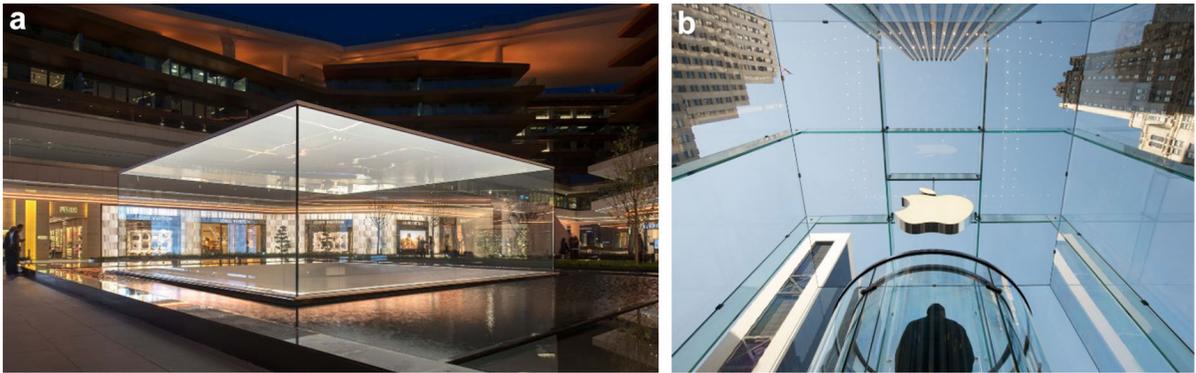
Fig. 2 Examples of glass panels with increased size, complexity and cost in architectural applications: **a** Apple Zorlu Centre in Istanbul (© www.fosterandpartners.com) and; **b** Apple Store at 5th Avenue – New York (© www.ecengineers.com)

approach, when dealing with high consequence of failure glass components that have been damaged in transit or during their service life, is to replace the glass component altogether. This remains a sensible and viable approach for small, low cost, and easy-to-replace glass panels, but as the size, complexity and cost of glass panels continues to increase (Fig. 2a, b), the replacement and disposal of the damaged glass becomes costly and unsustainable.

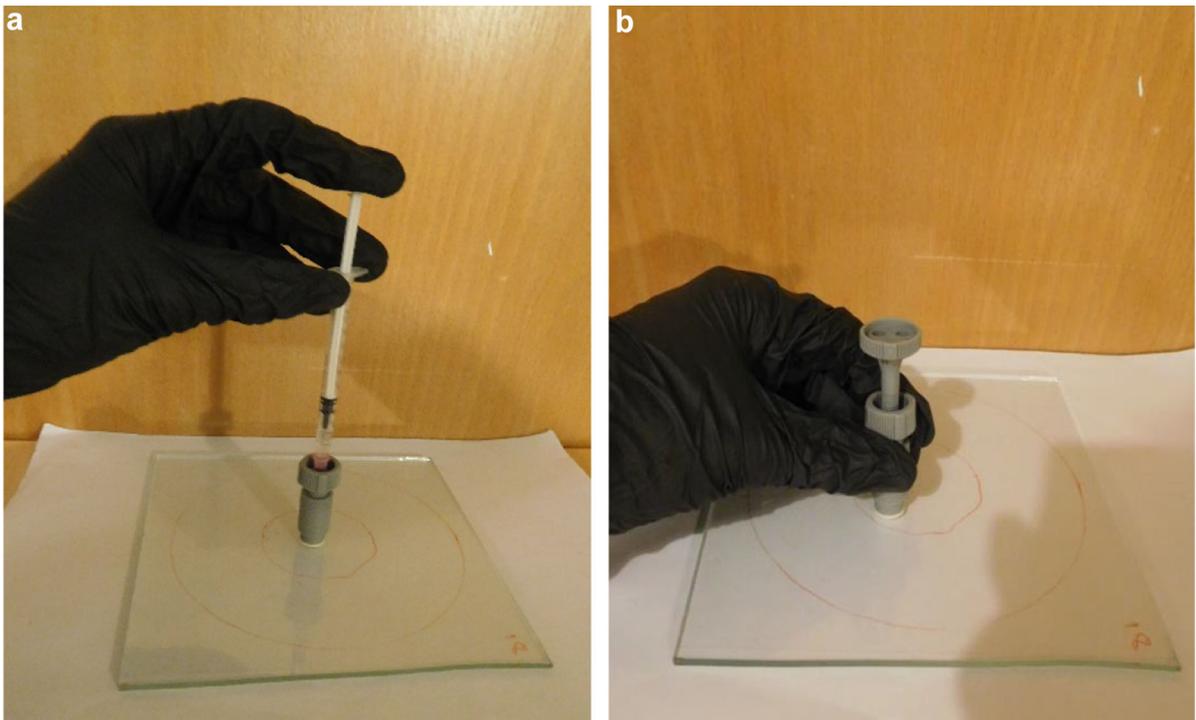
Fig. 3 Resin repair **a** resin injection and; **b** application of pressure to force the resin into the flaw

The repair (Fig. 3) comprised the following steps following the directions of the supplier:

- The injector barrel is positioned over the flaw and pressed manually to ensure a good seal;
- Resin is injected with a syringe in the barrel (Fig. 3a);
- The syringe is withdrawn and a piston is screwed into the barrel to increase the pressure and force the resin into the flaw; the barrel remains under pressure for a duration of 3 min (Fig. 3b);
- The piston is subsequently un-screwed slightly (≈ 10 mm) to induce suction and remove any residual air for a duration of 30 s;
- The same progress cycle is then repeated for a second time i.e. the injector is pressurized for 3 min and subsequently suction is induced for 30 s;
- The injector is then removed and any excess resin is gently wiped away;
- The repaired area is cured under a UV light for a duration of 5 min.

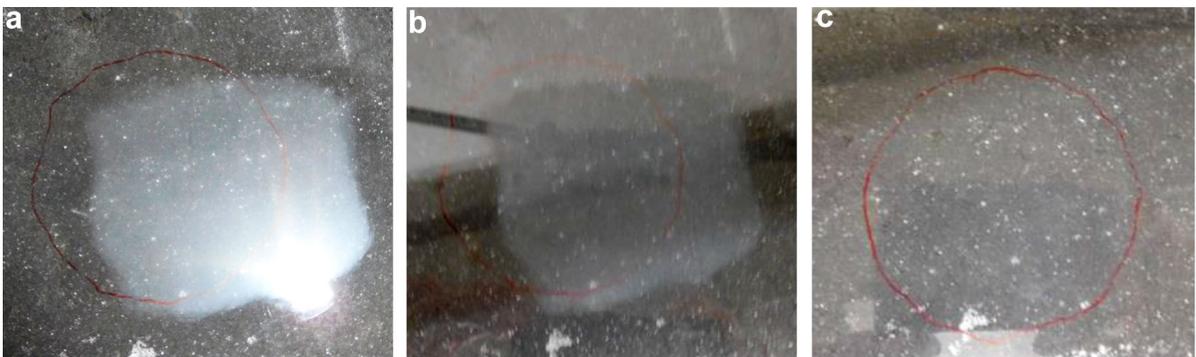
Fig. 4 Polishing repair: glass surface after polishing with: **a** coarse sanding pad; **b** fine sanding pad and; **c** rayon felt polishing pad

acquires an even, cloudy white surface at the end of this step (Fig. 4a);

- The finer sanding pad (GP 50) is then fitted and the rotary is again moved across the flaw in a similar manner until the repaired area acquires an even, light haze, with no dark marks or abrasion scratches (Fig. 4b) and;
- A rayon felt polishing pad is subsequently fitted to the rotary and a small amount of cerium oxide polishing compound (suspension of CeO_2 particles

with an average diameter of $1.2 \mu\text{m}$) is applied to the repaired area. The rotary and compound are moved slowly across the repaired area to polish it to a clear, glossy finish (Fig. 4c) and complete the repair process. As the compound dries out, a small amount of water is sprayed onto the glass to reactivate the compound. The glass surface is then wiped clean to remove any residual polishing compound.

The polish repair resulted in an aesthetically pleasing appearance; the flaws were no longer visible to the naked eye (Fig. 4c). At very shallow viewing angles, some out-of-flatness could be observed due to material removable. With refinement and better control of the polishing process, it is expected that an even more gradual thickness change could be achieved that would be indiscernible to the naked eye.

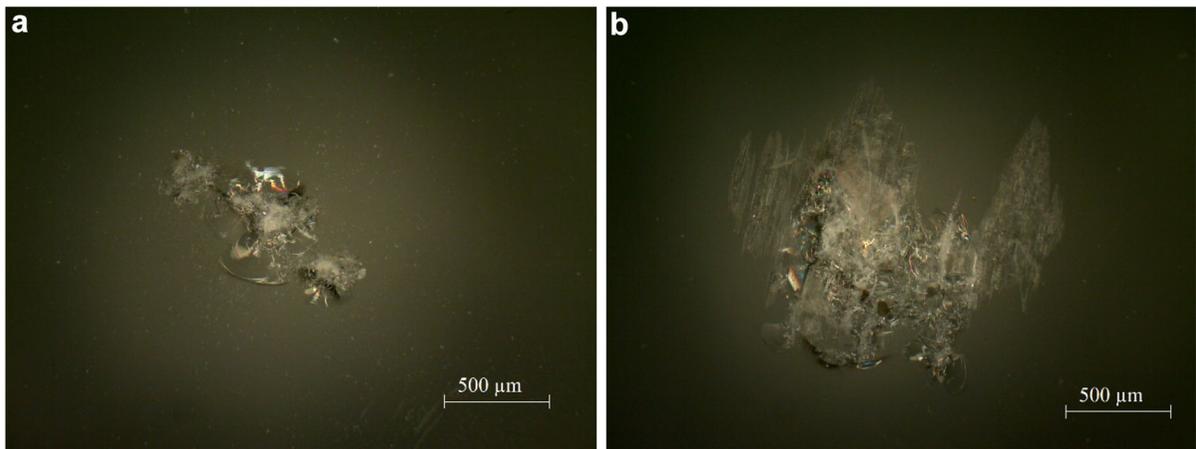
Fig. 5 a, b Artificial ageing: gravel impact flaws in AA glass

Artificial ageing consisted of 2 gravel impacts resulting on 2 separate flaws on the glass surface of each specimen e.g. Fig. 5a, b. In all of the artificially aged specimens, the fracture was found to originate from the location of one of the induced flaws. The cumulative distribution functions (CDFs) in Fig. 6a show that the artificially aged (AA) glass is significantly weaker than the as-received (AR) glass; a 68 and 65% reduction in strength is observed for the design ($P_f = 0.008$) and the mean ($P_f = 0.5$) strength respectively. The analogous reduction in strength for both fractile values is attributed to similar values of shape factor, β , of the Weibull distribution ($\beta_{AR} = 5.2$ and $\beta_{AA} = 4.8$, Table 2), which define the slope of the CDFs. Naturally aged glass typically exhibits low values of shape factor, which are of the same order of magnitude as those of the AA glass (Datsiou and Overend 2017a, b), thereby indicating that the artificial ageing method selected in this study is close to reality.

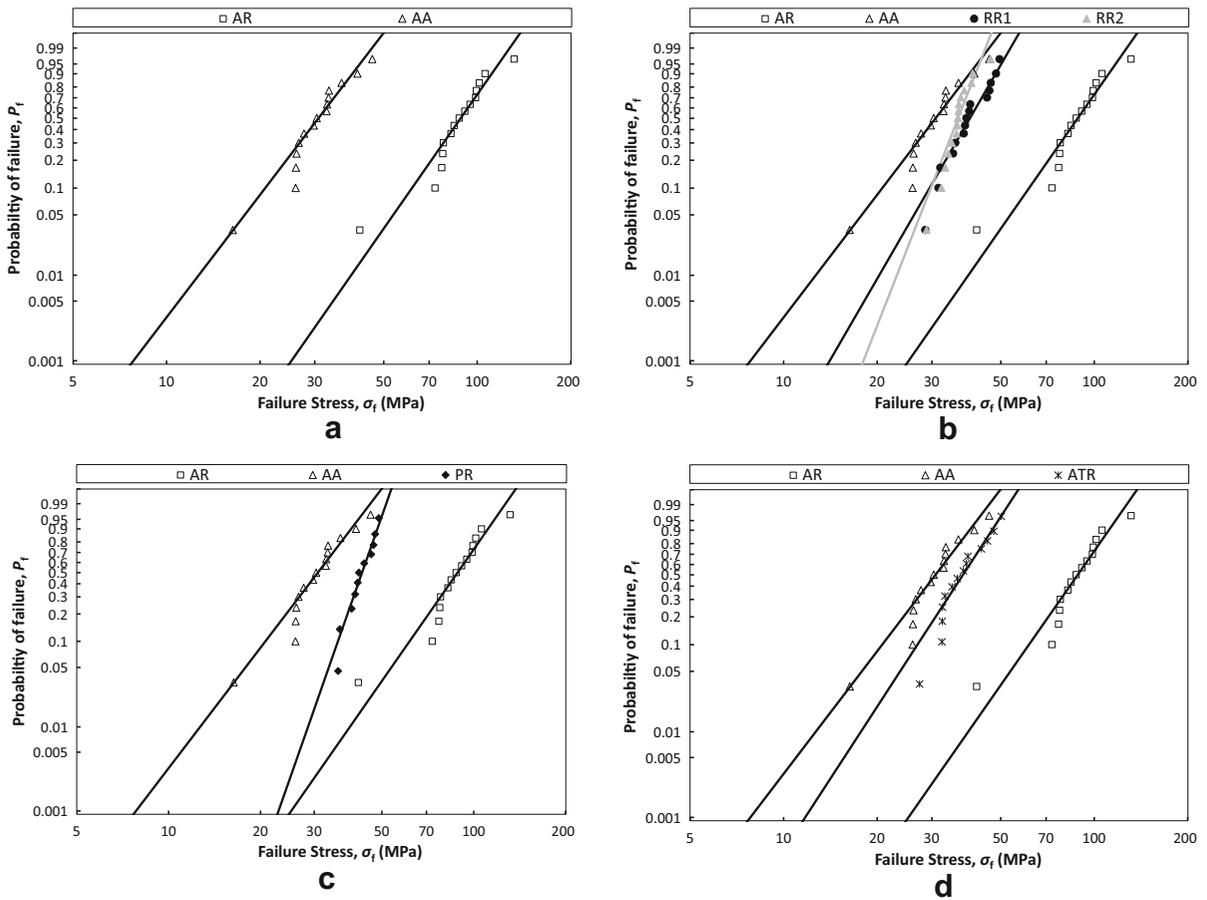
Fig. 6 CDF plots for: **a** as-received (AR) and artificially aged (AA) glass; **b** Resin repair #1 (RR1) & #2 (RR2); **c** polishing repair (PR) and; **d** acid treatment repair (ATR)

Both methods of resin repair (RR1 and RR2) increased the strength of the artificially aged (AA) glass (Fig. 6b); the highest strength recovery occurs at the low probabilities of failure with the design strength showing a 62 and 87% increase for the acrylic resin (RR1) and the methacrylate resin (RR2) respectively while a 29 and 18% increase is found for the mean strength for RR1 and RR2 respectively (Table 2). This increase in mean strength is similar to the 33 and the 30% increase found in Overend and Louter (2015) for acrylic resin repairs in scratched and intended glass specimens. Similarly to what is reported in Overend and Louter (2015), neither of the resins restores the strength of repaired glass to its as-received (AR) state; the shortage in strength compared to the AR glass was 48 and 55% for RR1 and 40 and 59% for RR2 at design and mean probabilities of failure, respectively. The increase in strength is potentially attributed to the restriction of sub-critical crack growth at the crack tip as water ingress is prevented by the resin. However, the value of the static fatigue parameter was kept constant ($n=16$) during the data analysis stage as this was not validated experimentally.

The methacrylate resin (RR2) resulted in a significantly higher shape factor than AA leading to a steeper CDF (Fig. 6b). This suggests that the efficacy of Resin #2 in strength recovery depends on the flaw size; it has a larger influence on the more severe flaws i.e. the flaws located on the lower end of the CDF. In contrast, the

Polishing repair (PR) produced a significant improvement in strength for both mean and design probabilities of failure (Fig. 6c) when compared to the artificially aged series (AA); a strength increase of 132 and 40% were noted for $P_f = 0.008$ and $P_f = 0.50$ respectively. However, the strength of the polish-repaired glass was inferior to that of as-received glass (AR) with a 25 and 51% shortfall in strength compared to its as-received state (Table 2).

Similarly to RR1, the shape factor of the CDF also increased considerably compared to that of AA glass leading to a steeper CDF (Fig. 6c). This indicates that the efficacy of the polishing repair is not the same for each flaw and could be potentially attributed to the occurrence of radial flaws in some artificially aged glass specimens. In other words, polish repair could be efficient in removing large visible pits on the glass surface but parts of median cracks or deep radial cracks, indiscernible to the naked eye, could remain in the glass mass after repair, thus decreasing the efficacy of the

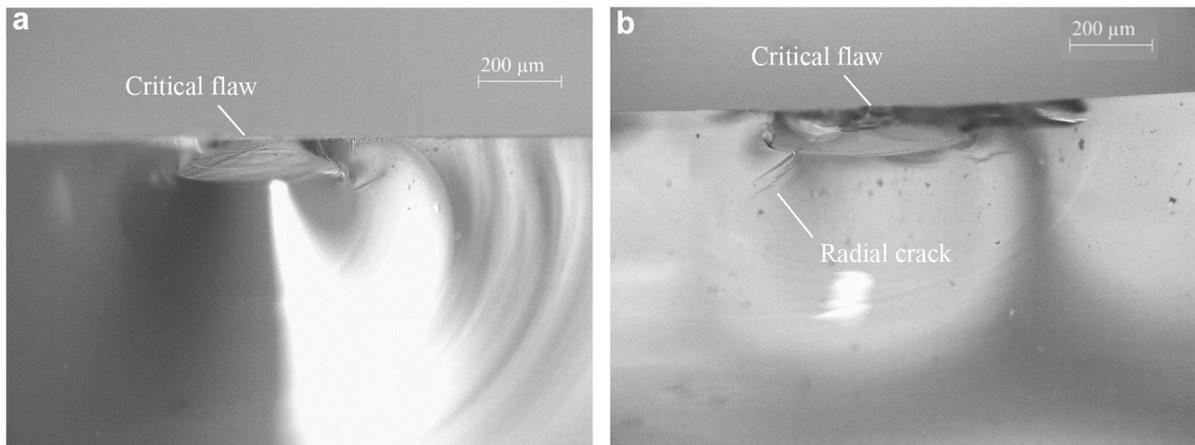
Fig. 7 Critical flaws in AA glass: **a** without radial cracks and; **b** with radial cracks

repair. Experimental fractographic evidence supports this hypothesis as it reveals that most, but not all, of the critical flaws of the AA series were accompanied by radial cracks (Fig. 7a, b). Another possible scenario behind the increased shape factor is that polishing repair may have fully removed the artificially induced flaws but introduced some additional, but less critical, flaws during the process via the sanding pads (Schula 2015); these flaws would be of homogeneous nature in all specimens leading thus to a steep CDF.

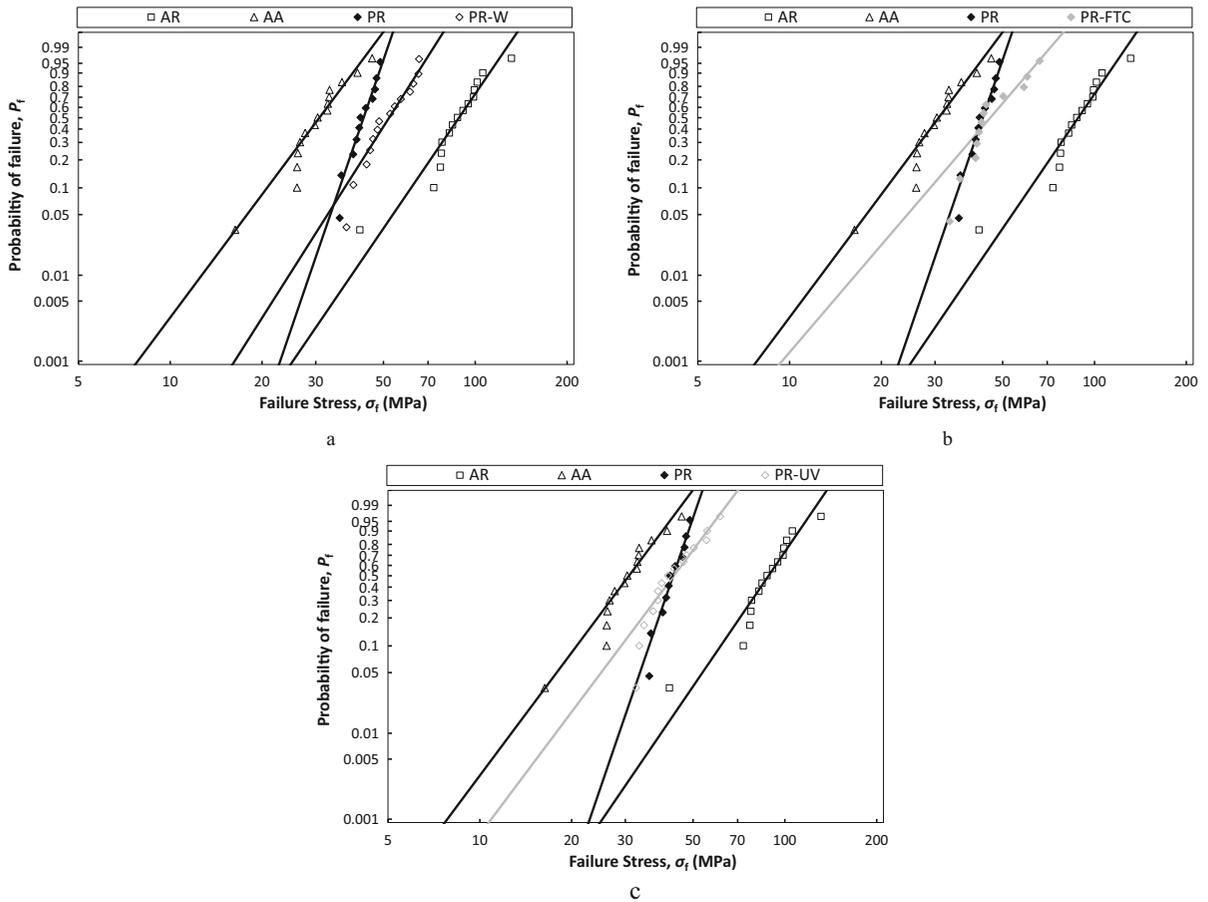
Fig. 8 CDF plots for polish repaired glass (PR) and environmentally aged polish repaired glass after exposure to: **a** water (PR-W); **b** freeze-thaw cycles (PR-FTC) and; **c** UV irradiation (PR-UV)

a shallower slope and a corresponding rotation of the CDF (Fig. 8a). A reduction of 15% is found for this reason for the design strength whilst an increase of 21% is found for mean strength.

series (Table 2). This larger scatter led to a smaller shape factor and therefore, a shallower slope and a corresponding rotation of the CDF (Fig. 8c) similar to the PR-W series. The mean strength remained largely unchanged before and after exposure to UV; however, the design strength showed a 40% reduction after UV irradiation as a result of the rotation of the CDF. The physical mechanisms behind this strength decrease are unknown and require further investigations in a future study.
