Landslide Hazard and Risk Management (WCoE 2014–2017)

Abstract

The World Centre of Excellence (WCoE) on Landslide Risk Reduction entitled "Landslide risk assessment and development guidelines for effective risk reduction" (2014-2017) was designed to contribute to the risk reduction effort formulated in the Sendai Partnership initiative. Several research activities were developed and their results were presented to a broad public through a series of articles, informative web pages and documentary movies. The research focused on improving landslide hazard assessment in a variety of natural environments, including deep-seated as well as shallow landslides. Landslide hazard assessment was applied practically through development projects in Ethiopia and Peru. Within the scope of the WCoE we proposed and conducted two projects of the International Program on Landslides (IPL). One of them is dedicated to compilation and analysis of glacial lake outburst floods (Database of glacial lake outburst floods (GLOFs)—project No. 179) at the global level. This potentially highly damaging natural phenomenon combines characteristics of floods and debris flows and often also involves landslides in

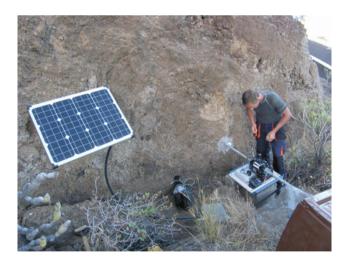
Fig. 1 One of the monitoring sites on the El Hierro Island, Canary Archipelago, Spain. The automatic crack gauge (in front of the person) records movements along a side scarp of the San Andrés deep-seated landslide

A fully automated deformation monitoring system with remote access was established on El Hierro Island, Spain (Fig. 1). Its goal is to record possible movement activity of incipient deep-seated landslides, where we so far have recorded creep movement of the order of 1 mm yr⁻¹ (Klimeš et al. 2016a, b). Recently, a "big data" approach has been used to improve interpretation of the detected movements, by considering a number of environmental factors which may affect the detected movements (Blahůt et al. submitted).
