Chapter 1

Water-Specific Imaging

1.1 Neutron Beam Imaging

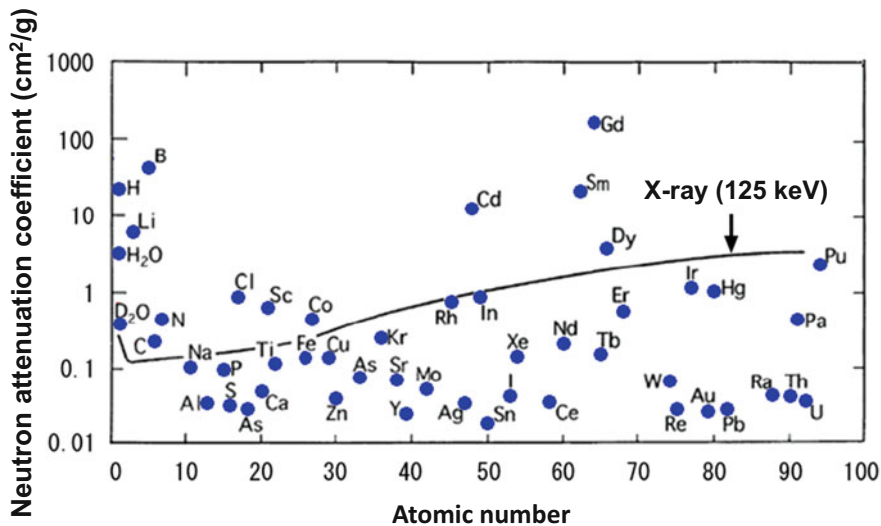
Fig. 1.1 Thermal neutron attenuation coefficient

The features of a neutron beam compared to that of an X-ray are shown in Fig. 1.1, where the neutron attenuation coefficient, indicating the difficulty in penetrating the elements, is plotted in a log-scale manner. Generally, the penetration rate of metals is high for neutrons, and a small amount of neutrons could penetrate the light elements, which overall is roughly the reverse of that of an X-ray.

As shown in Fig. 1.1, the attenuation coefficient of some light elements, including hydrogen, as well as rare earth elements, is extremely high, 100–1000 times higher than those of the other common elements. Because of the selective nuclear reaction of the neutron beam, when the neutron beam is used to irradiate the samples, including light elements or rare earth elements, the beam intensity is drastically reduced after penetrating the sample, which resulted in a clear image of these elements in the sample. In the case of X-rays, the beam reacts with electrons occupying the outside of the nuclide of the element. Since the number and density of the electrons increase with the atomic number of the element, the reaction of the X-ray with electrons increases, which results in a higher attenuation coefficient. Therefore, in the case of X-rays, this attenuation coefficient changes by factors, not by order of magnitudes, from lighter elements to heavier elements, which makes it difficult to distinguish the image of a specific element from that of the neighboring other elements.

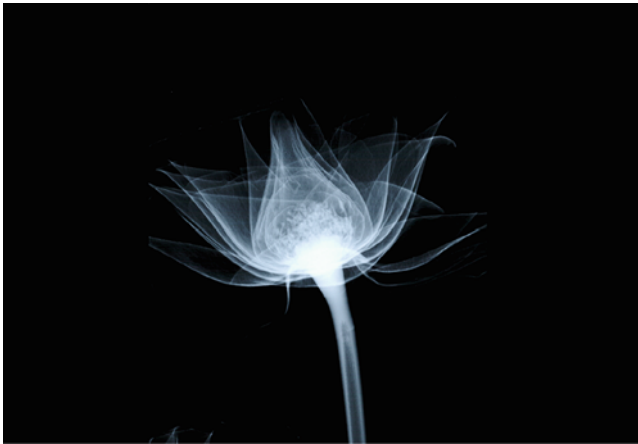
Fig. 1.19 Water image of a rose flower by the neutron beam

As an example of water analysis in a cut flower, a rose image is introduced. An important issue in the cut flower industry, especially for roses, is how to extend the flowering stage. In the case of a rose flower, sometimes the “bent neck” phenomenon occurs during the shipping of the cut flower. Once this phenomenon occurs, the bent neck never returns to the straight position and withers. The bending phenomenon always occurs at the stem, very close to the bottom part of the flower, and was hypothesized to be induced by water deficiency at this part of the stem. To determine from which regions the rose flower loses water, neutron imaging was employed.

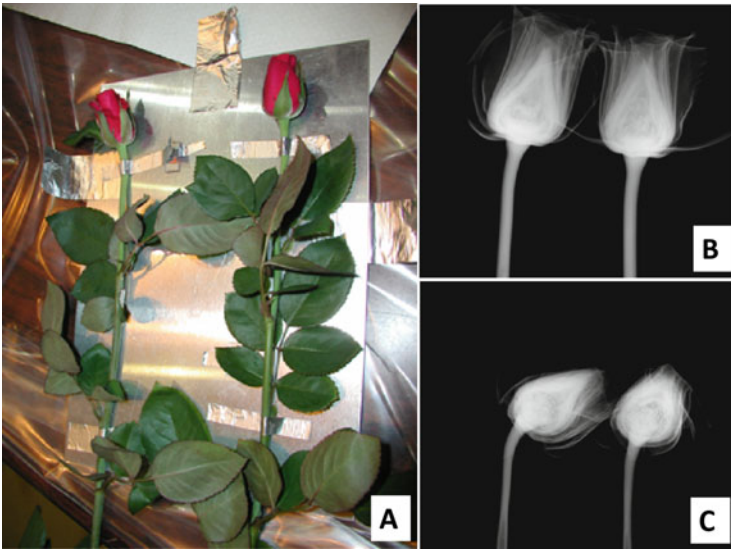
Fig. 1.21 Rose flower images before and after the bent-neck phenomenon. (a) Picture of rose flowers; (b and c) Water image of rose flowers before and after the bent-neck phenomenon. Under dry conditions, the water amount in the internode decreased and could not support the flower part to remain straight, so the flower part was bent

Figure 1.21 is a picture of cut rose flowers and neutron images of these flowers before and after the bent neck phenomenon occurred. To take the neutron image, flowers were fixed on an aluminum board with aluminum tape, as shown in

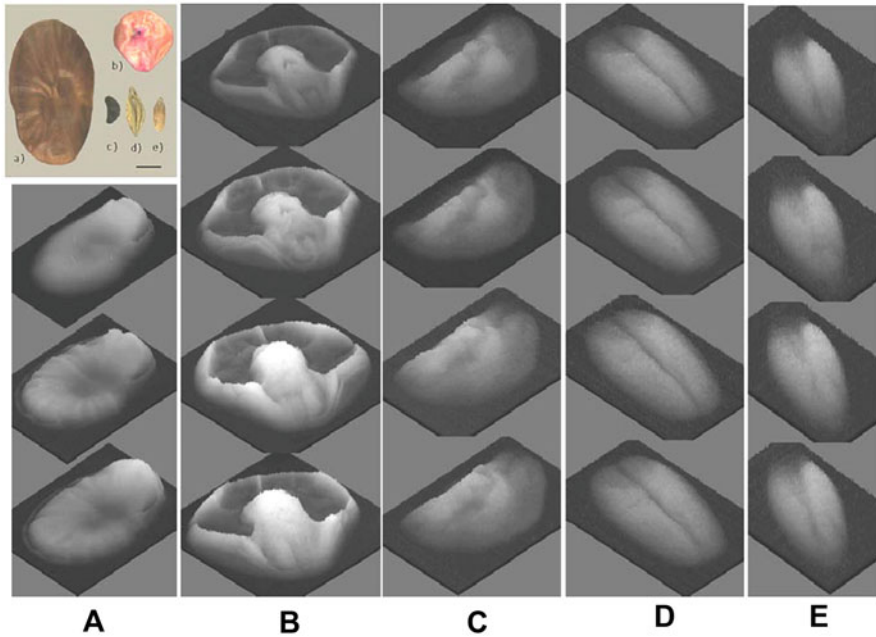
Fig. 1.29 Water absorption process of seeds [12]. Three-dimensional neutron images of the seeds during the water absorption process are shown from top to bottom. Five types of seeds were dipped in water: broad bean (**A**, *a*), corn (**B**, *b*), morning glory (**C**, *c*), wheat (**D**, *d*), and rice (**E**, *e*), and neutron imaging was performed after 1, 2, and 3 h. In the case of the broad bean, the images before and after 1 and 2 h of water treatment are shown. The height in the image represents the water amount, i.e., the whiteness in the image. The standard sample was simultaneously irradiated to normalize the whiteness of the image taken at different stages of water absorption. The distribution of water after absorption was not uniform in all seeds. Water preferentially accumulated at the embryo site in seeds. *Upper left*: photograph of five seeds. The *bar* indicates 5 mm

As shown in Fig. 1.29, the whiteness in seeds increased with increasing water amount in seeds, but the increase was not uniform. There seemed to be a specific route for water to move within the seeds. In the case of broad bean (*a*) and corn (*b*), the water amount was especially high in the embryo. However, in the case of wheat (*d*) and rice (*c*), water uptake was found to be higher at the endosperm. Swelling of
