Bioassay Vessel Rupture Analysis

Philip R. Vormelker

Abstract Two high-pressure bioassay vessels failed at the Savannah River Site during separate events using a standard procedure for microwave heating of biosamples. Improper installation of the thermal shield in the first vessel caused the rupture during microwave heating. The second vessel rupture is attributed to over pressurization during testing. The vessel rupture appeared to initiate in the mold parting line, the thinnest cross-section of the octagonal vessel. No material flaws were found in the vessel that would impair structural performance during typical usage. Limits to thermal cycling have been suggested to avoid premature vessel rupture due to fatigue.

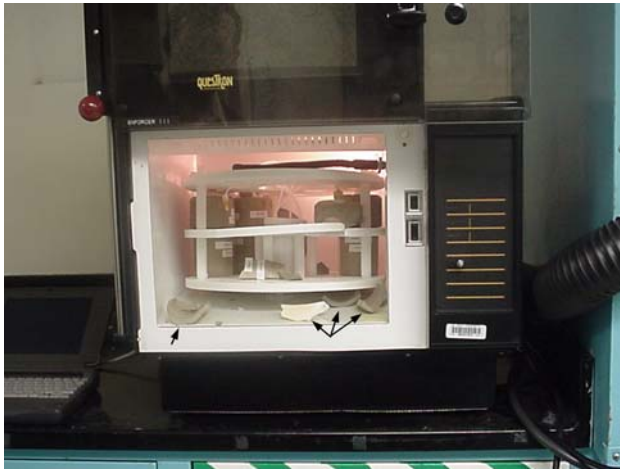
Fig. 1 Interior of microwave after vessel rupture. Parts of the failed vessel remained in the microwave after rupture (shown by arrows) and the vessel carousel was also damaged

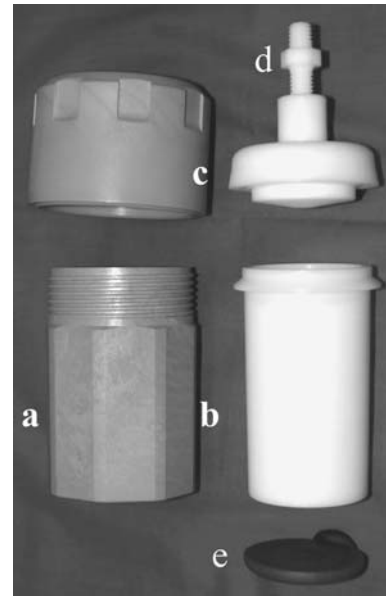
The vessel design (Fig. 2) is such that the bioassay sample is placed in the inner vessel which is then placed in the outer vessel. The cap to inner vessel is then fitted on top of the inner vessel. The screw on cap for the outer vessel is then placed over the inner vessel cap and tightened. The

tightening process seals the inner vessel cap to the vessel body creating a pressure tight container. The inner vessel slip on cap holds the pressure relief device. The pressure relief device includes a threaded nozzle with an internal hole and a pressure relief disk. The threaded nozzle is made of PTFE polymer while the relief disk is made of PFA (perfluoroalkoxy, a variation of PTFE). The inner vessel contains the biomaterial and is machined from a modified PTFE polymer, Dyneon TFM™ PTFE 1700 (DTFM).¹ This vessel is inserted into the outer vessel which is made of injection-molded polyetherimide Ultem™ 2300.² The PTFE and PFA polymers are nearly transparent to microwave energy due to their low dissipation factors (ratio of the material's power absorption (heat) to the power transmitted through it) [1–3]. Thus, heating of the inner and outer vessels is due to the heating of the contained bioassay samples.

Fig. 2 Components of outer (a) and inner (b) vessels and caps. This cap (c) includes threaded pressure relief nozzle (d). Thermal shield (e) is inserted in bottom of outer vessel

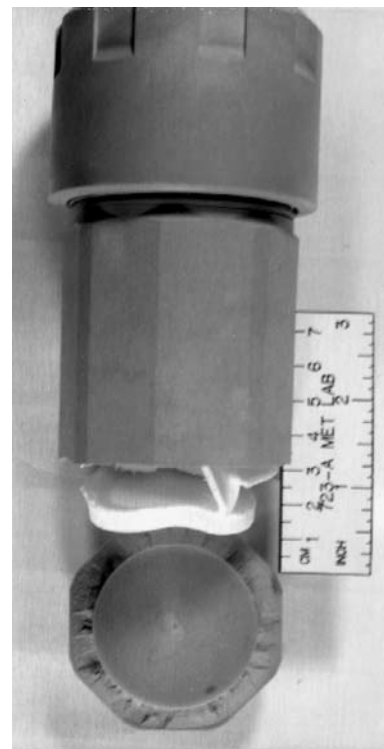
Figure 3 shows that the bottom of the outer vessel fractured with no visible cracking in the upper part of the vessel. The

Fig. 3 The first vessel rupture (No. 1) reveals full bottom head separation. This rupture mode differed considerably from the No. 2 rupture shown in Fig. 6

The fracture of the outer vessel would relieve the compressive axial stresses acting on the inner vessel wall and suddenly require the now non-supported, inner vessel wall to carry the tensile stresses induced by the internal pressure. The sudden change in stress state caused the inner vessel to fracture, as shown in Fig. 3.

Two bioassay vessels failed during testing in the SRS bioassay laboratory facilities. The first vessel rupture is attributed to incorrect placement of the thermal shield disk. A bright color stripe is suggested for use at the top of the inner vessel to allow quick identification of improper placement of the thermal shield. The second vessel rupture is attributed to over pressurization based on calculations and non-release of the pressure relief device. No flaws were found in this vessel that would impair structural integrity.

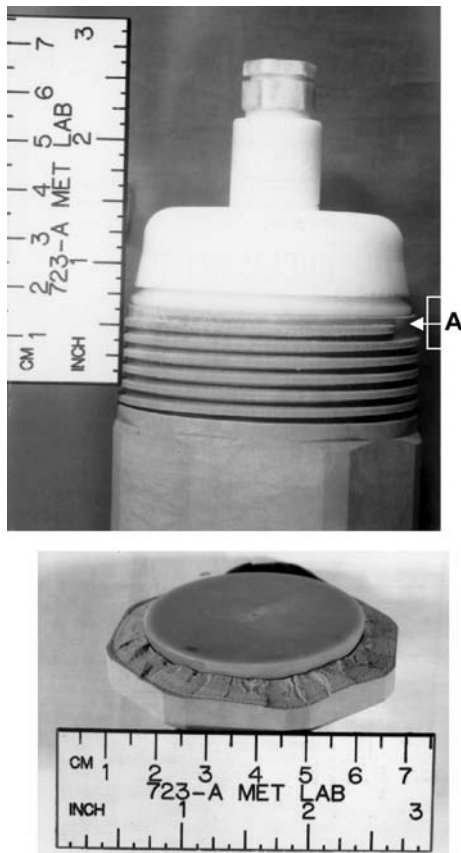
cap did not fail. In Fig. 4, the thermal shield is inserted into the bottom piece of the vessel in the upright position. The top surface of the shield is above the fractured surface.

Fig. 4 Inner vessel shown inserted into outer vessel with correctly placed thermal shield (lower photo). No gap is visible at A

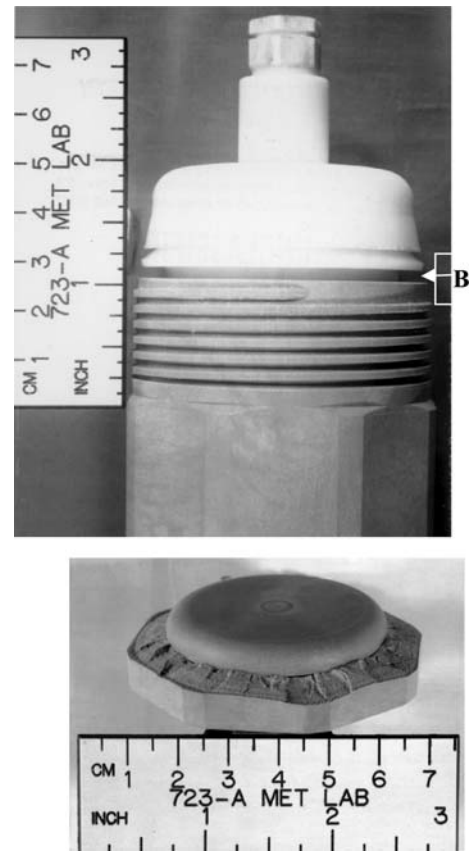
Fig. 5 Inner vessel shown inserted into outer vessel with inverted thermal shield as shown in lower photo. Note $\sim 1/16$ in. gap at B between inner vessel and top of outer vessel

However, where the shield is shown upside down (Fig. 5), the position of the fractured surface is near the bottom edge of the shield. This is consistent with the manufacturer's position that the vessels will fail at lower than anticipated pressures if the thermal shield is inverted. When the thermal shield is installed correctly, the installed inner vessel and cap will look like Fig. 4. When installed incorrectly, there is a slight gap, approximately $1/16$ in. (8 mm), as shown in Fig. 5. The tightening of the outer vessel cap when the thermal shield is upside down would therefore impose additional compressive stresses on the inner vessel and an axial tensile stress on the outer vessel. This axial stress is additive to the stresses induced by pressurization of the inner canister and will lower the rupture pressure of the outer container.

It is unlikely that circumferential pressure from thermal expansion of the thermal shield plays a role in the rupture. However, the combination of axial expansion of thermal shield and inner vessel pressure, coupled with the tightening induced stresses, could be sufficient to cause rupture at the bottom of the outer vessel. When the thermal shield is inverted, the tightening stresses could easily be higher than those induced with a properly placed thermal shield. This scenario is consistent with the manufacturer's position that an inverted thermal shield could lower the rupture pressure of the container system.

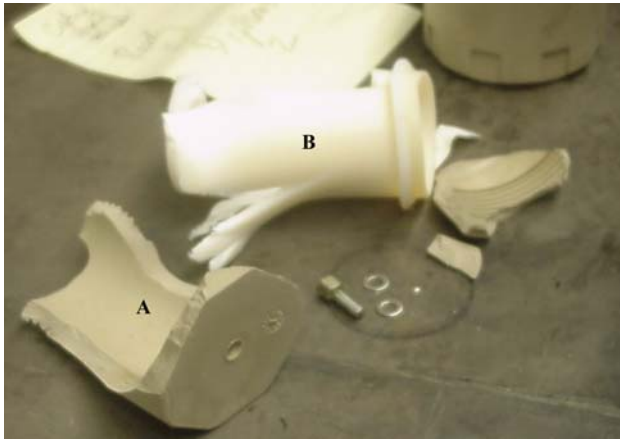
Initial observation of this rupture revealed that the outer vessel (PEI) cracked into multiple pieces while the inner vessel also showed multiple cracks but did not fragment nearly as extensively as the outer vessel (Fig. 6). Sides of the inner vessel (PTFE) appeared to have blown out with the initial rupture occurring near the bottom (Fig. 7 and 8). A bulge is visible on the side of the PTFE vessel, just above a “notch” in the fracture path (Fig. 8). A similar “notch” also appears in the outer vessel, just below the notch in the inner vessel (Fig. 8). The bulge is shown at higher magnification in Fig. 8B. No defect in the PTFE is visible at this location but this is considered to be the initial rupture site of the PTFE. It appears that pressure in the PTFE vessel caused localized expansion and ballooning of

Fig. 6 Parts of the second failed vessel that were ejected from the microwave oven. The outer vessel is identified by A with the inner vessel by B. The single screw and washers are not part of this vessel. The round component beneath the washers is the thermal shield

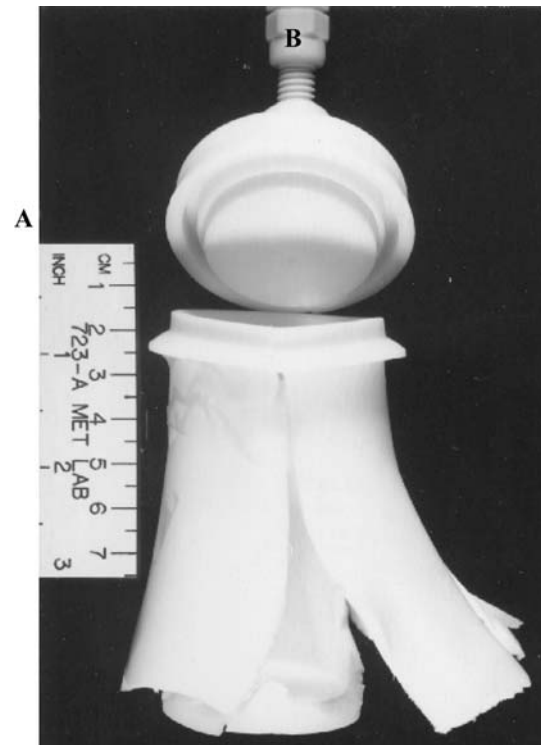
the inner vessel. The ballooned portion of the inner vessel pressed against the wall of the outer vessel, localizing the stresses in that region. When the localized stresses exceeded to fracture strength of the outer vessel, the outer vessel ruptured. The inner vessel was then free to expand and crack and fracture of the inner vessel initiated at the bulge. The inner vessel fracture was accompanied by both

Fig. 7 The initiation of rupture in the inner PTFE vessel (second vessel rupture) appears to occur either circumferentially at the bottom, in a vertical direction, or both

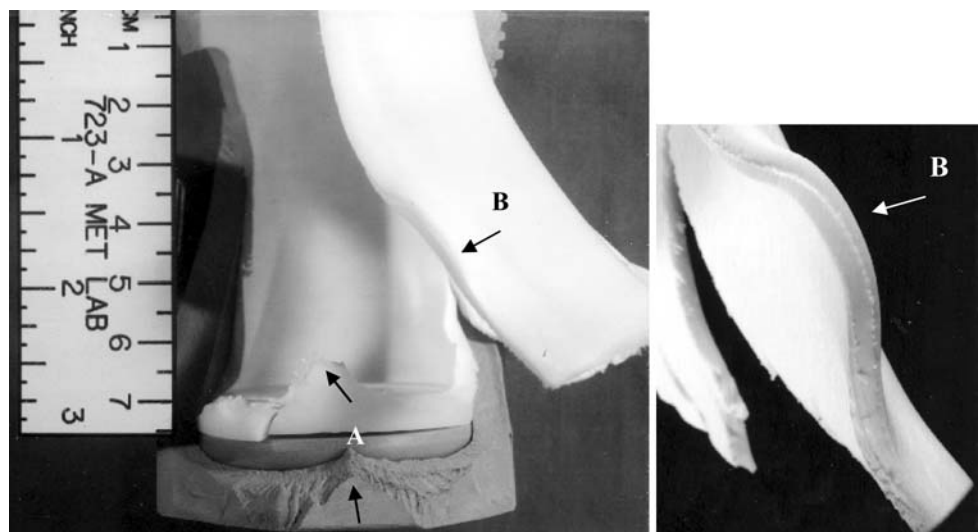
Fig. 8 Inner PTFE vessel of Fig. 7 is shown positioned within outer vessel. Note matching fracture peaks in inner and outer vessels (A). A bulge in the PTFE is visible at B with an enlarged view on right which is most likely the initial site of the PTFE vessel rupture after rupture of the outer vessel

from the conversion of absorbed moisture to steam in the annular space would have increased the strain energy in the vessel wall and may cause rupture at lower than expected inner vessel pressures. However, the rupture appears to have initiated near the bulge as shown in Fig. 8 and bulging would have been inhibited if pressure developed in the annular space.

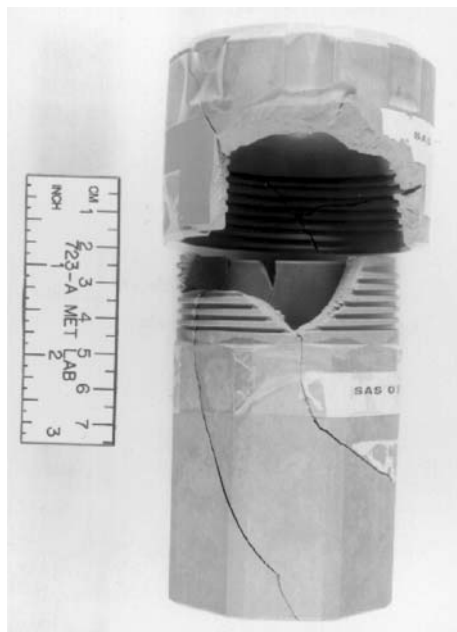
Fig. 9 The outer vessel from the second vessel rupture showing components taped together. Note that all cracks propagated along a curved path on the bottom part of the shell in this photo

together (Fig. 9). The multiple cracks in the outer vessel and the associated cracking of the screwed on lid show that the initial fracture was accompanied by the rapid release of stored strain energy. Some of the stored strain energy was released by the formation of new fracture surfaces in the PEI outer vessel. The crack pattern (Fig. 10 and 11) suggests the mold parting line was a region that was very susceptible to fracture. An injection molded part usually displays two lines, 180° apart where the mold separates, similar to a clamshell. When the components of Fig. 9 and 10 are laid side by side, fracture at the mold parting line is clearly visible (Fig. 11). However, other crack paths were also active during the fracture process. It should be emphasized that the fracture of both the inner and outer vessels was accompanied by large-scale strain energy release and multiple fractures.

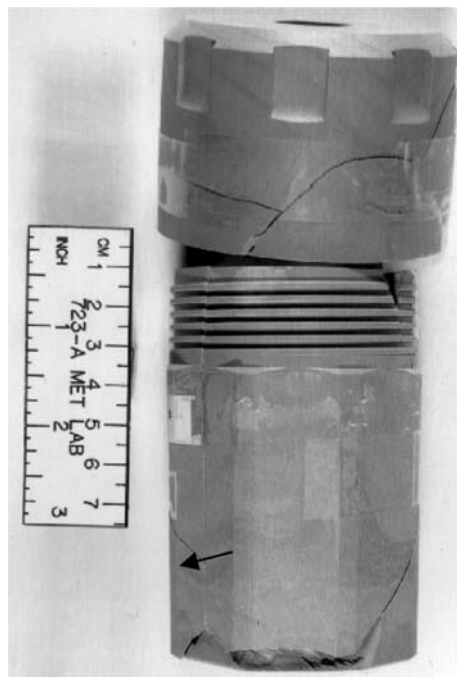
Fig. 10 Opposite side of the failed outer vessel from Fig. 9 with components taped together. In this case, a crack is barely visible along the mold parting line at arrows

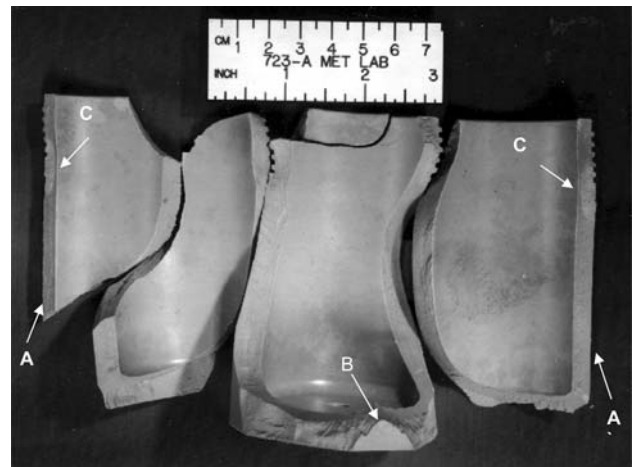
Fig. 11 Second vessel rupture. Failed outer shell components lined up side by side to show vessel fracture surfaces. The mold parting line is located at arrows marked A. The crack appears to initiate either near B or slightly above it where the bulge in the PTFE vessel occurred. At C the fracture surface appears lighter, possibly due to a decrease in crack growth rate because of the constraint imposed by the cap that was present over the threaded portion of the container

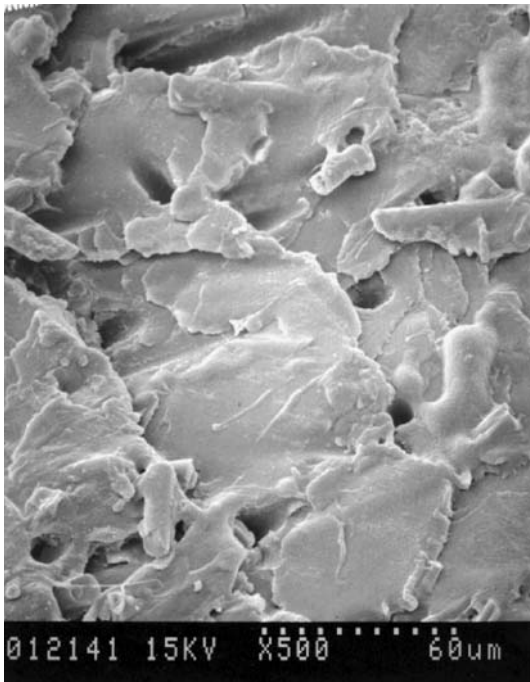
Fig. 12 Fracture surface below light color C location in Fig. 13. The fracture surface appears very brittle and is consistent with rapid crack growth rates. Round holes are prior fiber locations. Note that the magnification is only 500× compared with 800× in Fig. 13

SEM evaluation of the fracture surfaces showed two different types of fractures. One (Fig. 12) shows a flat, brittle fracture typical of rapid crack growth in fiber reinforced plastics. This fracture topography was found in the grey colored areas lying below the light color area (C) of Fig. 11. Another type of fracture topography was observed in light color area at C. This topography was typical of slow crack growth in ductile, fiber reinforced plastics (Fig. 13), and shows both fiber pullout and plastic deformation of the polymer matrix. When compared to the fracture surface of a deliberately failed vessel, the induced fracture surface (Fig. 14), the surface of Fig. 13 appears very similar but the induced fracture showed less evidence of plastic deformation.

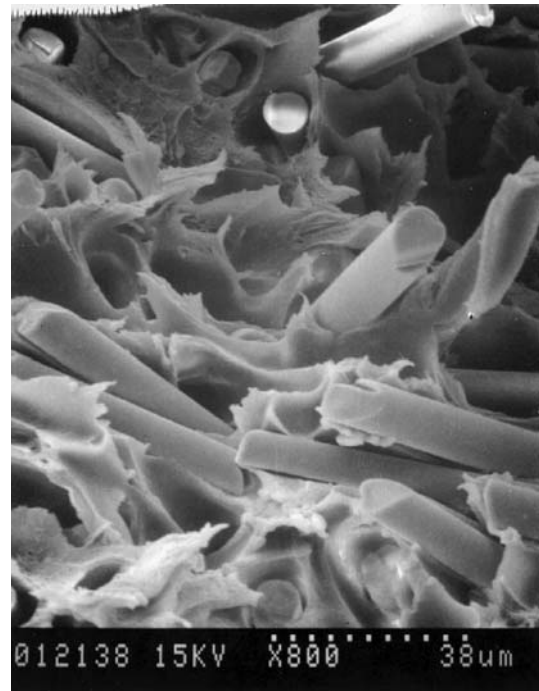
Fig. 13 Fracture surface at C location (light color) in Fig. 11 showing glass fibers sticking out of a torn, ductile surface. This topography suggests low crack growth rates

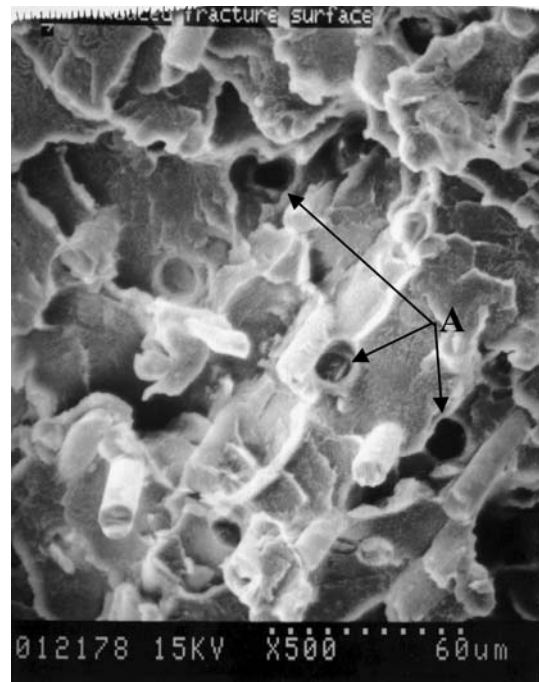
Fig. 14 Fracture surface of induced rupture of new vessel showing relatively flat but ductile surface with fibers and a few holes (A) where fibers were pulled out. This fracture surface suggests crack growth rates intermediate between those associated with Fig. 12 and 13

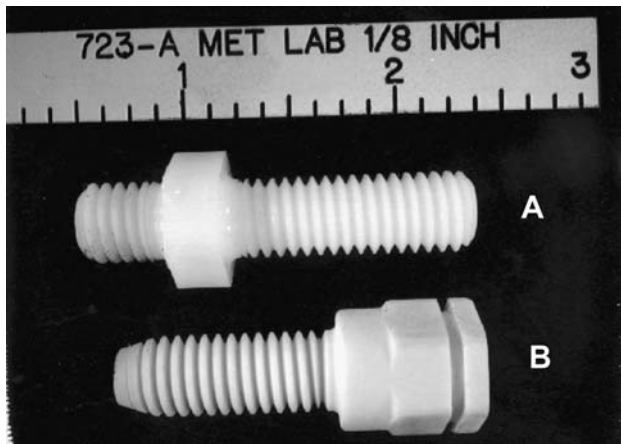
Fig. 15 Pressure relief nozzle types. Type A (new design) was used in an earlier vessel rupture. Type B (old design) was used in both ruptures described in this paper. Note the longer taper on Type B versus Type A

720 psig (5 MPa). Pressure testing was performed to determine release pressures of samples from our inventory. The pressure relief device includes a threaded nozzle (Fig. 15) allowing it to be hand threaded into the cap on the inner vessel and a rupture disk. The rupture disk, a solid, circular disk (Fig. 16) made of Teflon PFA (polyperfluoroalkoxyethylene), is inserted in the cap prior to threading the nozzle. The disk is approximately 0.020 in. (0.5 mm) thick with a 0.315 in. (8 mm) diameter and is

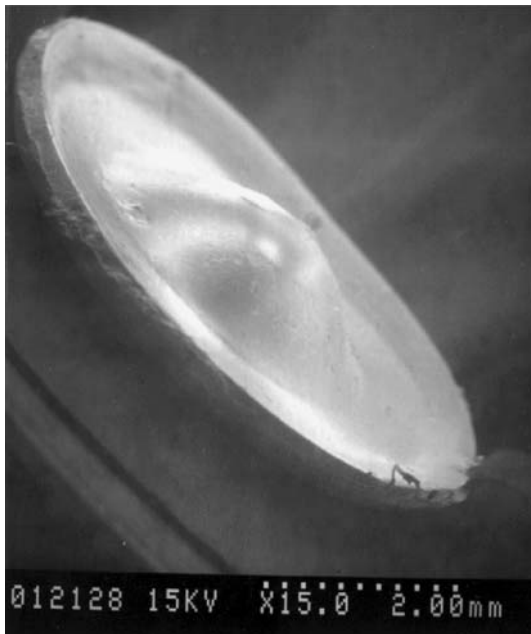
Fig. 16 Pressure relief disk from testing. The taper on the nozzle allowed disk deformation as pressure increased. Note the rolled-up edges. This disk does not rupture at normal operating pressures but distorts to allow air to escape around the nozzle threads

designed to deform around the circumference to allow pressure release through the threads.

However, it should be recognized that failure is a very infrequent event and that the consequences of any failure can be minimized by reducing the maximum pressure allowed to develop in the inner vessel. Therefore, at a minimum, the pressure release device should be modified to assure vessel venting at the desired maximum pressure.

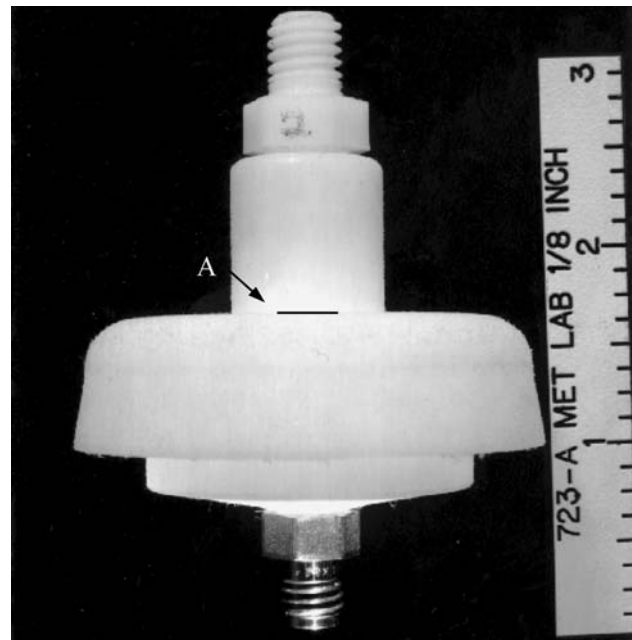
Fig. 17 PTFE inner vessel cap with pressure fitting attached for testing rupture disk rupture. Heating tape was wrapped around the outer diameter to increase temperature. The pressure relief disk is inserted at position A, beneath nozzle

The inner vessel cap was drilled and threaded to allow for hose attachment to a high-pressure fitting (Fig. 17). Early testing with a used nozzle and new rupture disk resulted in measured release pressures of 1025–1267 psig (7–8.7 MPa). This testing was accomplished using a pressure rise rate of 120 psig/min (0.8 MPa/min). Heater tape was wrapped around the cap for testing at higher temperatures, 98–104 °C. At the elevated temperature the release pressure was measured at 785–968 psig (5.4–6.7 MPa). These elevated temperature tests were conducted using a new nozzle of the old design and a lower pressure rise rate. Pressure release in all tests was very audible and gage pressure dropped significantly. It was also observed that the used nozzle was easy to hand thread whereas the new nozzle was more difficult. After the initial test with the new nozzle, the ease of threading was similar to that for used nozzle. Pressurization of the new threads probably caused thread deformation to allow easier fit-up during the next use.

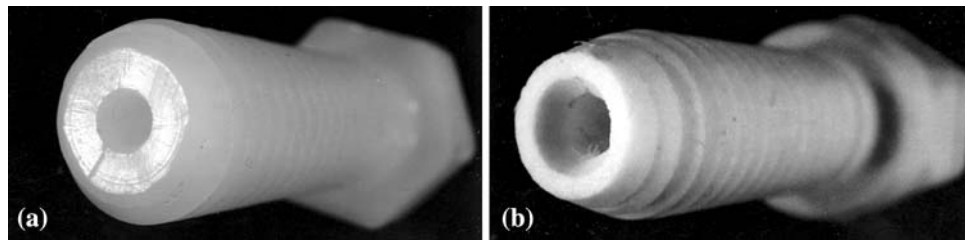
Doubling the pressure rise to 240 psig/min (1.7 MPa/min) resulted in release pressures of 1398–1428 psig (9.6–9.9 MPa) with a used and a new nozzle (old design). Since these pressures were very high, a pressure rise of 120 psig/min was used for remaining tests. A new nozzle design (Fig. 18) with a flat face was also tested. At room temperature, the release pressures were 832–848 psig (5.7–5.9 MPa)

Fig. 18 Face of Type A pressure relief nozzle is flat with no ID taper. Face diameter is approximately 5/16 in. Hole diameter is approximately 0.075 in. Face of Type B pressure relief nozzle has a taper. Face diameter is approximately 5/16 in. Hole diameter (B) is approximately 0.080–0.084 in.

with gage pressures dropping very slowly after the release. These pressure values were a little higher than with the old design nozzle. This is expected since the new nozzle design has a flat head versus the bevel design on the old nozzle. In all tests, the rupture disk did not fail but did provide a path for pressure release. However, the relief pressures were higher than the manufacturer's test results. These higher than anticipated release pressures are consistent with the bioassay vessels failures during service. Simply put, the pressure inside the inner vessel may not have been released by the rupture disk and the inner vessel pressure ultimately exceeded the pressure required to induce rupture in the outer vessel.
