Infrared Techniques for Practical Defect Identification in Bonded Joints in Liquefied Natural Gas Carriers

R.C. Tighe¹ · J.M. Dulieu-Barton¹ · S. Quinn¹

Abstract A robust and reliable method for the identification of defects in adhesively bonded joints used in the membrane containment system used to store liquefied natural gas during transport on board ships is required. The adhesively bonded interface of the membrane system may contain low volume defects known as kissing defects, which are extremely difficult to detect using portable inspection techniques. A novel methodology for detecting such defects is described in the paper. To demonstrate the approach simulated kissing defects were produced in a controlled fashion in a representative secondary membrane bond using silicon grease contamination. The defects were detected using an active thermographic approach known as pulsed phase thermography (PPT) which detects subsurface defects by monitoring the effect they have on the propagation of heat through a component. Due to the low volume of kissing defects, they generally have minimal effect on the heat propagation, so the detection was made possible by application of a small loa

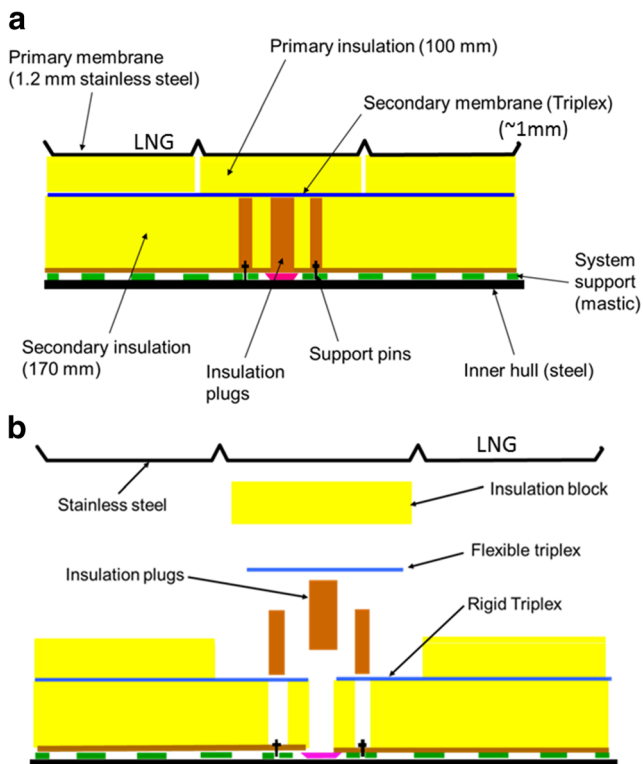
Fig. 1 (a) Schematic of GTT Mk III LNG carrier bonded joint and (b) in shipyard construction of the secondary membrane [3]

are thoroughly inspected during manufacture as, once approved, they are sealed below thermal insulation and the metallic primary membrane and so are no longer accessible for inspection. It is assumed by the manufacturers that once the bond is inspected during the construction stages and approved that it will remain approved through life. Should any subsequent inspections be required it would be necessary to dismantle the primary membrane and insulation layers, hence it is of paramount importance that the bonds be suitably inspected to avoid costly remedial work.

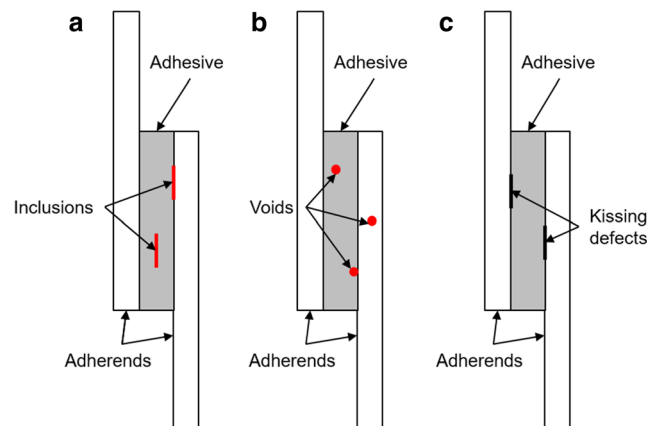
Fig. 2 Three categories of defects typically found in adhesive joints; (a) inclusions, (b) voids and (c) kissing defects

Several types of defects occur in adhesive bonds [5, 6]. These may be considered to fall into three main categories, see Fig. 2. The first type are inclusions, which are the physical inclusion of a foreign material in the adhesive joint, as in Fig. 2(a). These could occur, for example, if positioning tape is left on the adherend (material being bonded) and has adhesive applied

over it. The second type are voids which are caused by the inclusion of air in the joint, see Fig. 2(b). These could occur between the adhesive and adherend during joint assembly or be found in the adhesive itself if air is introduced, e.g. during mixing of a two part adhesive. The final category of defect are kissing defects. Kissing defects are the result of improper adhesion between the adhesive and the adherend, as shown in Fig. 2(c), where the adhesive/adherend interface is not as strong as expected for that joint configuration [6]. A decreased level of adhesion leads to reduced joint strength and is a significant threat to structural integrity. As all components of the joint are present and in contact, kissing defects are the most difficult type of defect to detect using NDE techniques. The present paper focusses on the detection of kissing defects as these are the most challenging defect to detect as they provide very little material property contrast to aid NDE techniques in their detection.

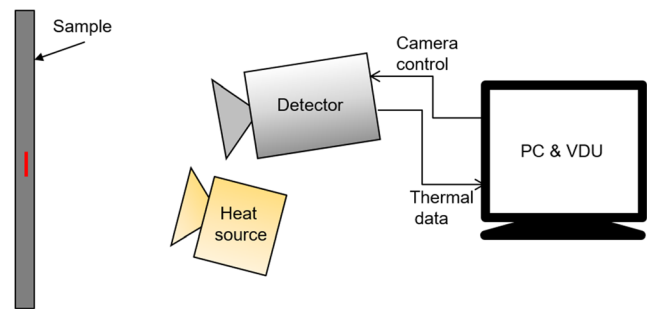
Fig. 3 Schematic of pulse phase thermography experimental set-up

A schematic of the experimental set up for PPT is given in Fig. 3. As only single sided access is available for the Triplex joints the inspection must be carried out using reflection mode PPT where the heat source and infrared (IR) detector are on the same side of the bond. When dealing with such thin materials the impact of using reflection mode compared to through transmission mode (with the detector and heating on opposite sides of the component) on the identification of defects is negligible. PPT involves the application of a pulse of heat to the surface of the material. Once the surface is heated an IR detector is used to monitor the surface temperature evolution as the heat front propagates through the thickness of the material. Where the material is

laterally uniform across the area of inspection the heat front will propagate uniformly and the surface temperature will remain uniform. However, where there is a region of differing thermal properties, such as if there was a void below the surface, the heat propagation will be affected. The variation in heat front propagation local to such a defect will result in non-uniformity in the surface temperature over the defect. From this non-uniformity the location and extent of a defect may be inferred. While for shallow defects, that create a strong thermal contrast, the defects can be visible directly in the recorded thermal data it is generally necessary to post process the thermal decay data into phase data using a fast Fourier transform. The application of the FFT involves processing the data from each pixel through time into phase data [30]. This enables external effects such as surface reflections and non-uniform heating to be reduced and deeper or less strongly contrasting defects to be revealed.

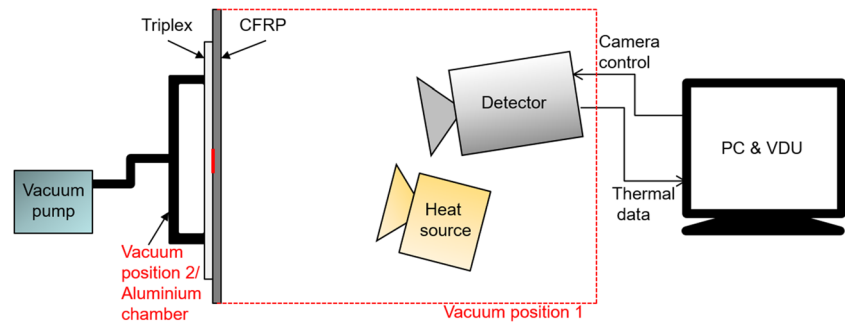
Fig. 4 Vacuum loading options on CFRP-Triplex bond with simulated kissing defect

All thermography based techniques rely on there being a contrast in material and defect thermal properties. Kissing defects however, offer little or no thermal contrast, thus would not normally be identified using this approach. A novel aspect of this work is to apply a small non-destructive load to open kissing defects to enhance their thermal contrast and enable defect detection. The Triplex bond lends itself to this approach as there is a stiffness mismatch between the flexible and rigid Triplex, i.e. between the two adherends of the joint and the flexible Triplex of the accessible adherend. When the flexible Triplex is loaded it will more easily deform than its rigid counterpart, enabling a kissing defect to be opened. Furthermore, due to the low level of loading required to elastically deform the flexible Triplex material it may be possible to use a vacuum to open existing defects to enable their detection. The final concept would be to have a PPT inspection system contained within a vacuum hood, making a portable practical tool as shown in Fig. 4, labelled vacuum position 1. However, due to the cooled nature of the photon detector used, initial tests have applied the load to the rear of the sample while inspection is carried out on the opposite surface, as shown in Fig. 4, labelled vacuum position 2. The initial setup required two sided access to the bond which would limit the application of the technique in its current form, however this enabled a proof of concept to be investigated. It would be

layout $[0\ 90]_s$, as shown in Fig. 4. In the laboratory trials the bond is inspected from the CFRP side, although in practice inspection will occur through the flexible Triplex, as in the first round of trials. The adhesive used for the simulated joint was an epoxy based adhesive, creating a total bond thickness of 1.4 mm. A 20 mm square patch of silicon grease contamination was introduced to the CFRP side of the bond with total bond dimensions of 250×150 mm. The silicon grease created a liquid layer style simulated kissing defect. The vacuum was applied, as shown in Fig. 4 as vacuum position 1, by using a small portable aluminium chamber, which was attached to the sample using sealant tape. A standard laboratory vacuum pump was used to apply the vacuum; the levels of vacuum pressure achieved are defined relative to the pump performance, i.e. 100% is maximum vacuum applied by the pump which creates a pressure of approximately 0.15 bar and 0% is atmospheric pressure, approximately 1 bar.

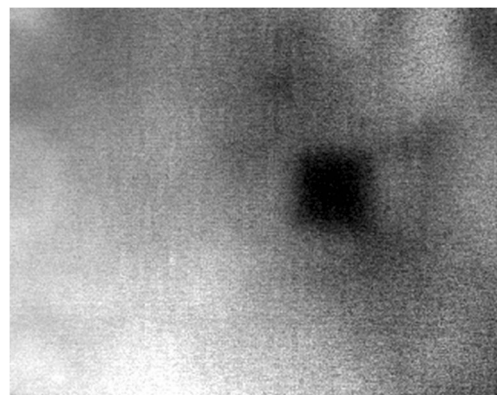
Fig. 5 PPT phase data identifying PTFE insert in Triplex bond through inspecting through rigid Triplex

The PTFE is clearly identified in the RT-FT bond, as shown in the PPT phase data in Fig. 5. This initial test confirmed the PPT setup and experimental procedure selected was suitable for identification of defects with inspection through the Triplex. Using this defined procedure the second joint configuration containing the stiffness mismatch between the FT and

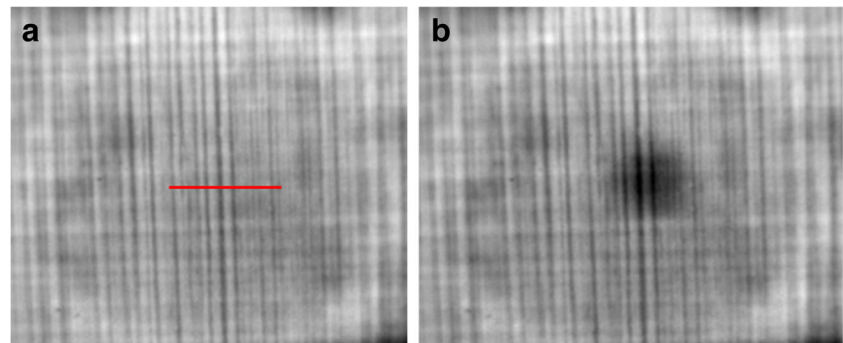
Fig. 6 PPT phase data for the CFRP/Triplex bonded sample (a) unloaded and (b) full vacuum applied to the rear of the sample

the CFRP was then inspected with the application of vacuum loading for kissing defect detection. Figure 6(a) and (b) show the PPT phase results of the defect region with no load applied and full (100%) vacuum loading. The lighter circular ring visible in the edges of the images is due to the presence of the aluminium vacuum chamber attached to the rear of the sample. It is clear that without the addition of load the silicon grease contamination is not visible in the phase data, as is expected for a kissing defect. When the vacuum is then applied the defect becomes easily identifiable in the centre of the image in Fig. 6(b). This is emphasised in the profile data taken horizontally across the centre of the defect position, as shown in Fig. 6(a), for the fully loaded and unloaded conditions. The profile plot, in Fig. 7(a), also demonstrates that the regions away from the defect, i.e. the well bonded regions, are unaffected by the application of the vacuum, hence the defect is not propagated by the loading and the technique is non-destructive. It should be noted that an unloaded image was taken after the full vacuum was applied and the profile returned to that obtained prior to loading, demonstrating that permanent deformation had not occurred in the flexible Triplex by the vacuum loading. The joints were also inspected several times, each time giving consistent results further ensuring that the

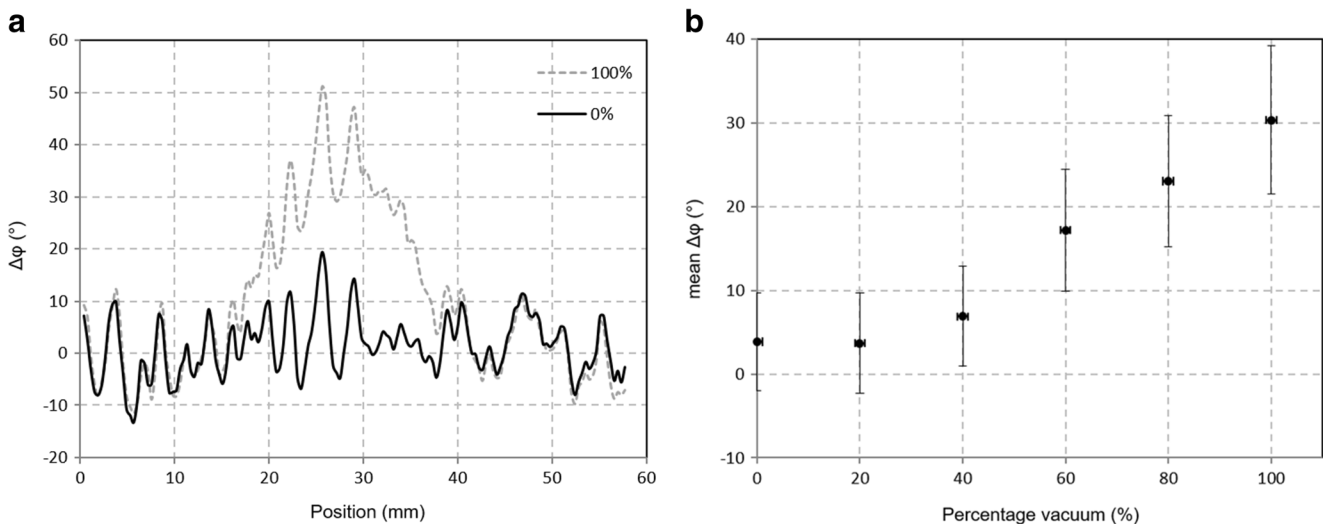
Fig. 7 (a) phase contrast profiles taken across the defect region under vacuum loading conditions of 100% vacuum and 0% vacuum and (b) the mean phase contrast between defect and non-defect regions taken across the width of the defect related to partial vacuum percentage applied

defect was not propagated during the vacuum loading. Fig. 7(b) shows the mean phase contrast between the defective and non-defective regions for each vacuum partial pressure applied. The defect becomes identifiable in the mean phase contrast data at just 60% of vacuum pressure, thereby highlighting the low level of load required to generate such results. The level of loading required to open the kissing defect is dependent on the stiffness of the material and the size and geometry of the defect. Therefore, should a maximum tolerable defect be determined to be smaller than that tested in the present paper, it would be necessary to ensure sufficient load was applied to reveal such a defect. Definition of such a threshold size is beyond the scope of the current work.
