3D finite element coupled analysis model for geotechnical and complex structural problems of historic masonry structures: conservation of Abu Serga church, Cairo, Egypt

Sayed Hemeda*

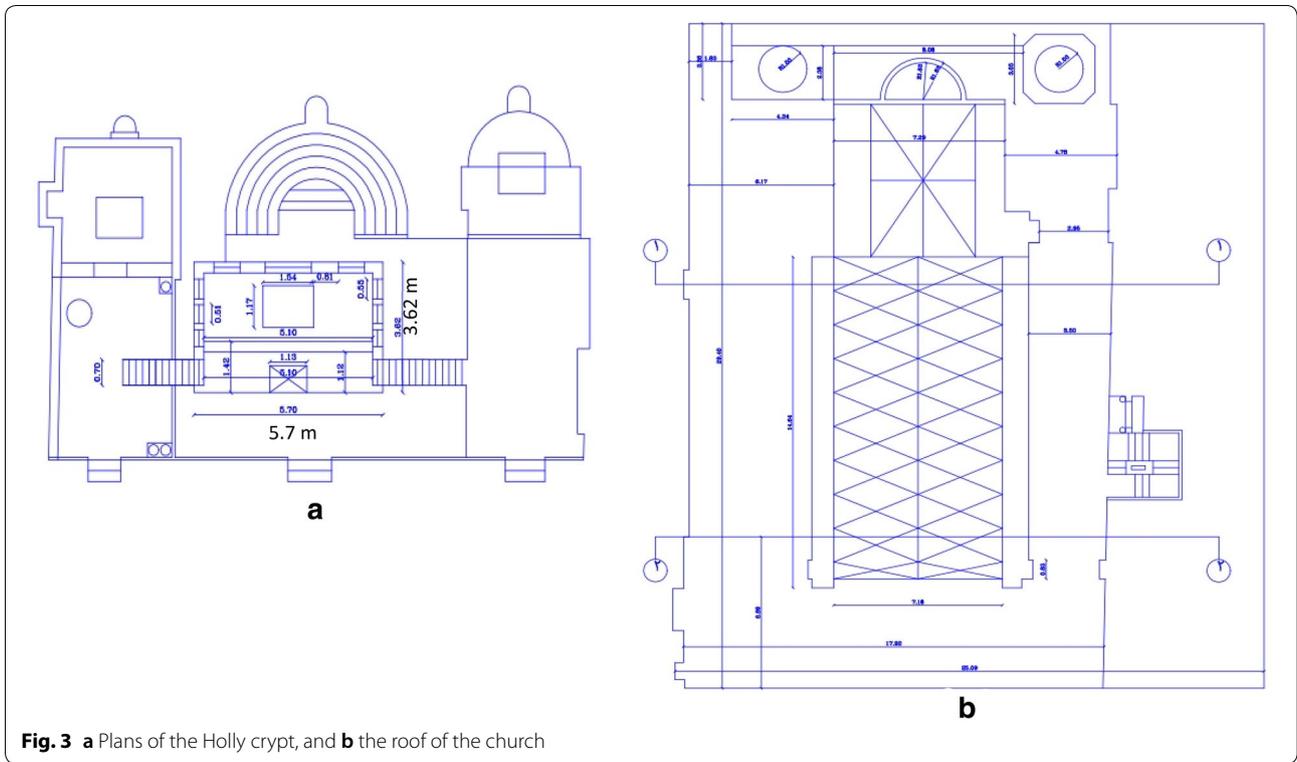
Fig. 3 a Plans of the Holly crypt, and b the roof of the church

Three sanctuaries occupying the eastern side of the church. In the northern and southern ones, there are internal underground stairs leading to the Holly crypt. The height of the Holly crypt is about $6.5 \times 5 \times 2.5$ m with two columns rows containing a longitudinal series of arches on each row. These two rows of columns are divided into three long shallow domes, which can be considered a plateau with northern and southern passages. [22] Modern architectural surveys and studies presented in this study indicated that the length of the church is 29.40 m and its total width, including the external open

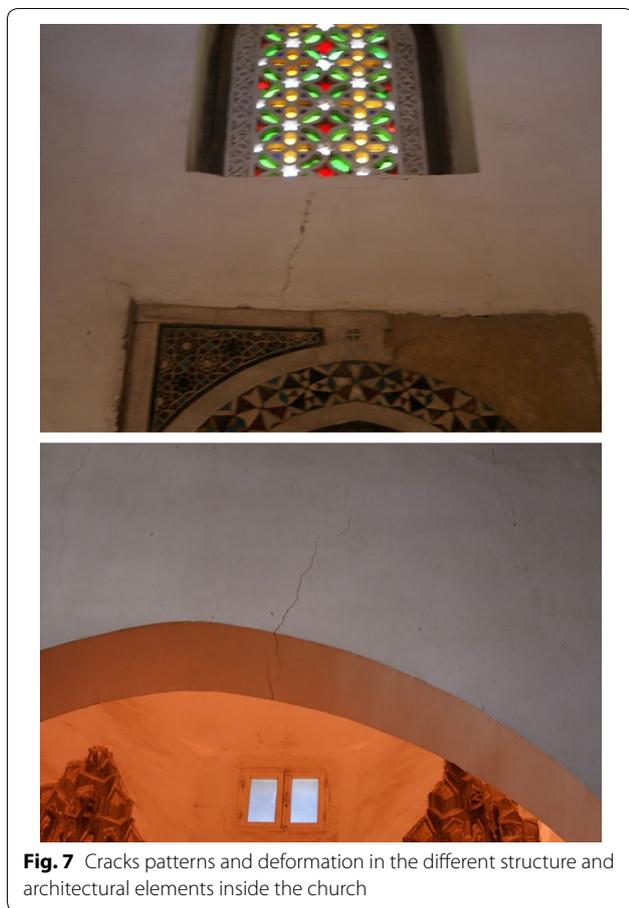
Fig. 7 Cracks patterns and deformation in the different structure and architectural elements inside the church

The internal deformities of the two facades of the church are clear, as shown in Fig. 6. Settlement and the rotation and inclination of the structural marble columns and the different cracks in the arches inside the church are well observed; also the vertical cracks in the lintels inside church are shown in Fig. 7.

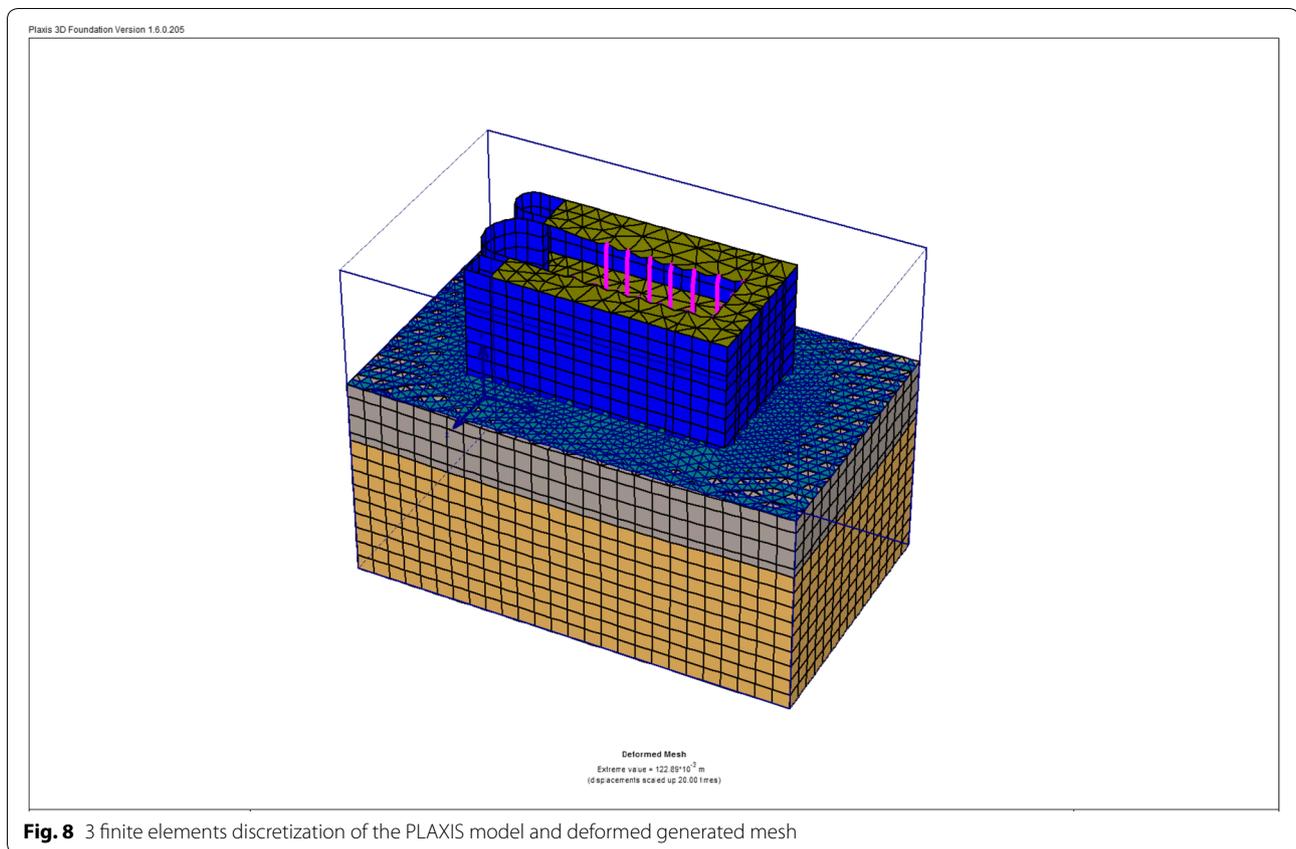
Fig. 8 3 finite elements discretization of the PLAXIS model and deformed generated mesh

Numerical modeling of the plane strain using the PLAXIS 3D (version 2018) was adopted. Consists of 15 nodes of finite trigonometric elements with a medium precision network to reduce the calculation time. All the geotechnical characteristics of the soil layers and engineering characterization of the building materials of Abu Serga church are listed in Tables 2 and 3. The

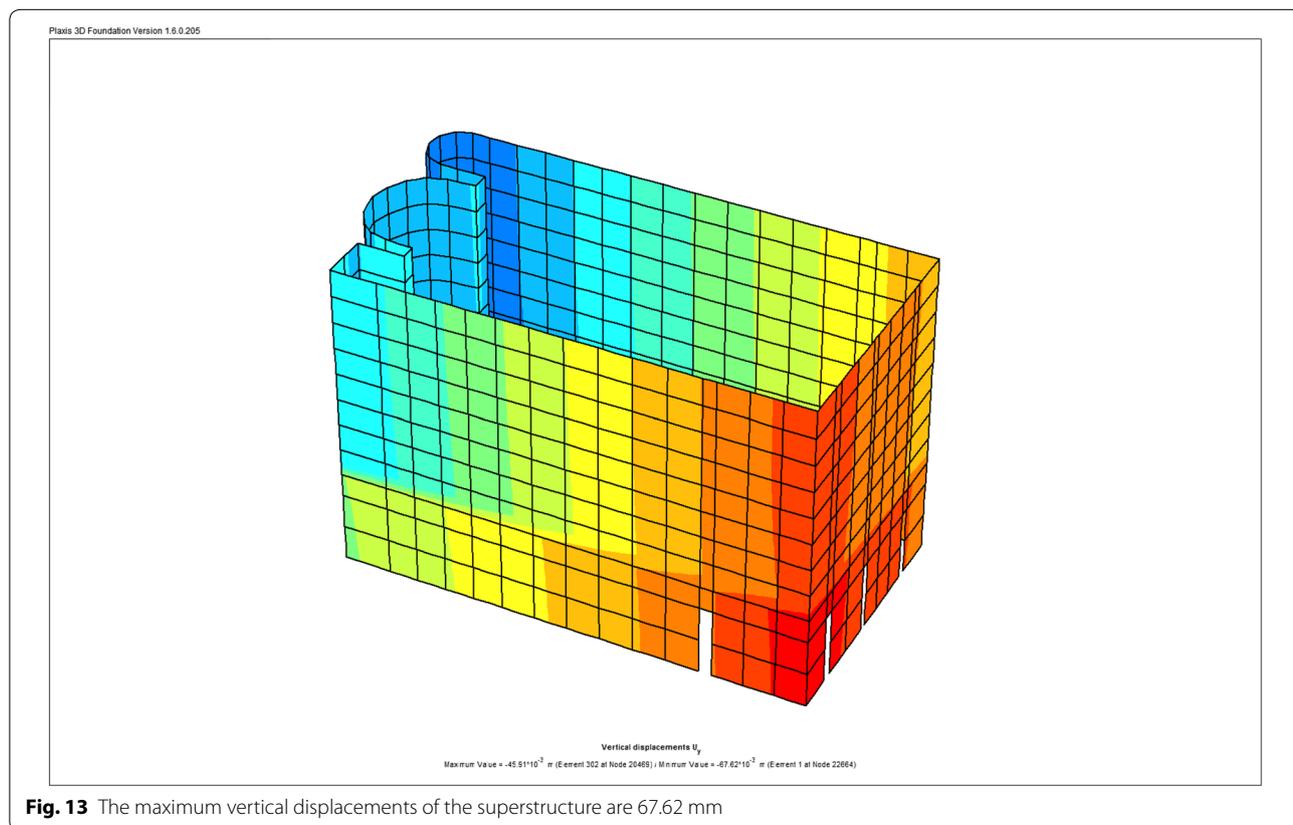
Fig. 13 The maximum vertical displacements of the superstructure are 67.62 mm

The subsidence and settlement of the subsoil may affect seriously the superstructure of the church. The main reasons were the consolidation of subsoil clay layers. Also the shear failure characteristics of subsoil may lead to the ground subsidence. The results of the numerical analysis indicated that the distribution of the U_y vertical displacement of the church superstructure, with a maximum value of 67.62 mm, and minimum U_y value

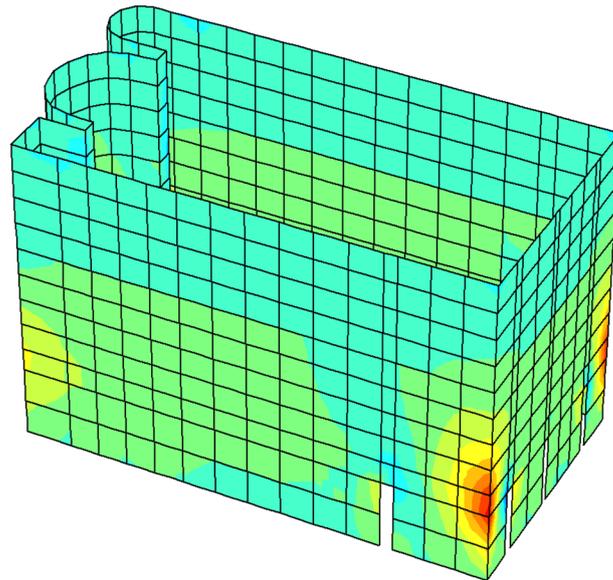
Axial forces N_1
Maximum Value = 300.06 kNm (Element 589 at Node 25288) | Minimum Value = -784.85 kNm (Element 589 at Node 25288)

Fig. 14 The extreme value of the axial force N1 on the superstructure of the church is 784.85 kN/m

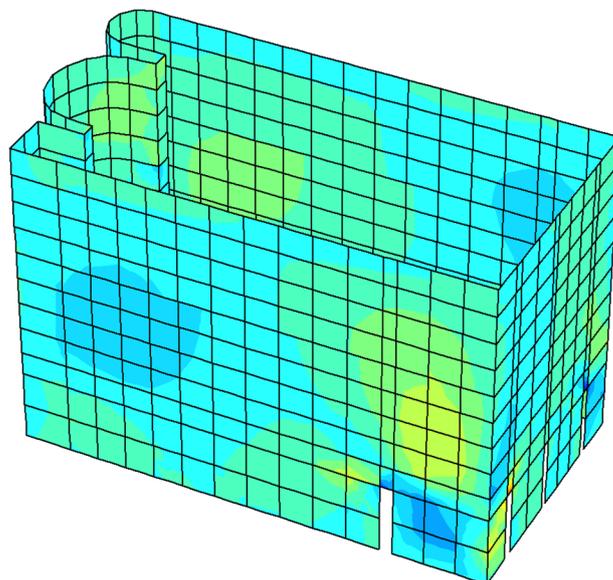
Shear forces Q_{12}
Maximum Value = 305.38 kNm (Element 424 at Node 25266) | Minimum Value = -208.96 kNm (Element 487 at Node 25161)

Fig. 15 The extreme value of the shear forces Q on the superstructure of the church is 305.38 kN/m

The shear force $Q1$ on the superstructure of the church, is with a maximum value of 305.38 kN/m, and the minimum value is 208.96 kN/m as shown in Fig. 15 which represent the maximum/minimum principal stresses. Figure 16 shows the maximum/minimum principal stresses, the bending moments of $M1$ on the superstructure of the church, with a maximum value of 104.88 kN/m and the minimum value is 80.32 kN/m. bending moment 105 kN per length unit is relatively high value, it may be the main cause of the out-plane deformation and the cracks patterns on the main facades of Abu Serga church, and it observed and recorded from the field and experimental studies.

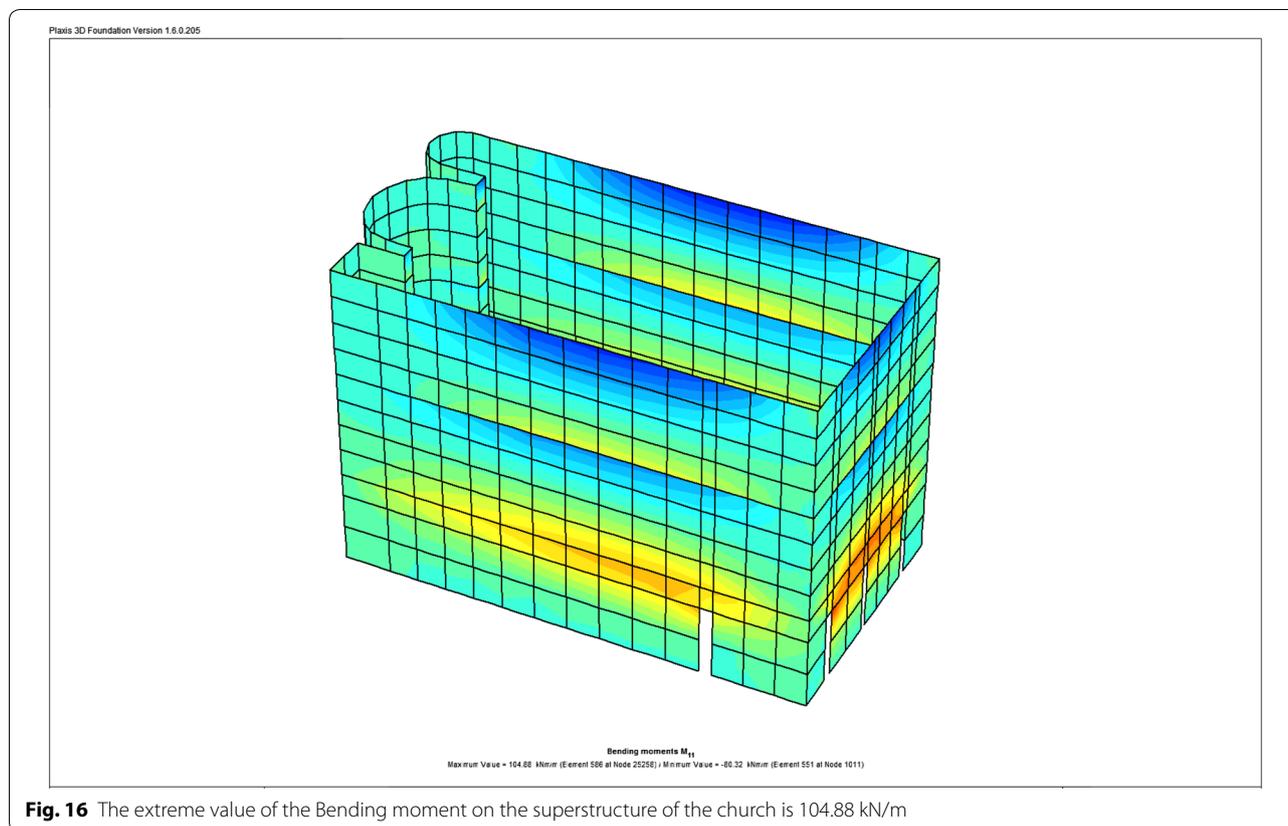
Fig. 16 The extreme value of the Bending moment on the superstructure of the church is 104.88 kN/m

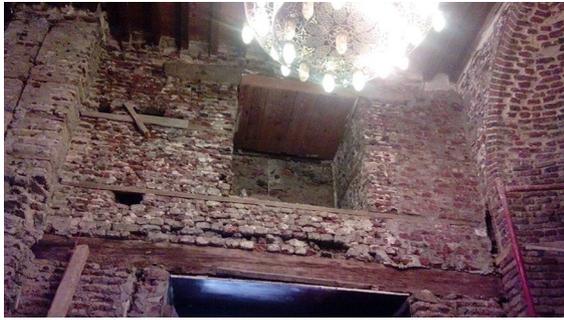
Fig. 19 Extensive disintegration and degradation of the bricks walls of the church due to the subsurface water rising

Figures 18 and 19 illustrate the state of preservation of the church before the strengthening and retrofitting intervention project. Figures 20 and 21 illustrate the strengthening and intervention retrofitting processes and measures which had been done during the restoration project for Abu Serga church.

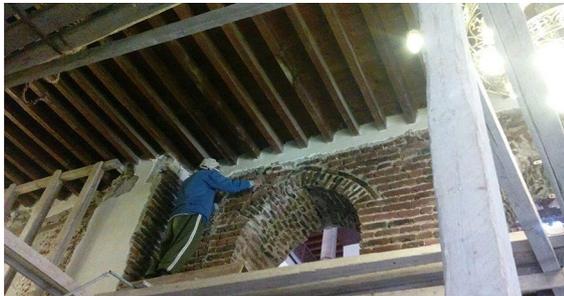
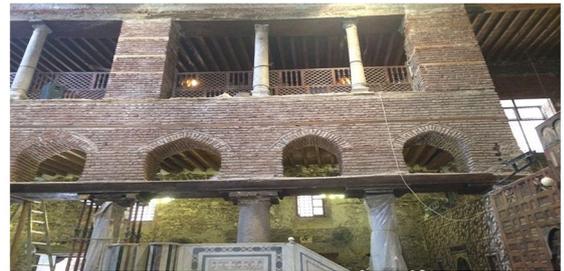
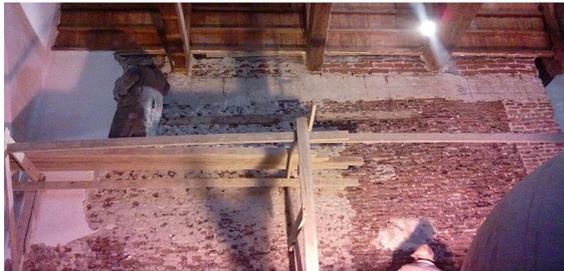
Fig. 20 Abu Serga church's wall stitching and strengthening

Extensive grouting was undertaken for filling of the wide cracks across the highly disturbed walls zones penetrating 200–300 mm into the walls. Grouting was carried out prior to the prestressing of the anchors to work load levels.

Restoration and improvement the connections between brick walls. To prevent wall cracks in the longitudinal direction, reinforce the walls with high-strength strips and insert at least 50 mm in the wall joints in some layers. The number of common layers entered in the ranges was calculated according to the additional tension obtained through the analysis, as shown in Fig. 17. It recommended the inclusion of lead strips with a thickness of about a few millimeters in joints per 1.5–1.5 m above ground to ceiling in double walls. For the stone sections, it should not be isolated. This causes fins to be caused by small, low-magnitude earthquakes, but they are stopped for centuries and prevented from ascending and damaging the structure. After the structural reconstruction of the brick walls, it was necessary to reset all surfaces using lime mortar and remove previous interventions using cement paste.

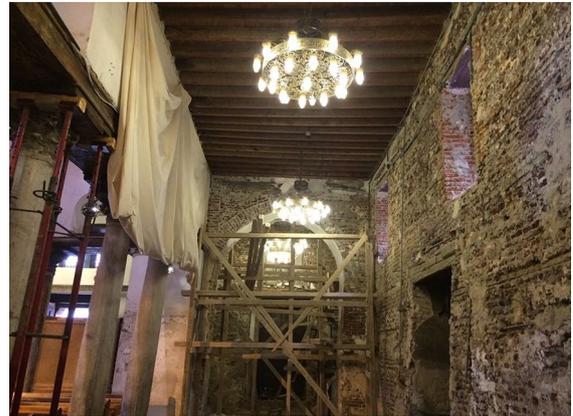
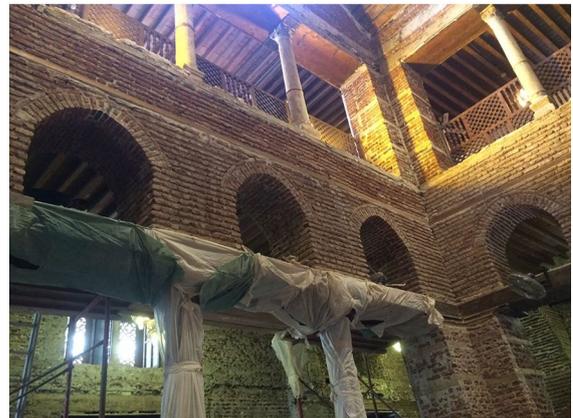
Fig. 21 The strengthening of the structural twelve columns and brick pillars

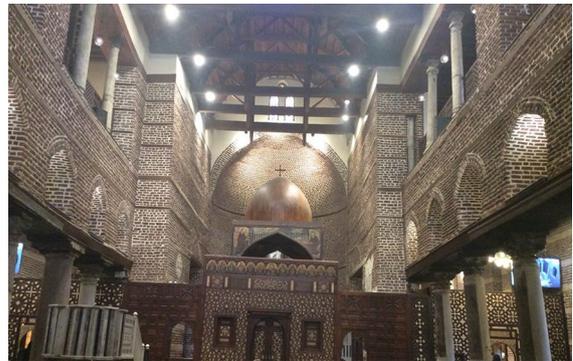
Fig. 22 Abu Serg church after the retrofitting intervention project, the nave of the church

The present preservation state of the church is provided after the complete installation of remedial measures for therapeutic intervention as shown in Figs. 22 and 23, especially in the cleaning of walls, removal of salt and stitching, and supporting the reinforcement of marble columns with designed steel rings.

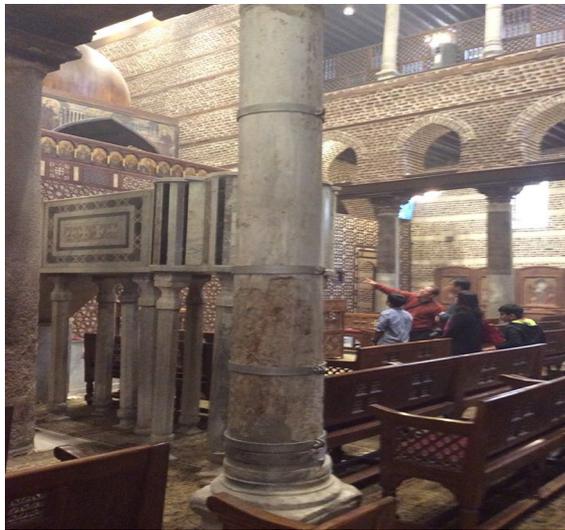
Fig. 23 Strengthening and reinforcing of structural marble and granite columns with steel ring beams
