# Evaluation of the mechanical properties and critical slope parameters of mine tailings at Enyigba, South eastern, Nigeria

Ogbonnaya Igwe\* and Chidinma Chukwu

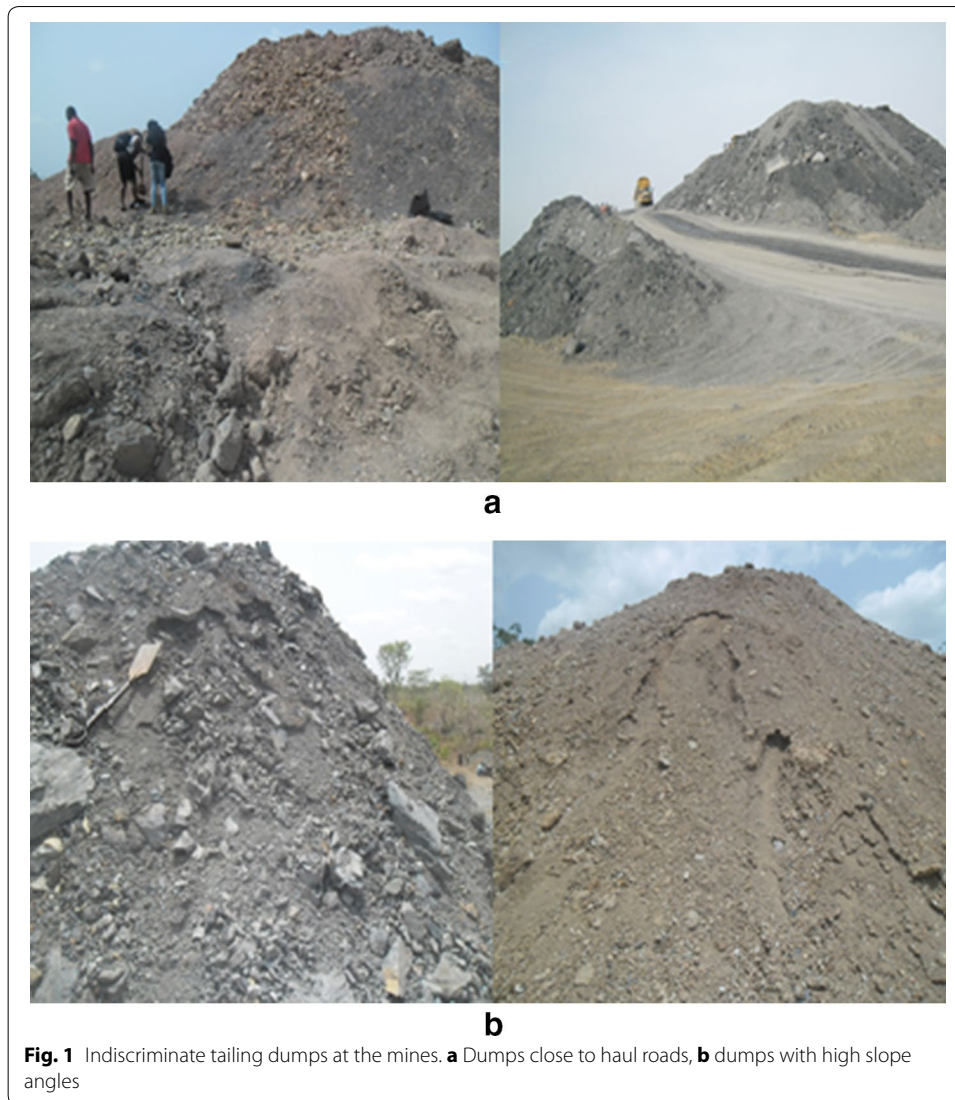
Slope geometry and other measurements were taken on fifty slopes in the study area. Most slopes were observed to be concave in curvature (Fig. 1), and from the field measurements, slope angles of the individual slopes ranged from 30° to 60° (Table 5). Most landslide events have normally been reported to occur on concave slopes with slope angle ranging between 36° and 58° [27, 28, 46, 47].

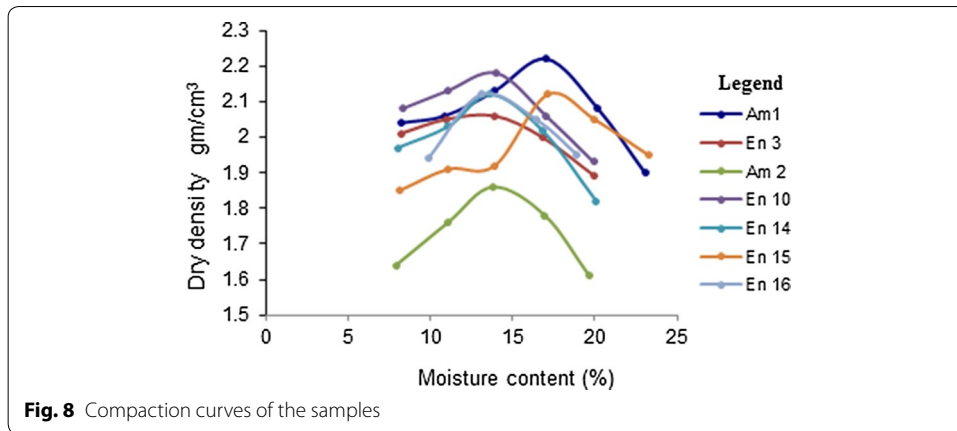
Figure 8 shows compaction curves of the samples. The compaction result showed that the soil optimum moisture content (OMC) ranged between 13.45 and 17.05%, while the maximum dry density (MDD) ranged from 1.86 to 2.22 g/cm<sup>3</sup> (Table 2). These values are suggestive of slope material with average OMC and moderate MDD. The curves represent that of low to medium plastic clays described by Maduka et al. [39], thus assenting with the consistency limits. Arora [3] noted that heavy clays of very high plasticity have very low–moderate dry density and high optimum water content, which is consistent

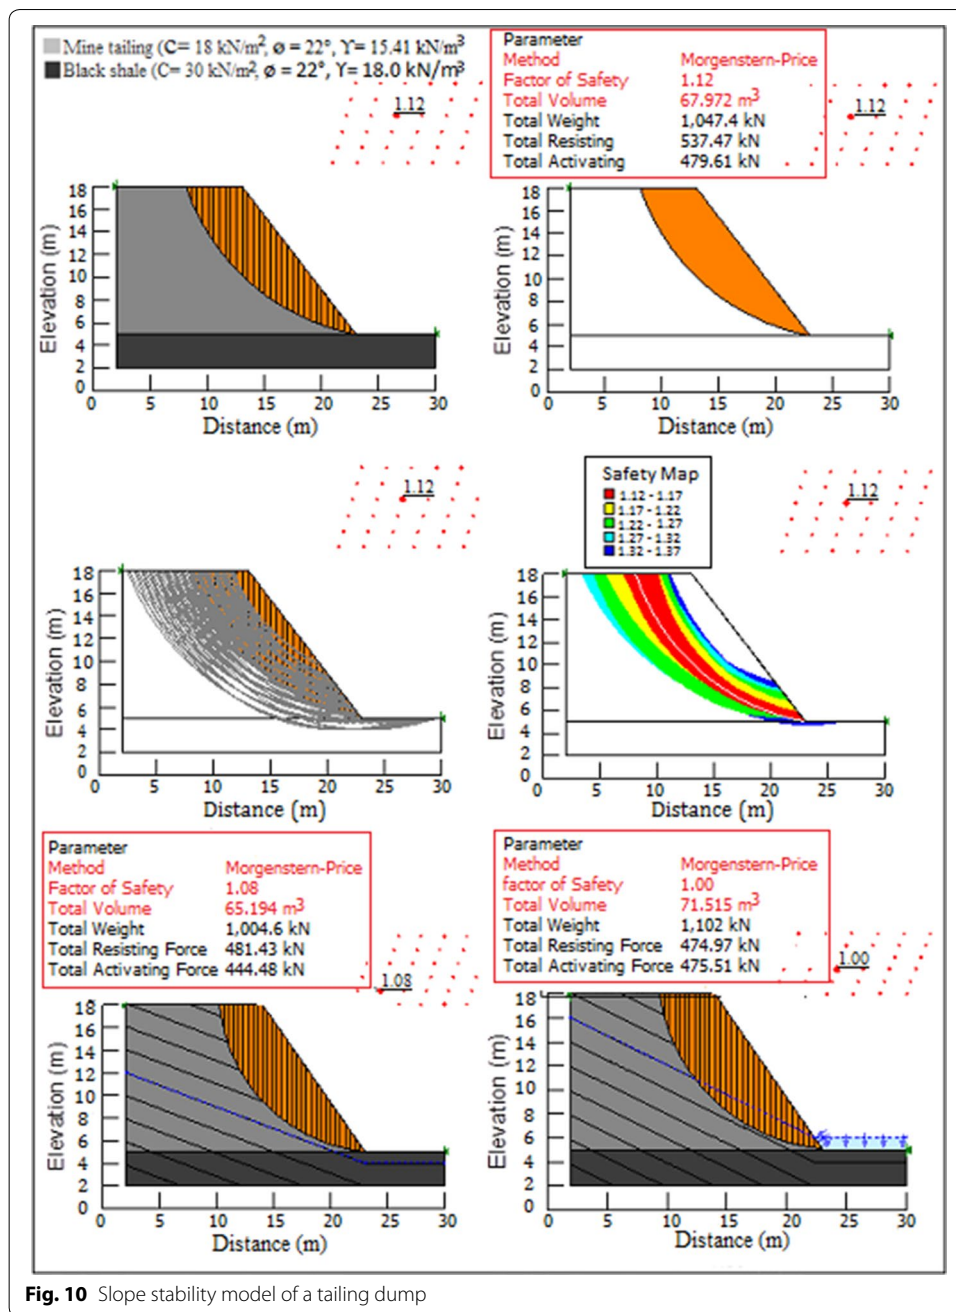
**Fig. 10** Slope stability model of a tailing dump

The FS generated for slope EN14 was 1.12, implying marginally stable slope (Fig. 10). The FS of some of the other slopes in Enyigba mine dumps are shown in Table 4. The FS recorded at the site ranges from 1.00 to 1.30, implying critical stability to marginally stable slopes (Table 4). To enable the plot of a safety map for the studied slope, several trial slip surfaces were analyzed at the time. Two hundred trial slip surfaces were evaluated (Fig. 10c), and FS generated was between 1.12 and 1.79. The safety map generated is shown in Fig. 10d, and has the color band covering FS between 1.12 and 1.37. The map showed the zones of which FS are similar. The most critical slip surfaces (lowest factors of safety) lie within the red band, which is the area of interest, and on which safety of a slope is considered. The areas under the red band cover the range of FS between 1.12 and 1.17 (Fig. 10d). These are the range of FS at which a possible slope failure could occur. Outside these zones (red bands), slope failure may likely not occur.

The strong relationship (0.721) between specific gravity ( $G_s$ ) which is the weighted average of soil minerals (excluding air and water) and bulk density could be pointing to the type of material that made up the slopes, whether they are competent materials or incompetent materials that deteriorate on moisture influx [2]. Generally, the soil properties linked with slope failure were observed to range between low to moderate in slope material (see Table 2), which could be the reason for the moderate stability recorded by the analyzed slopes (see FS results in Table 4 and Fig. 10).

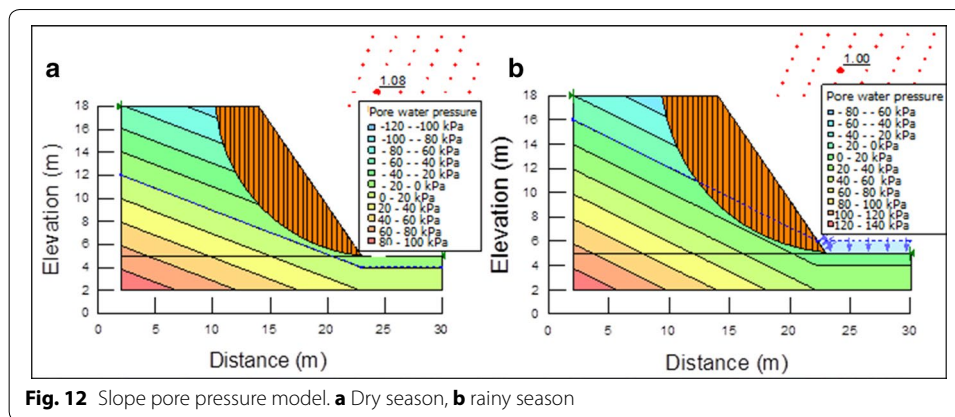
With water in and around the tailing slope, activating forces could be greater than the resisting forces through increase in pore pressure. Figure 12 revealed that pore pressure acting on the base of the analyzed could be as low as between 0 and 20 kPa during the dry period (Fig. 12a) but could rise to 60–80 kPa during the rainy season as seen in Fig. 12b. This rise in pore pressure may cause a decrease in shear strength, and possibly triggering a slope failure if it persists.

The drop in FS may continue as water surges within and around the slopes until failure is initiated at  $FS < 1.0$ . At  $FS < 1$ , a mass wasting process such as landslide or mudflow

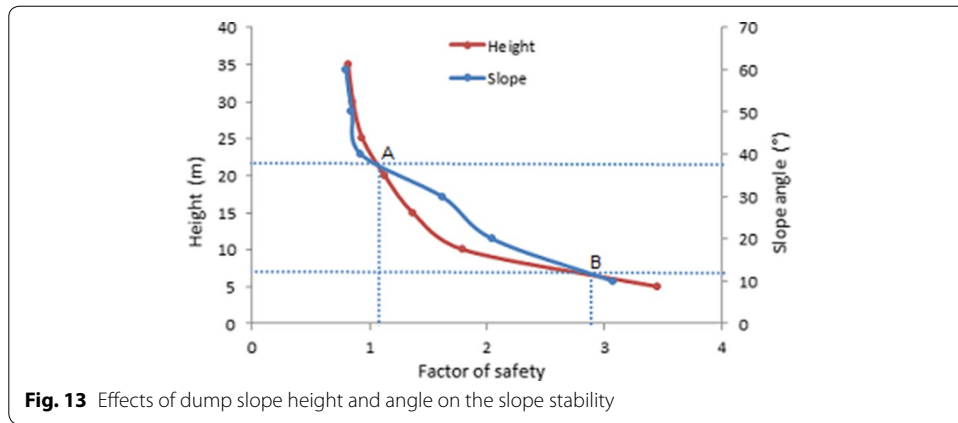
Tables 9 and 10 are results of the effect of height and angle variations on FS of an average strength dump slope. The results of the effects of slope height and angle were plotted in the same plot area as shown in Fig. 13. From Fig. 13; FS is 3.4 at 5 m slope height which signifies a very stable slope. But same slope at 25 m high and above presented FS (ranging from 0.94 to 0.82) lower than 1, implying very unstable or failed slope. The critical stability was observed at 20 m with FS (1.12) marginally greater than 1 (Fig. 13). Other authors have observed that FS reduced logarithmically with respect to increase

For a slope optimization, it would be better to consider both slope geometric properties simultaneously by correlating their graphs. Looking at the graphs (Fig. 13), it is interesting to observe that both graphs intercepted at various points, and these could be points of balance of both of their effects on the FS. These points could be harnessed in striking a balance between what heights or slope angles are suitable for a dump waste design. From Fig. 13, the slope can be noticed to be stable at both points (A and B) of interceptions with FS at approximately 1.2 and 2.8 respectively. At point A, slope height and angle are 20 m and 35° while at point B, both are 7 m and 11° respectively. Therefore, to solve the stability challenge, it would be good to design the dump waste storage fitting to point B. But to overcome the space limitations and cost of managing several slope, it would be proper to optimize the waste dump design to Point A for maximum storage. This could be the reason why earlier analyzed slope (see Fig. 10) and other slope on the studied site are still stable at their various height and angle range (between 18–20 and 30–40° respectively). In a situation where the predesign model intercepted once, it would be proper to design according to the single point of interception.

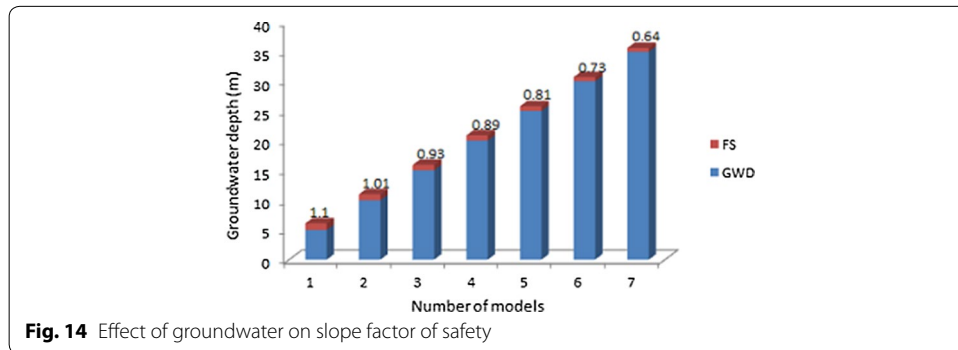
The strength of a slope materials and groundwater depth (GWD) could have severe implications on the stability of the slope (Tables 11, 12, 13). Figure 14 shows the variations of FS with respect to groundwater level (depth). As earlier suggested, the material properties were kept constant together with the slope geometry (height = 35 m and angle = 40°).

The factor of safety was computed to be 1.1 for groundwater depth of 35 m below the slope surface and decreased to 0.64 with increase in groundwater to 5 m from the slope surface (Fig. 14). This is 41.8% decrease in FS in 85.7% increase in groundwater depth, which is to say that the effect of the increase (decrease in FS) is almost half of the increase itself (increase in GWD). Therefore, water is playing a significant role in the stability of waste dump. This result agrees with the findings of other workers on effect of groundwater depth on waste dump stability, who noted that a rise in groundwater level of dump slope reduces drastically the slope factor of safety [48]. Figure 14 indicated that groundwater should be reduced beyond 25 m (35–10 m) below the slope surface in order to reduce the risk of instability.

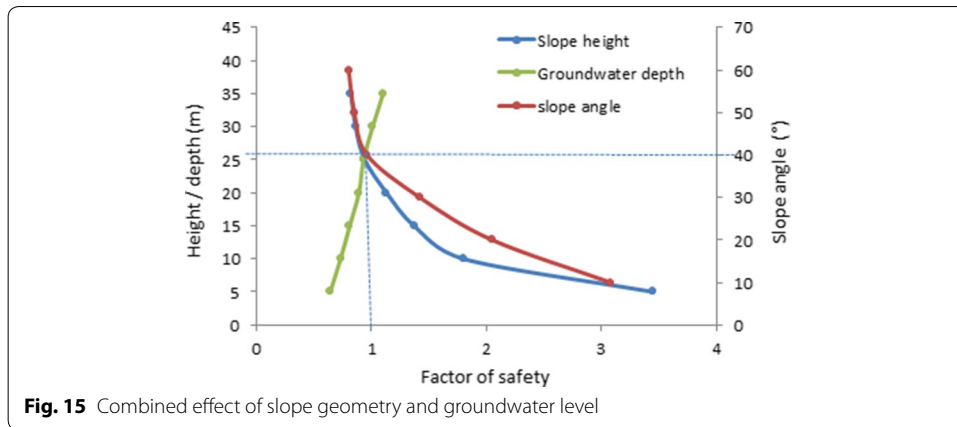
**Fig. 15** Combined effect of slope geometry and groundwater level

Combining simultaneously the effects of slope height, slope angle, and groundwater level presented just one optimization point (Fig. 15) which is different from the two presented by the combined effects of slope angle and height only in Fig. 14. The factor of safety dropped from 1.2 to 1.0 but the height and slope angle increased from 22 to 26 m and 38° to 40° respectively. This implies that the studied slope could be unstable at height

more than 26 m and angle higher than 40° if the combined effects of the slope geometry and groundwater level are considered (Fig. 15).

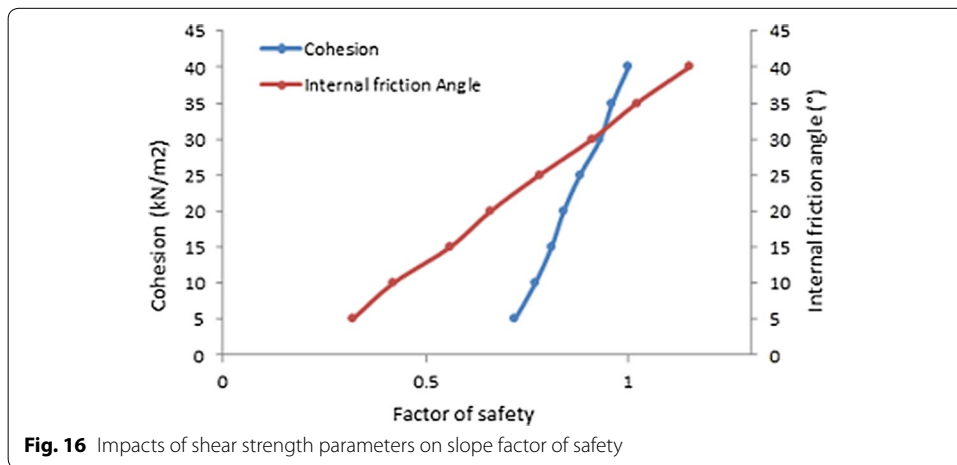
**Fig. 16** Impacts of shear strength parameters on slope factor of safety

It can also be observed from the two graphs that FS increases in a linear progression with increase in either of the shear strength parameters. These linear relationships reinforces that dump waste materials obey Mohr–Coulomb principles [60]. However, the inclination of the FS is more noticeable with friction angle than cohesion for similar ranges of variation of cohesion and internal friction (Fig. 16). All the values of FS that fall below 1 (which is the minimum threshold value required to keep a slope theoretically stable) suggests that the slope is unstable at that values of cohesion and friction angles or have probably failed [27, 28, 30–32, 38, 60], and probably by circular mode. This suggests that the analyzed slope would be critically stable with cohesion at 40 kPa and/or internal friction angle greater 35° with FS marginally above 1.0. But, it should be noted that with FS equal to 1 or slightly greater than 1, the slope would require stabilization to increase the FS to 1.5 which is often recommended and normally used to augment for the inconsistencies in modeling. The method of benching (which help moderate slope height and angle) proposed by Maduka et al. [38] can be employed to improve the slope stability.
