# Evaluation of corrosion level of naturally corroded bars using different cleaning methods, computed tomography, and 3D optical scanning

Ignasi Fernandez

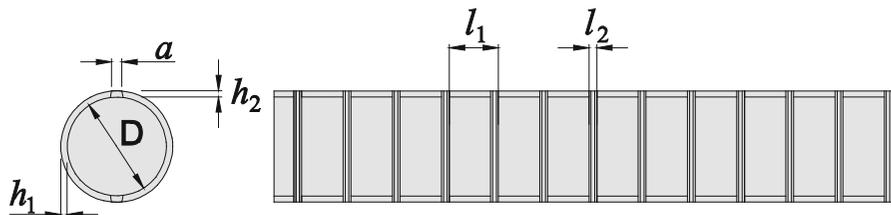
**Fig. 1** Geometry of ribbed reinforcement bars

The following bar specifications were measured from the uncorroded samples by using a Vernier Calliper with a resolution of 10  $\mu\text{m}$ , as shown in Fig. 1 and Table 2. The values given correspond to the measurement averages.

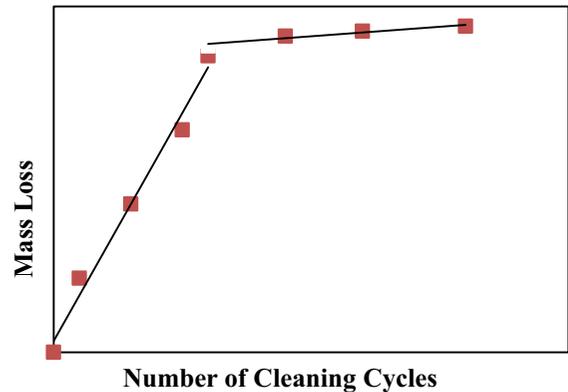
**Fig. 2** Standard recommendations for cleaning corroded steel bars [20]

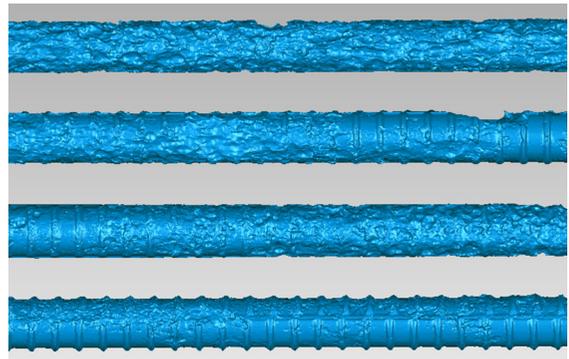
The outcome of the optical measurement corresponded to a very fine mesh of triangular surface polygons connected by nodes, see Fig. 3. The average size of the element corresponded to 0.014  $\text{mm}^2$  with a side length of approximately 0.15 mm. The number of triangular elements in each scanning was between 2,000,000 elements and 3,000,000 elements depending on the corrosion level. A global coordinate system,

**Fig. 3** 3D surface generated from the 3D scanning

( $X, Y, Z$ ), was established and referenced to the end of the bar. The high resolution of the surface mesh allowed for a sufficiently detailed description of the geometry of the bar to obtain information on features including pit depth and length, pit distribution, and loss of cross-sectional area along the bar length.

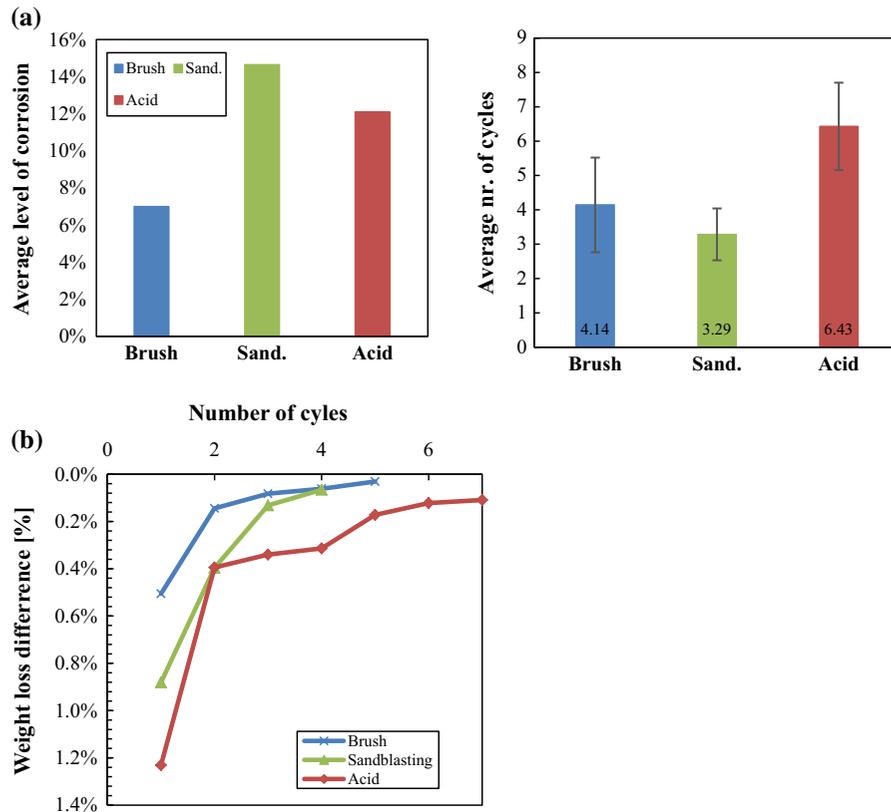
Figure 4a shows the average mass loss of all bars cleaned with each cleaning method. The same proposed methodology [20] was followed for each cleaning method with reiterated cleaning cycles until the mass loss was lower than 0.2% of the last measured weight. However, large differences were observed in the final measurements between the three selected options as shown in Fig. 4a. The sandblasted specimens exhibited the largest measured corrosion level, systematically both for all the specimens, and for the average level of corrosion in each group. This was followed by the acid cleaned specimens. Finally, the mechanically brushed specimens exhibited the smallest measured corrosion level. The methods were expected to result in similar levels of the average mass loss, since the bars were randomly obtained from the tested beams, from areas which had been exposed to similar aggressive environment and subjected to similar damage (all the specimens presented clear signs of deterioration). Thus, the fore-mentioned discrepancies indicate that the proposed recommendations did not provide information to a user with respect to the degree of cleanness of the bar at the end of the process, as opposed to whether the performed cleaning method reached its maximum cleaning capacity for a set of specific conditions including steel type, initial amount of mortar, and corrosion products attached or cleaning agent (such as chemical, or brush). This assertion is backed by Fig. 4b, in which the average number of cycles applied to each specimen to reach the necking point together with its standard deviation is shown. It was observed that the number of cycles remained constant regardless the final level of corrosion.

As shown in Fig. 4b, the number of cycles necessary to obtain a weight loss difference lower than 0.2% within cycles (which was defined by the authors as a reference value based on the degree of harshness of the cleaning methods) ranged between 4 cycles and 7

**Fig. 4** **a** Average mass loss for the different cleaning methods. **b** Examples of cleaning cycles for each cleaning method

cycles according to the method for representative specimens. Sandblasting reached its highest cleaning capacity in fewest number of cycles whereas acid immersion needed the highest number of cycles to reach the defined threshold. The cleaning speed of the metallic brush method ranged in between that of sandblasting and acid immersion on an average, although the scatter observed among the different bars increased in contrast to those observed in the other methods. This scatter could indicate higher dependence of the brush cleaning method on the actual corrosion level than the others.

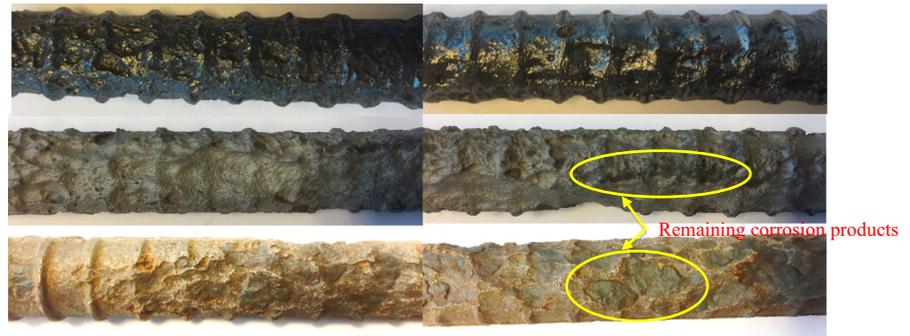
However, direct conclusions to assess the actual accuracy of the method could not be extracted from the results after cleaning since the results only expressed a relative comparison with respect to the initial weight and did not provide any indication as to whether or not the bar was completely cleaned. Nevertheless, the maximum cleaning capacity was definitely reached for each method. Figure 5 shows a few bars after rust removal.

Important differences were observed in the final shape of the surface after cleaning. The finishes for the different methods corresponded to shiny and smooth

**Fig. 5** Cleaned bars. From top to bottom, the figure shows metallic brush, sandblasting, and acid immersion

for metallic brush, matt and granulated for sandblasting, and dark brown for acid cleaning. All the methods showed corrosion pits along the bar irrespective of the finish for each method. However, the depiction of pits was significantly more clear after sandblasting when compared to the other methods, as shown in Figs. 5 and 6. Subsequently, a more comprehensive impact of the corrosion on the bar surface was observed in which larger and deeper pits were found in the sandblasted bars as shown in Fig. 6. This was not obtained when the bars were extracted or when the bars were cleaned with the two other methods.

It should be noted that neither metallic brush nor acid immersion specimens portrayed any remaining corrosion products after the bars were cleaned. The shiny and smooth surfaces due to the metallic brush covered the remaining corrosion products attached to the bar. However, few pieces jumped off and the bars exhibited the aforementioned products when the bars were tested under a tensile load [27]. With respect to acid immersion, the surface after cleaning exhibited a homogeneous dark brown finish and did not allow the detection of the presence of remaining corrosion products. Clusters of corrosion products indicating the presence of a significant amount of rust attached to the

bar were only unveiled after a significant period of time elapsed as shown in Fig. 5. This was potentially due to the drying out of the acid solution and the occurrence of slight corrosion in the sound steel that changed the surface shade.

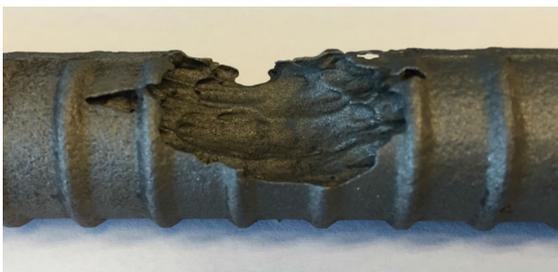
**Fig. 6** Pits unveiled after sandblasting

Conversely, sandblasted specimens always exhibited remaining rust clusters that were distributed along the bar during the cleaning cycles. Specifically, the mentioned clusters were also used as additional visual criteria to define the exposition time in each cycle. Nevertheless, there was a significantly lower presence of rust clusters at the necking point in the case for sandblasting when compared with acid cleaning as clearly shown in Fig. 5. The remaining corrosion products on the bar surface were a result of the compromise between the corrosion products and sound steel removed in each cycle, which must always be lower than the method harshness. Corrosion products, in addition to sound steel must be removed in the cycle in order to maintain the accuracy of the measured level of corrosion.

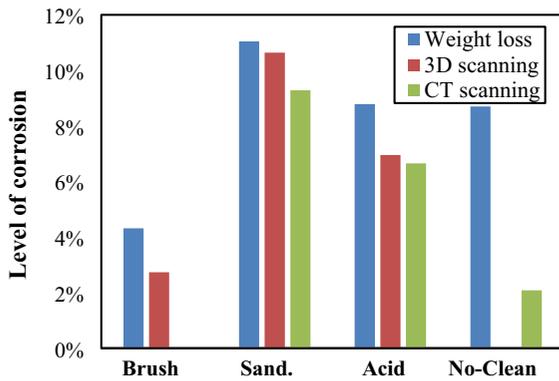
Figure 7 shows an overall description of the obtained results by means of depicting the average measurements. As shown in the figure, 3D scanning

**Fig. 7** Average corrosion level for each presented method

measurement. Average 3D scanning and weight loss values described very good agreement with respect to sandblasting cleaning method, and the difference

between the average weight loss and that in CT scanning was higher for all the cleaning methods.

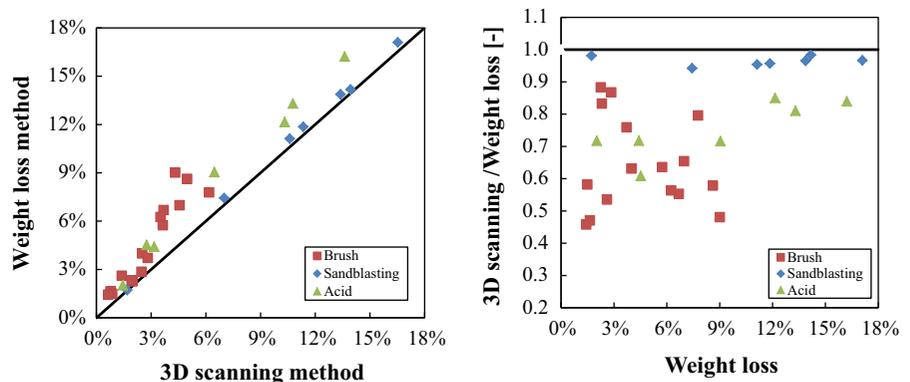
A direct comparison between single weight loss and 3D scanning corrosion levels for the three proposed cleaning methods is shown in Fig. 8a. As shown, gravimetric weight loss typically resulted in higher corrosion levels when compared with those from 3D scanning measurements irrespective of the utilised cleaning method. However, the results indicated better agreement between the weight loss and those of 3D scanning for the sandblasted bars wherein there was a minor difference between both methods. In contrast, both acid and metallic bristle brush exhibited higher deviations when compared to sandblasting. Metallic brush cleaning exhibited the maximum difference, and the obtained values followed a trend in which a higher corrosion level led to a higher discrepancy between both measurements. Additionally, the highest corrosion level measured using both weight loss and 3D scanning was observed for the sandblasted specimens, and this was followed by the acid and the metallic

**Fig. 8** Comparison of 3D scanning versus weight loss measurements for different cleaning methods

brush. This is potentially related to the efficiency of the cleaning method.

Generally, sandblasting cleaning yielded the best agreement irrespective of the actual corrosion level as shown in Fig. 8b by the ratio of 3D scanning to weight loss measurement. Acid cleaning exhibited a slightly better agreement when the corrosion level increased, and this indicated that the accuracy of the cleaning method was less relevant for increases in the corrosion level. Conversely, metallic brush cleaning displayed large scatter and a clear trend was not observed.

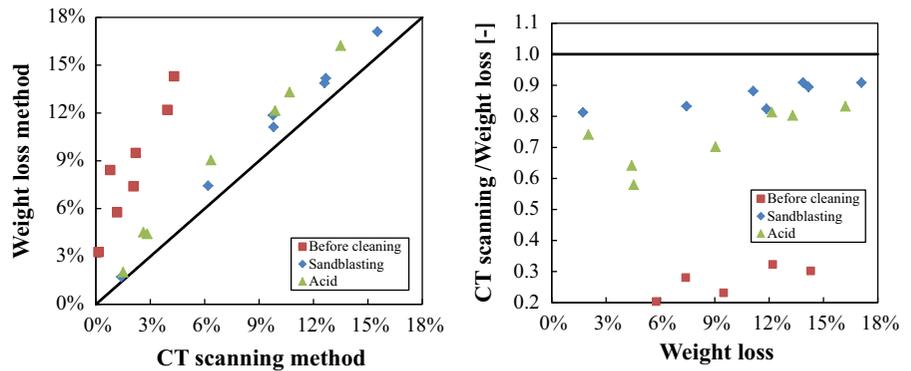
The same comparison for the CT scanning technique is presented in Fig. 9. The CT scanning measurements resulted in smaller corrosion levels when compared with the weight loss measurements. The same behaviour was observed for all the cleaning methods as well as for the bars scanned prior to cleaning. In a manner, similar to the 3D scanning results, the best agreement between CT scanning and weight measurements was exhibited by the sandblasted specimens while the bars scanned prior to cleaning showed the maximum disagreement.

**Fig. 9** Comparison of CT scanning versus weight loss measurement for different cleaning methods and prior to cleaning

On average, corrosion levels measured for the bars that were cleaned using sandblasting as preferred cleaning method were higher, followed by the bars cleaned by acid immersion and the uncleaned bars in terms of both weight loss and CT scanning measurements as shown in Fig. 8. This result along with the fact that the different bars were considered arbitrarily within the tested beams indicates that the accuracy of the rust removal was strongly dependent on the employed cleaning method.

The accuracy of both cleaning methods (acid and sandblasting) seemed to follow a trend that indicated that the accuracy of the cleaning method became less

relevant when higher corrosion levels were observed as shown in Fig. 9b, i.e. the more corroded the bar, the better the performance of the cleaning method. Nevertheless, the ratio of CT scanning to weight loss measurement did not correspond to values exceeding 0.9, which clearly showed a limitation of the accuracy of CT scanning. Furthermore, the corrosion level evaluation results of the uncleaned bars by using CT scanning technique revealed that the selected accuracy value was not sufficient to distinguish between the rust and steel, and consequently, it is necessary to carefully clean the bars prior to scanning.
