Appendix A—Emilia Earthquake

In May 2012, two major earthquakes occurred in Northern Italy, causing 27 deaths and widespread damage. The most affected municipalities are 39. The provinces concerned are Modena, Ferrara and to a lesser extent Bologna, Mantova, Reggio Emilia and Rovigo. The epicenter located between the towns of Finale Emilia and San Felice sul Panaro (Modena) and Sermide (Mantova) (Fig. A. 1).

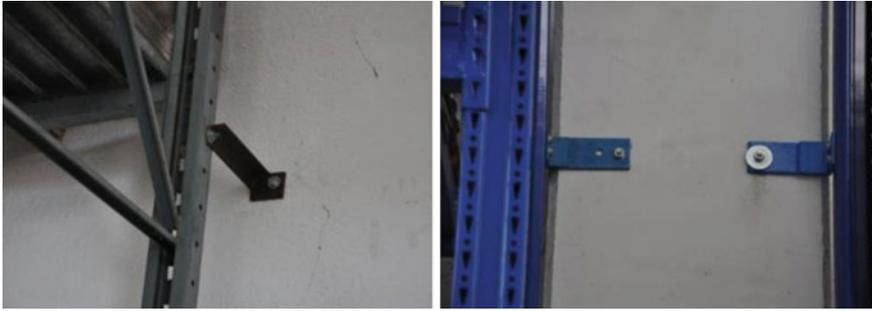
Fig. A. 3 Detail of anchored rack

Often racking systems are anchored both to non structural (e.g. concrete cladding) or structural (e.g. concrete slabs and foundations) parts of the warehouse. Seismic actions will be transmitted mutually between the two structural systems (rack and warehouse) and can bring to unexpected consequences if not correctly taken into account during design (Fig. A. 3).

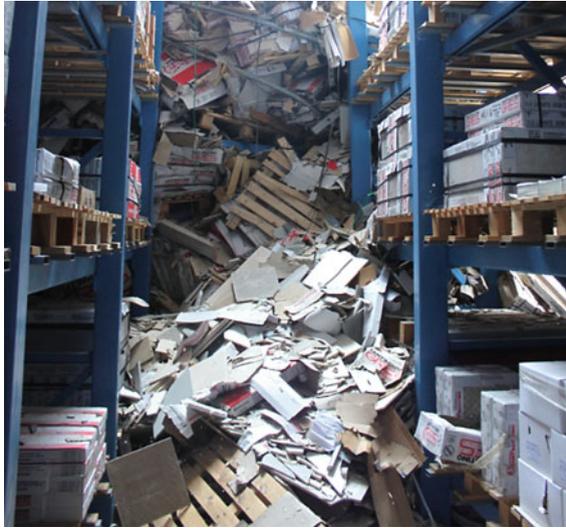
- Obstruction of escape routes (Fig. A. 4).

Fig. A. 4 Serious calamity at the passage way

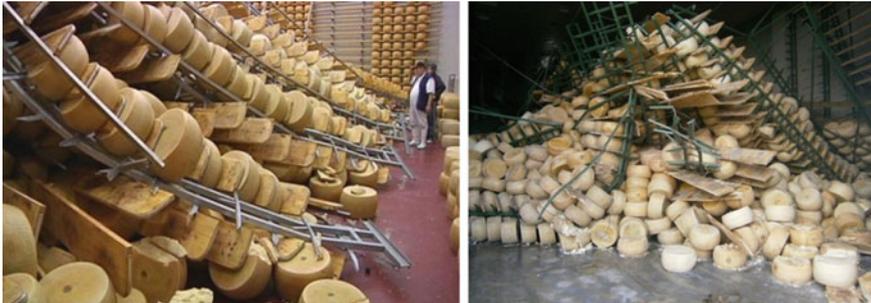
The fall from shelves and the damage of valuable Parmesan cheese inside storage warehouses, became the symbol of the economic loss related to Emilia Romagna Earthquake (Fig. A. 5).

Fig. A. 5 Example of collapse with damage of parmesan cheese

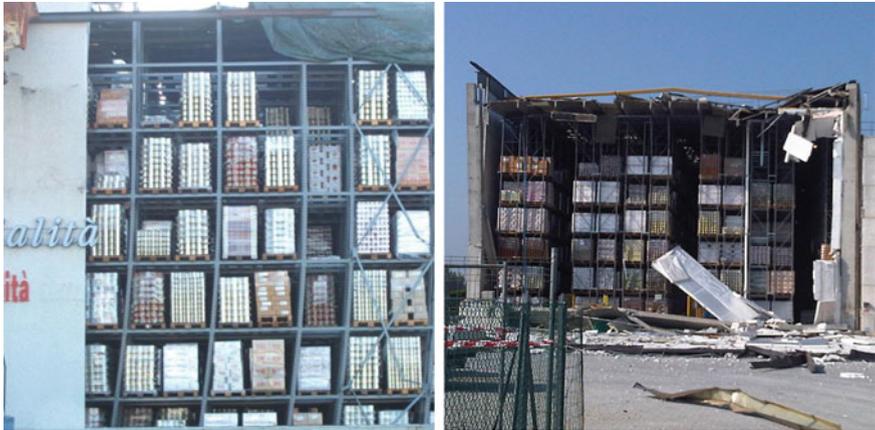
The following picture shows the beginning of a global collapse mechanism of a fully loaded racking system. In this case part of the lateral walls and of the roof, in precast r.c. elements collapse during the earthquake. The fully loaded racking

system survived and was able to sustain the roof slabs that collapsed during the shock. Collapse of a warehouse where r.c. precast panels of the lateral cladding and of the roof collapsed while the steel rack survived, despite damages, and was able to sustain the roof (Fig. A. 6).

Fig. A. 6 Onset of global collapse mechanism

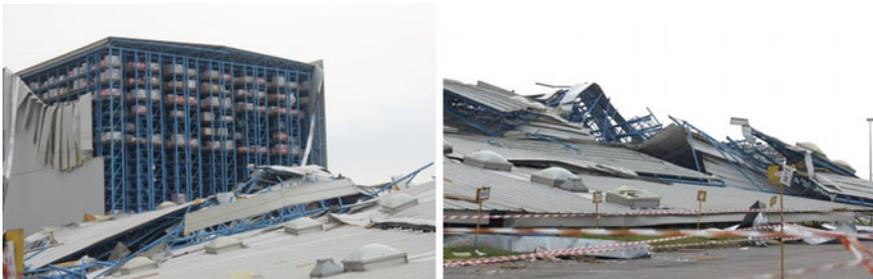
An example of the complexity of the behavior of this type of structures is the ceramic warehouse in Sant’Agostino. As shown in the Fig. A. 7, part of the structure totally collapsed while part of the same warehouse did not move.

Another aspect underlined by the image above is the layout of the stored pallets. As it is known, the distribution of masses along the height of the structure can highly influence the seismic response of the rack.

Fig. A. 7 Collapse of warehouse in Sant’Agostino
