CUI Failure of a Hot Oil Line Due to Intermittent Operations

Abstract Insulated hot oil lines on high-temperature/intermittent duty are typically vulnerable to increased risk from corrosion under insulation (CUI) failure. This paper presents the results of an investigation into a CUI failure at an onshore natural gas-processing plant and also discusses the key issues affecting intermittent duty. The inadequate coating was degraded during high-temperature duty (up to 240 °C) followed by water ingress through degraded insulation mastic and sealant and resulting in (up to 3 mm) chain (coalesced) pitting during ambient temperature downtime, at damaged coating locations from the 2 to 10 o'clock locations. Several recommendations are proposed for addressing the underlying technical and systemic causes of the failure.

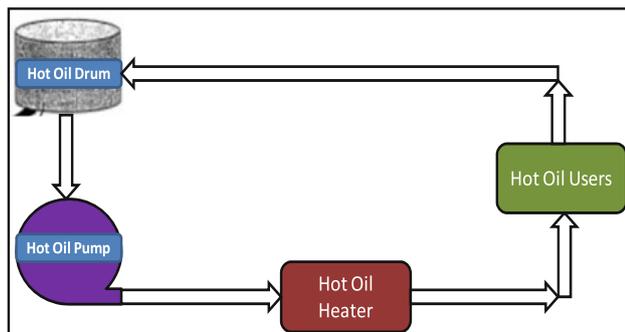
the gas-processing plant. An overview is shown in Fig. 1. The lines are operated once a month, for up to 5 h, to temperatures up to 240 °C. When not in operation, the system remains idle at ambient temperature for the rest of the month. The operating pressure is approximately 7 bar. The pressure at the hot oil circulation pump is 6.7 bar.

Fig. 1 Hot oil system
