Failure Analysis of Cracks Formed at Extrados of Bend Pipe of API 5L X65M Grade

Abstract A metallurgical and root cause analysis was performed on hot induction bent pipes that exhibited cracking at the extrados. The bent pipe of 1016 mm (40 in.) diameter by 18.5 mm wall thickness was API 5L X65 PSL2 line pipe containing a longitudinal submerged arc weld. A metallurgical cross section was removed at a crack on the bent pipe extrados to document the crack morphology using optical microscopy. In addition to the cracking, golden-yellow streaks were visible at the extrados of the bent pipe. The composition of the streaks was examined using scanning electron microscopy with energy dispersive spectroscopy.

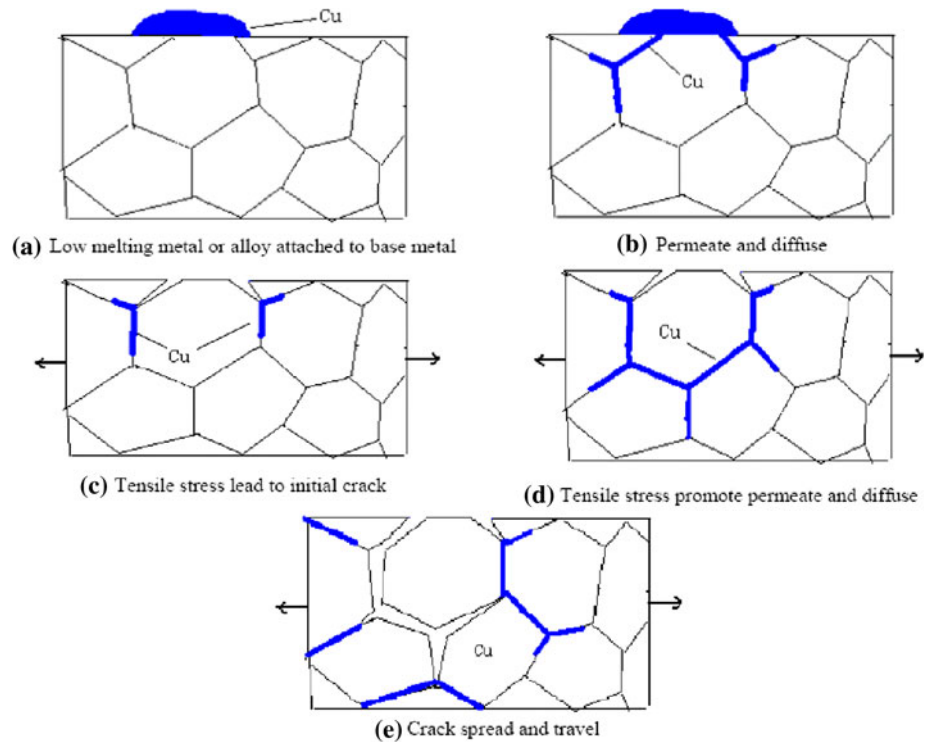
There are three prominent possibilities of copper entrapment in steel, plates, and pipe manufacturing as shown in Fig. 5:

Fig. 5 Prominent possibilities of copper entrapment

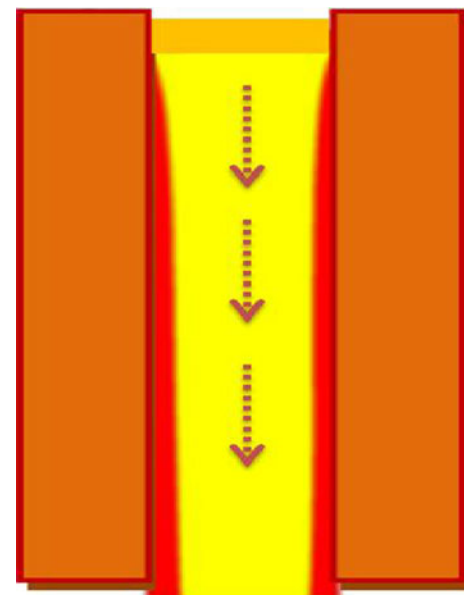
The copper entrapment in the steel during the continuous casting (Fig. 6) stage from the water-cooled copper mold is ruled out in the present investigation. If copper was entrapped in the steel during continuous casting, then cracks would have formed at the slab narrow or broad face which would further create a crack in the plate. However, no cracks were reported while plate rolling or during pipe manufacturing.

Fig. 6 Water-cooled Cu Mold

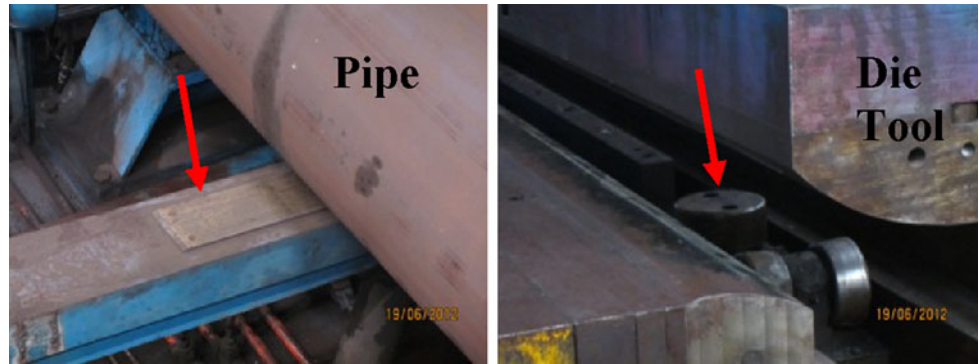
The Cu-alloy plates used on entry side skids and the copper blocks used inside the lower die of the JCO mill may be the potential sources for copper to get stuck on and embedded into the pipe surface during pipe forming. The steel plate is skidded through the Cu-alloy plates and the pipe is pushed up by copper blocks during the forming operation (Fig. 7).

Fig. 7 Cu/Cu-alloys used during JCOE forming

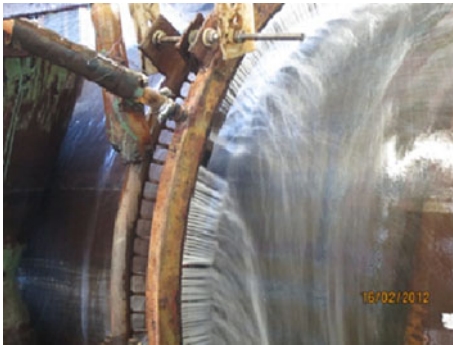
There is a far remote possibility of copper entrapment from the copper induction coil used for heating during bending.

Approximately ~25 mm distance is maintained between the induction coil and the steel surface. Further, there is air pressure which will wipe out any particles falling on the hot annular ring if any copper flakes off from the induction coil. The induction coil (Fig. 8) is cooled from the inside by circulation of de-mineralized water and hence temperature will not cross the prescribed limit.

Fig. 8 Induction coil of copper
