CASE HISTORY—PEER-REVIEWED

# Grade P110 Tubing Shredded by Downhole Detonation

**Abstract** A failure analysis was performed on a length of API 5CT Grade P110 tubing that failed while being used in a drilling operation. Approximately 10 feet of the tubing was shredded by axial slits, and there were collapsed zones above and below the failure. The slits were at 45° to the tubing surface and showed very fine microvoid coalescence. Metallographic examination showed that the slits had formed along adiabatic shear bands. The presence of adiabatic shear bands indicated an extremely high strain rate. That, combined with the orientation of the slits, indicated that the failure was caused by a detonation of gasses in the annulus surrounding the tubing. Well operations responsible for the detonation will be briefly addressed.

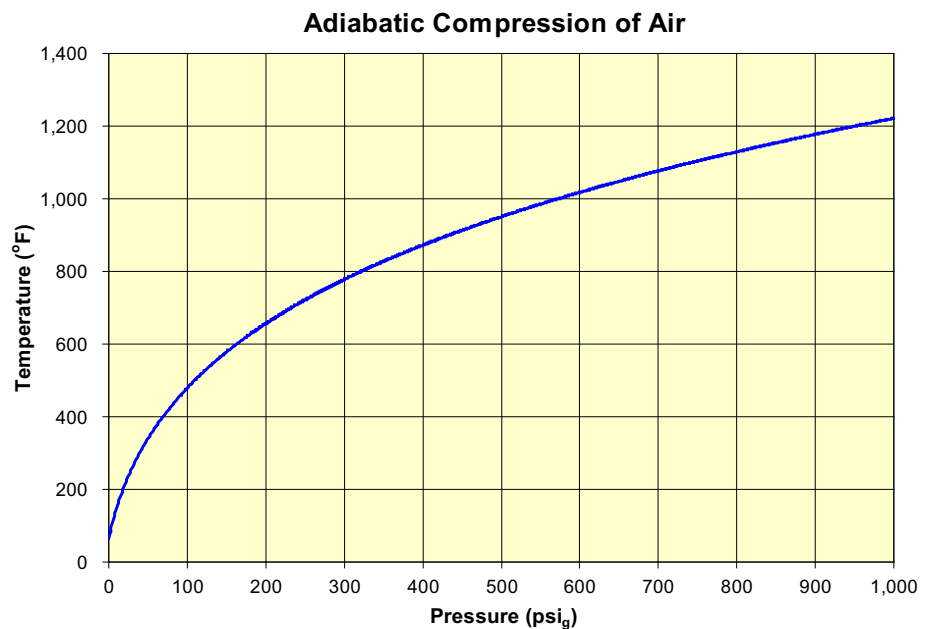
**Fig. 8** Temperature increase due to adiabatic compression of air

When atmospheric air is compressed, the local temperature increases because of the compression of the air molecules in a confined space as illustrated in Fig. 8.

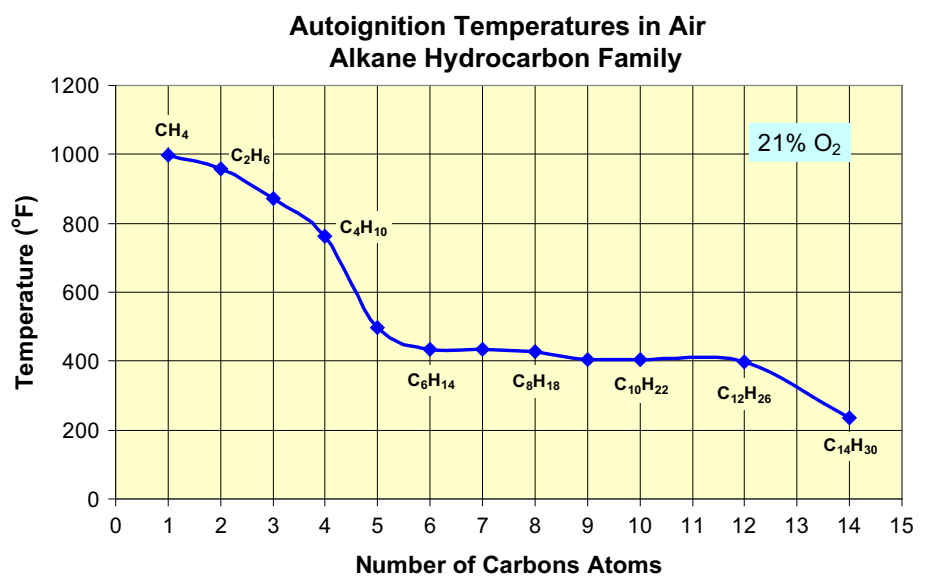
**Fig. 9** Autoignition temperatures of alkane hydrocarbons declines with chain length

Figure 9 illustrates the autoignition temperatures for aliphatic hydrocarbons commonly produced. The ignition temperature tends to decrease with the number of carbons in the chain. An increase in pressure typically reduces the spontaneous ignition temperature.

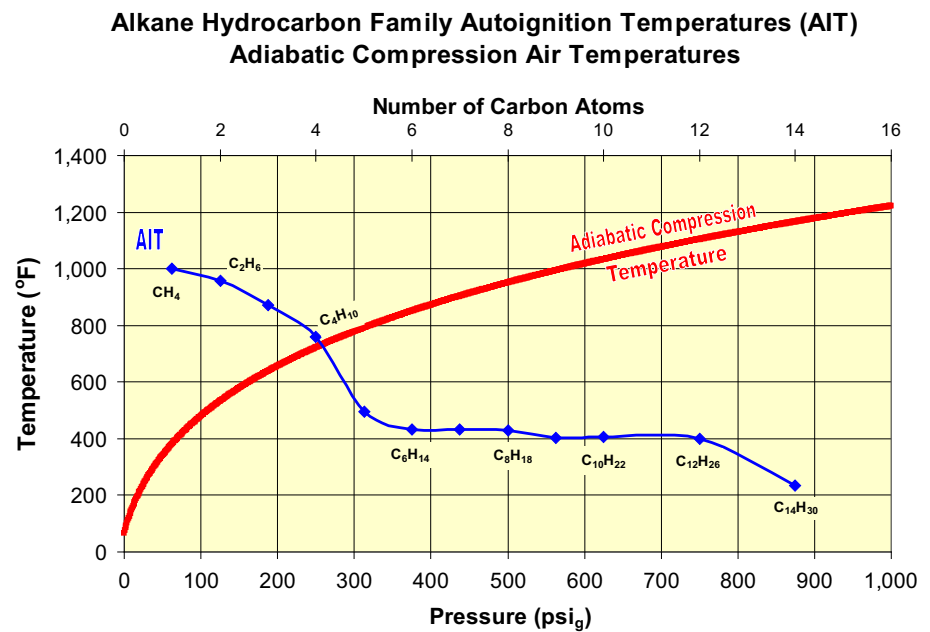
**Fig. 10** Autoignition temperatures of alkane hydrocarbons superimposed with temperature change due to adiabatic compression of air

A superposition of the adiabatic heating of air and the autoignition temperature of alkanes in Fig. 10 illustrates why downhole detonations seem to occur more frequently in the presence of condensates, also known as “wet” gas. The higher molecular weight chains require less

temperature, and correspondingly less compression when mixed with air, in order to detonate.
