# Post-Damage Repair of Prestressed Concrete Girders

Chris Ramseyer<sup>1)</sup>, and Thomas H.-K. Kang<sup>2)</sup>,\*

**Abstract:** Concrete is an economical construction material and for that reason it is widely used in buildings and infrastructures. The use of deicing salts, expansion joint failure, and freeze–thaw cycles have led to concrete bridge girders experiencing corrosion of steel reinforcement and becoming unsafe for driving. The goal of this research is to assess the effectiveness of current and possible repair techniques for the end region of damaged prestressed concrete girders. To do this, three American Association of State Highway and Transportation prestressed concrete girders were tested to failure, repaired, and retested. Three different repair materials were tested including carbon fiber, glass fiber, and surface mounted rods. Each different repair material was also tested with and without injected epoxy. Comparisons were then made to determine if injecting epoxy had a positive effect on stiffness and strength recovery as well as which repair type regained the largest percentage of original strength.

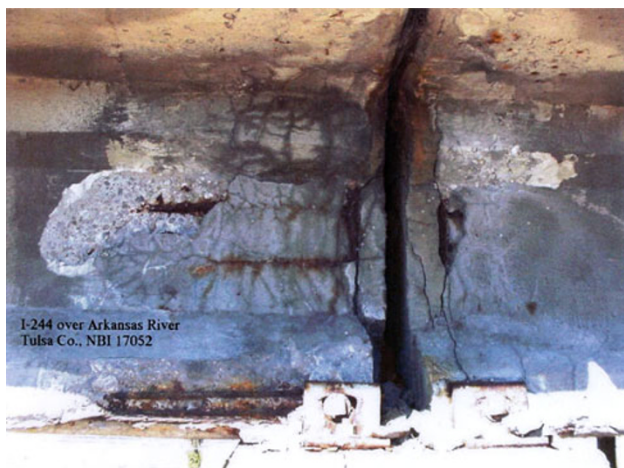
**Fig. 1** Damage in the end region of an AASHTO bridge girder.

Transportation (AASHTO) prestressed concrete bridge girders. Note that to the authors' knowledge, no research has been conducted, nor are there any prediction models available on the shear strength of post-repaired beams that experienced shear failure prior to the repair. Figure 1 shows damage in the end region of an AASHTO bridge girder on I-244 over the Arkansas River in Tulsa County, Oklahoma, U.S.A.

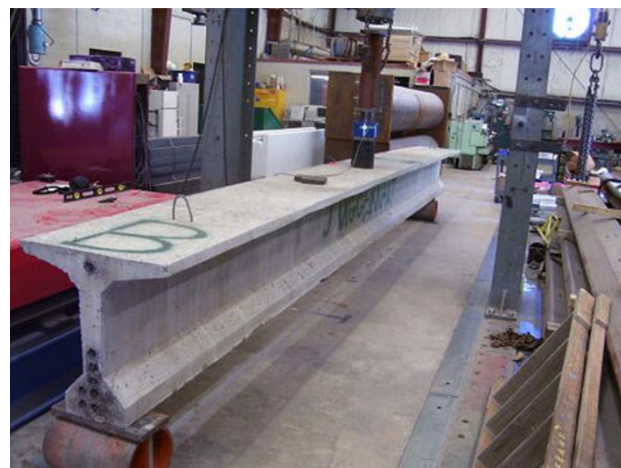
**Fig. 2** Beam during bending test.

For the bending test setup, full-scale Type II AASHTO girders with a depth of 915 mm (36 in.) and an area of 2,380 cm<sup>2</sup> (369 in<sup>2</sup>) were placed on simple supports located

at 6.3 m (20 ft. 9 in.) from the center of the girder. Nine 15.2 mm (0.6 in.) diameter Grade 270 seven-wire strands were used as tensile longitudinal reinforcement, and the specified concrete strength was 40 MPa (6,000 psi). The beams were supported on the rollers with one end above the roller and the other end extending 914 mm (three feet) past the support to keep the ends independent of each other (Figs. 2, 3). This independence was necessary due to the destructive shear testing of the beam ends later in the test series. Note that all the tested beams had the same conditions and materials.

The load was applied using a 1,780 kN (400 kip) hydraulic cylinder mounted to a testing frame. A grout pad was placed directly on the beam surface and a steel plate was placed on top of the leveler. A 445 kN (100 kip) load cell was put in place with a steel cylinder on top of the load cell to provide good contact and protect the cell. Finally, a metal box-frame extension was included to close the gap between the hydraulic cylinder and the rest of the testing equipment. This extension was loosely supported by chains as a safety precaution in case the loading apparatus happened to fall (Fig. 4). The vertical deflection measurements were taken using a string potentiometer which was attached to the top flange of the beam by a clamp and small diameter bent metal rod. Deflection and load measurements were collected and recorded by the data acquisition system.

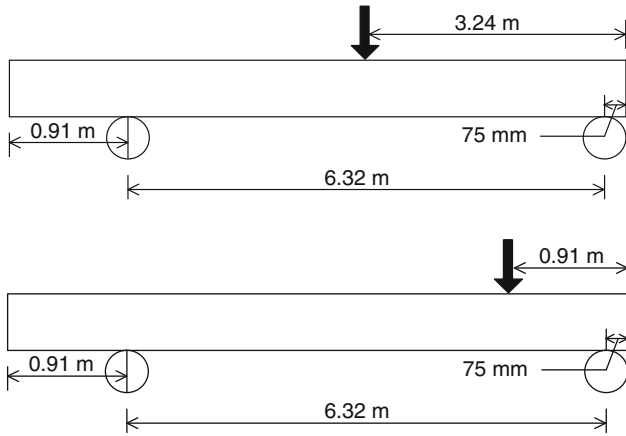
**Fig. 3** Location for loading points and supports during bending and shear tests.

was supported with the same distance from each end, as was done in the bending test; however, the load was applied only 914 mm (3 ft) from the end in question (Figs. 3, 4).

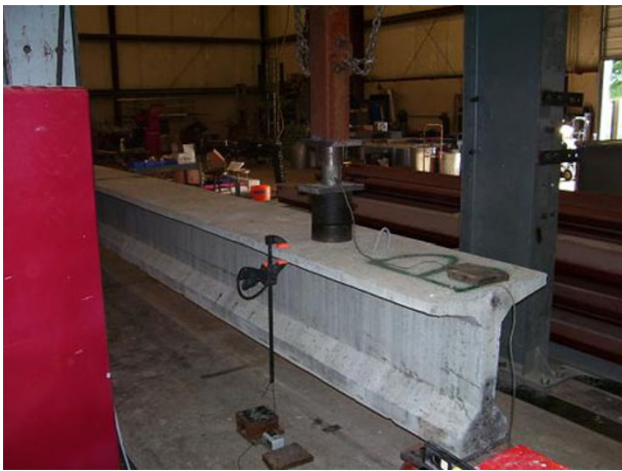
**Fig. 4** Beam during shear test.

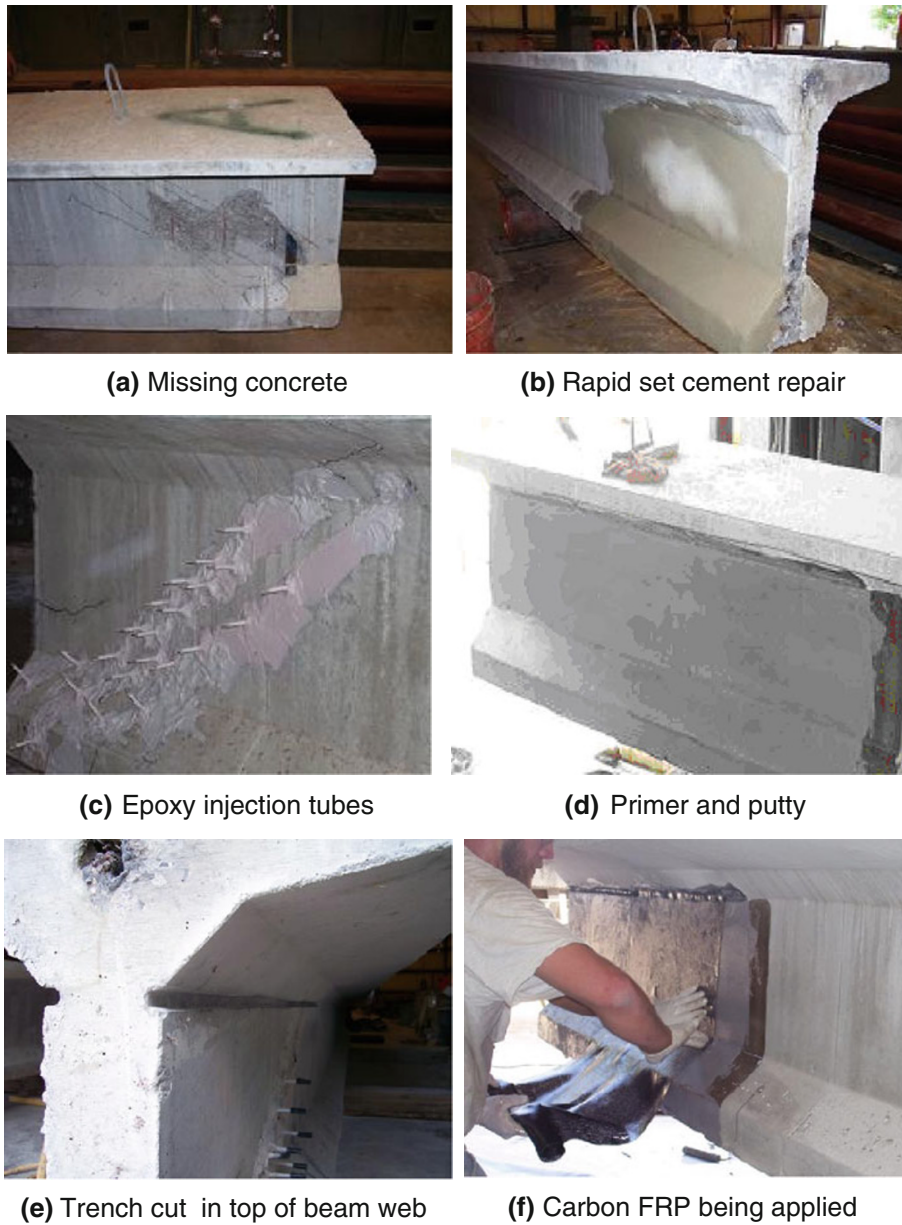
Fig. 5 Beam post-damage repair.

beams. Rapid set cement was added to ends where there was a significant amount of missing concrete (Fig. 5).

Once the repairs were finished, the bending and shear tests were repeated as previously described. The load was not paused during the loading process to mark the cracks because they could not be seen due to the repairs (Fig. 5). Also, on the final tests a piece of neoprene was placed on top of the plate that was on the roller to even out the uneven surface of the bottom of the beam.

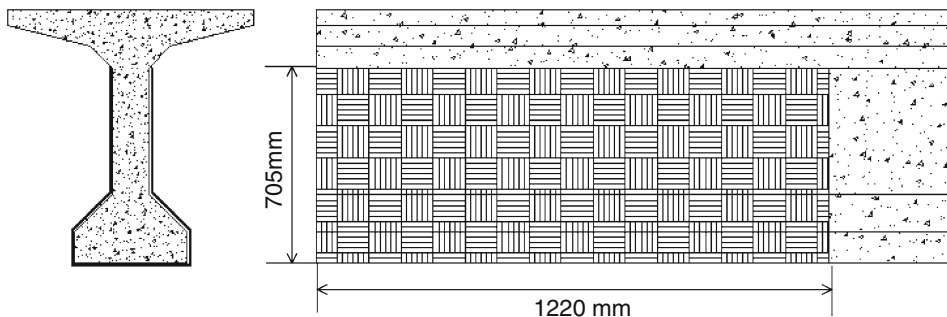
Fig. 6 Configuration of FRP application to the AASHTO prestressed concrete girder.

One end of each beam was epoxy-injected. To accomplish this, toothpicks were placed in the cracks then small tubes were placed over the toothpicks. Putty was added to seal off the cracks and hold the tubes in place. When the putty was cured the toothpicks were removed and epoxy was then injected under pressure through the tubes and into the cracks. The tubes were then capped off. Once the epoxy had cured the putty and tubes were ground off so the surface was smooth. Two types of FRP sheets were applied: carbon FRP and glass FRP. The fiber was soaked in a saturate then placed over the primer and putty. Rollers were used to remove surface imperfections. Grooves were cut in the beams and metal rods were placed in them to hold the fiber sheets in place. A diagram showing FRP dimensions is presented in Fig. 6.

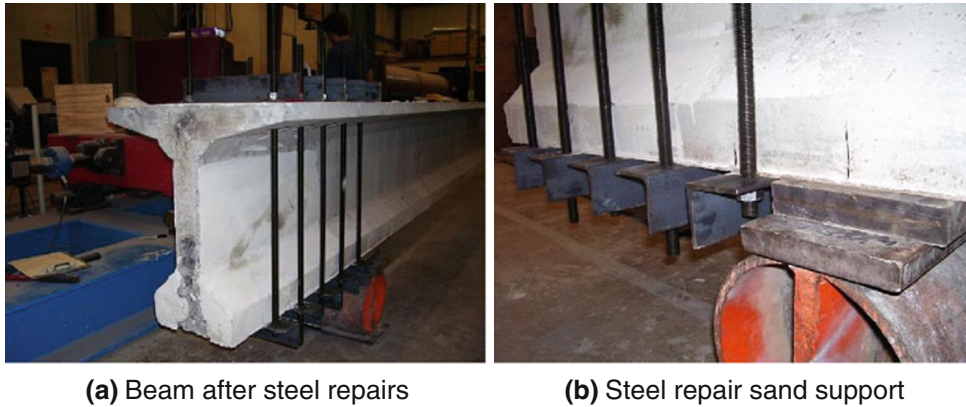
**Fig. 7** Post-damage repair using surface mounted rods.

While the FRP repairs were curing the surface mounted rod repair was conducted for the last beam. It was decided to use five sets of stirrups on each end, evenly spaced out over the crack area, to complete the repairs. Threaded steel rods with a diameter of 19 mm (3/4 in.) were used in conjunction with 76 × 76 × 6.35 mm (3 × 3 × 1/4 in.) angle steel to create the stirrups. The angle steel was cut into 406 mm (16 in.) lengths and had two 0.8125 mm (13/16 in.) holes drilled into one side so that the closest edges of the holes were 254 mm (10 in.) apart. This hole placement allowed the steel rods to pass just on either side of the bulb on the beam (Fig. 7).

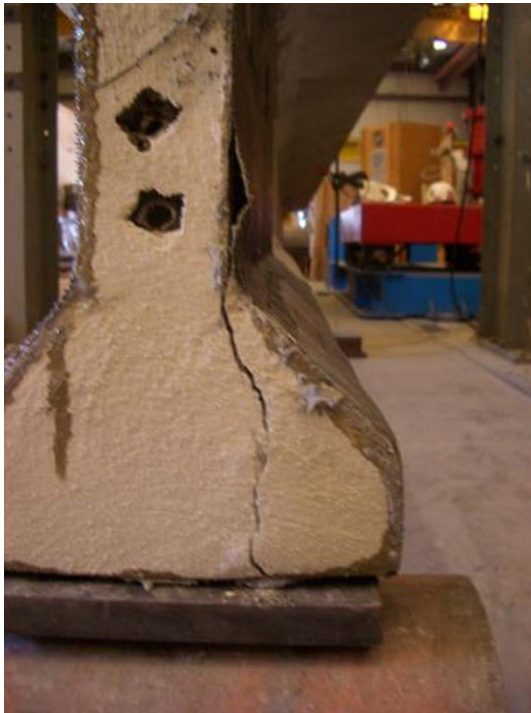
**Fig. 8** Premature crack on *beam 1 end A*.

beam (*beam 1*) strengthened with carbon FRP but without epoxy, the end of the beam began to fail (Fig. 8). This might have been due to the bottom surface of the beam being uneven, causing stress concentrations. As a result, a neoprene pad was added between the beam and its support to provide a better contact surface and reduce stress concentrations on the bottom bulb of the beam. However, at the end of the testing program cracking had still occurred at all of the ends not repaired with epoxy. These results indicate that the existing unrepaired cracks due to the absence of epoxy injection ended up being the cause of the problem.

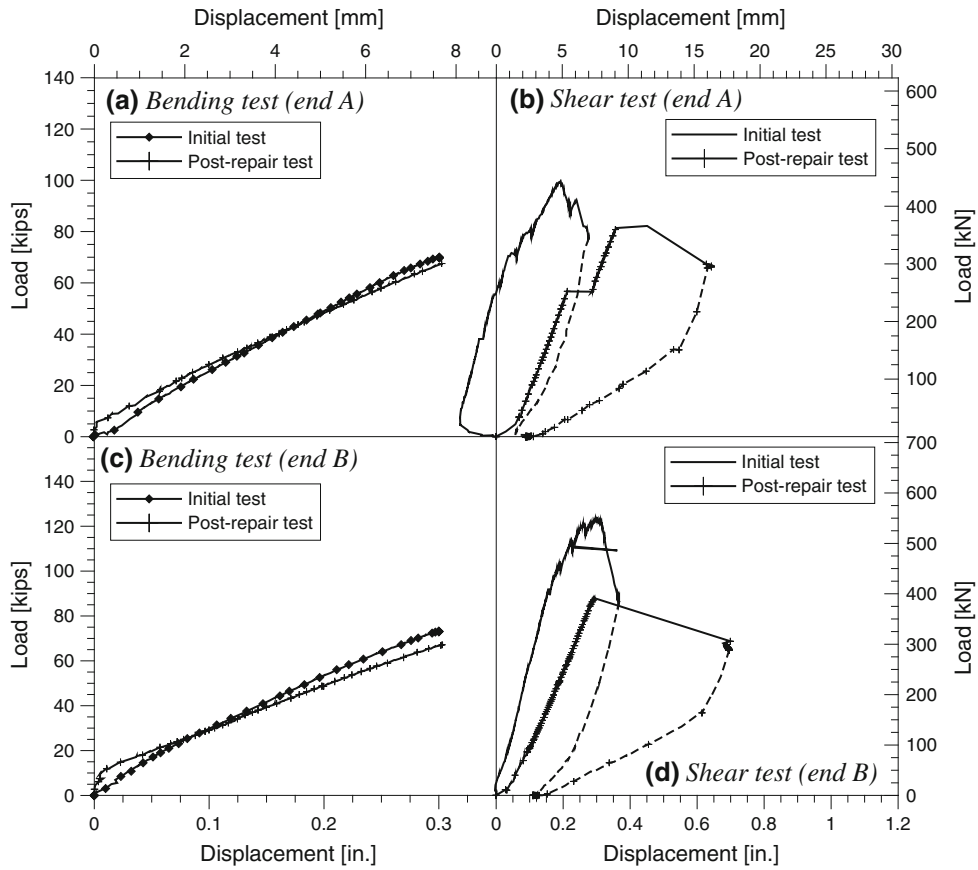
**Fig. 9** Data from bending and shear tests of *beam 1*.

Several of the graphs show an initial deflection opposite of the expected (Fig. 9). This was likely a result of a combination of the beam not being exactly flush with its reaction point and the load not being applied in the direct center of the beam causing the beam to roll to one side slightly before coming to a rest, giving the initial deflection.

Tables 1 and 2 provide the data on the maximum loads that each beam end achieved for each test as well as how each was repaired and the percentage of initial loading returned after post-damage repair. The graphs shown in Figs. 9, 10 and 11 give an overview of how each beam reacted in deflection as load was applied until its maximum was reached and unloaded. The graphs also provide a comparison between how the beam reacted on its initial test and how it reacted during the tests after repairs (Fig. 10).

Figures 9, 10 and 11 show that during the bending tests both of the ends (epoxy or no epoxy) varied from their initial lines by approximately the same amount as each other of the course of the test. However, the graphs of the shear testing reveal a large difference between the injected and non-injected ends. The epoxy-injected ends were able to keep their deflection much closer to that of the original test than the ends without the injection.

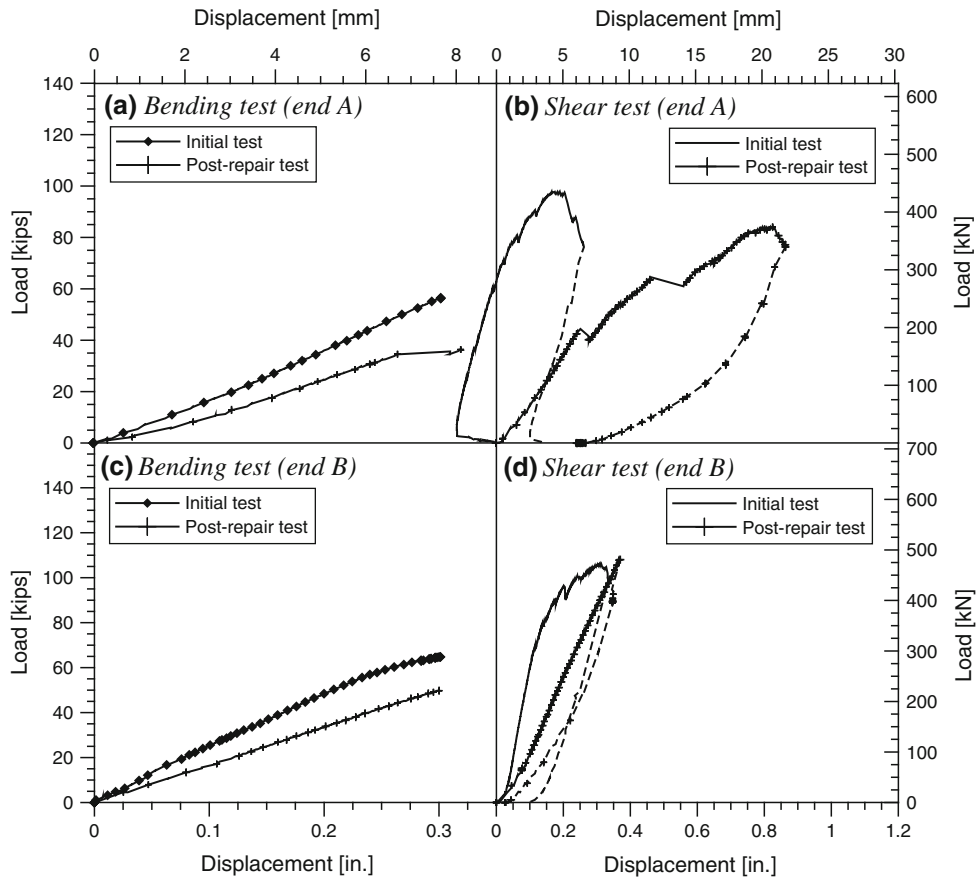
**Fig. 10** Data from bending and shear tests of *beam 2*.

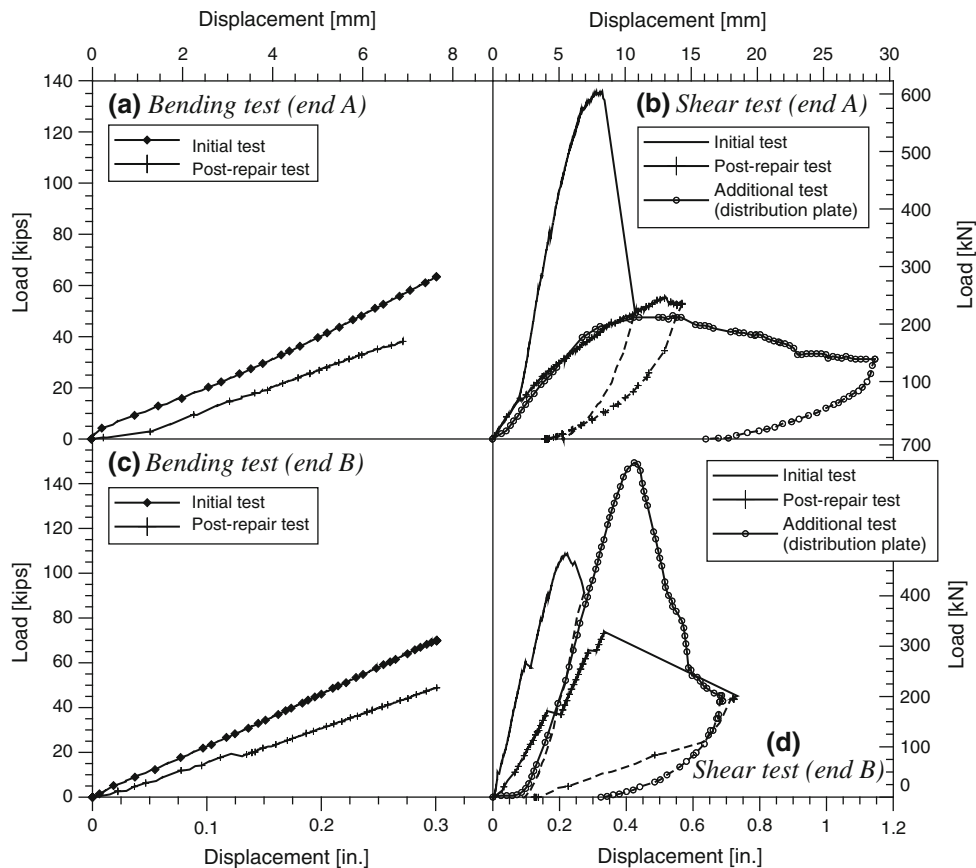
Fig. 11 Data from bending and shear tests of beam 3.

Another important thing that the graphs reveal is the load (the peak of the post-repair test) a beam still supported after the loading cycle ended on its shear test. When the peaks of the repaired tests are compared to the peaks of the initial tests it can be seen that the initial shear strength was not re-gained after the FRP repair. However, the effect of adding the distribution plate was prominent. The significantly larger shear strength was obtained for the repaired beam compared with the initial shear strength (Fig. 11). It is the only one that showed potential for an increase in strength of the beam.
