# Copper distribution and oxidation states near corroded fasteners in treated wood

Metal fasteners are used to hold wood structures together. In outdoor applications, these fasteners are subject to corrosion when the wood is treated with certain preservative treatments. Typically, these treatments contain copper. Prior work has hypothesized that the mechanism of corrosion in treated wood involves reduction of copper ions from the wood treatments. However, copper was rarely detected in the corrosion products of metals embedded in treated wood, which contradicts the hypothesized mechanism. This present work utilizes synchrotron based X-ray fluorescence microscopy (XFM) and X-ray absorption near edge spectroscopy to examine the corrosion mechanism in treated wood by looking at the spatial distribution and oxidation states of copper in the treated wood near the fastener and in the corrosion products removed from the fastener surface. The samples were obtained after a 1-year corrosion test. In the wood cell walls, the oxidation state of the copper treatment did not change in the immediate vicinity of the fastener, although there was a depletion of copper near the fastener. Furthermore,

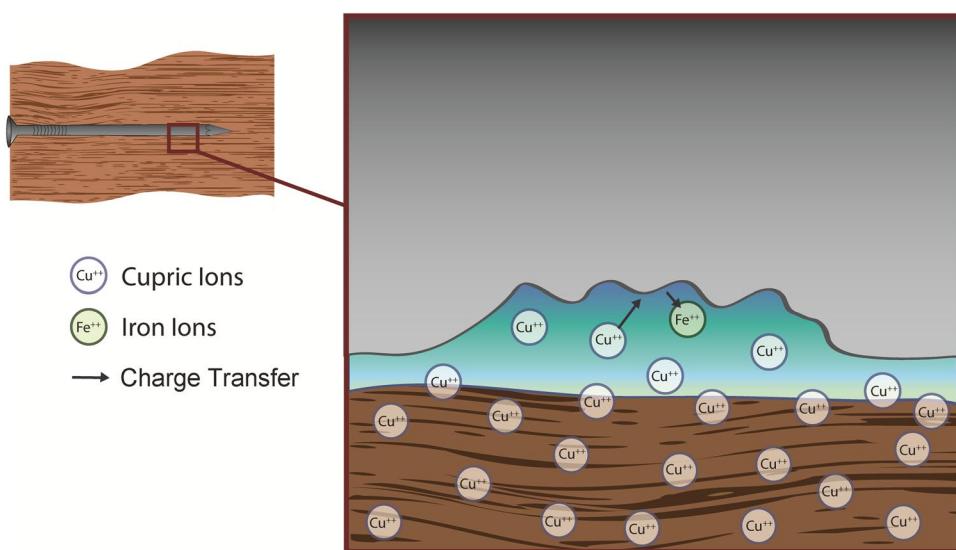
**Fig. 1** Schematic illustration of the corrosion mechanism in treated wood which shows cupric ions from the wood preservative being reduced at the fastener surface. Reprinted with permission from [12]

Corrosion of fasteners in contact with preservative treated wood is believed to involve the reduction of copper ions from the wood preservatives (Fig. 1) [5, 12, 14]. It has been reported that over 95% of the copper from the wood preservative is held within the wood as cupric ( $\text{Cu}^{++}$ ) ions [15]. Thermodynamically, these cupric ions are unstable in the presence of steel or galvanized (zinc coated) steel fasteners in wood as illustrated in Pourbaix diagrams [12]. However, stainless steel fasteners, which are noble to copper in the galvanic series, have negligible corrosion rates in treated and modified wood [11, 16]. Kinetically,

The XFM maps in Figs. 4 and 5 are some of the first experimental evidence that test hypothesized mechanism for corrosion in treated wood; namely that the corrosion mechanism involves migration and reduction of copper in the wood preservatives (Fig. 1). From these data it appears

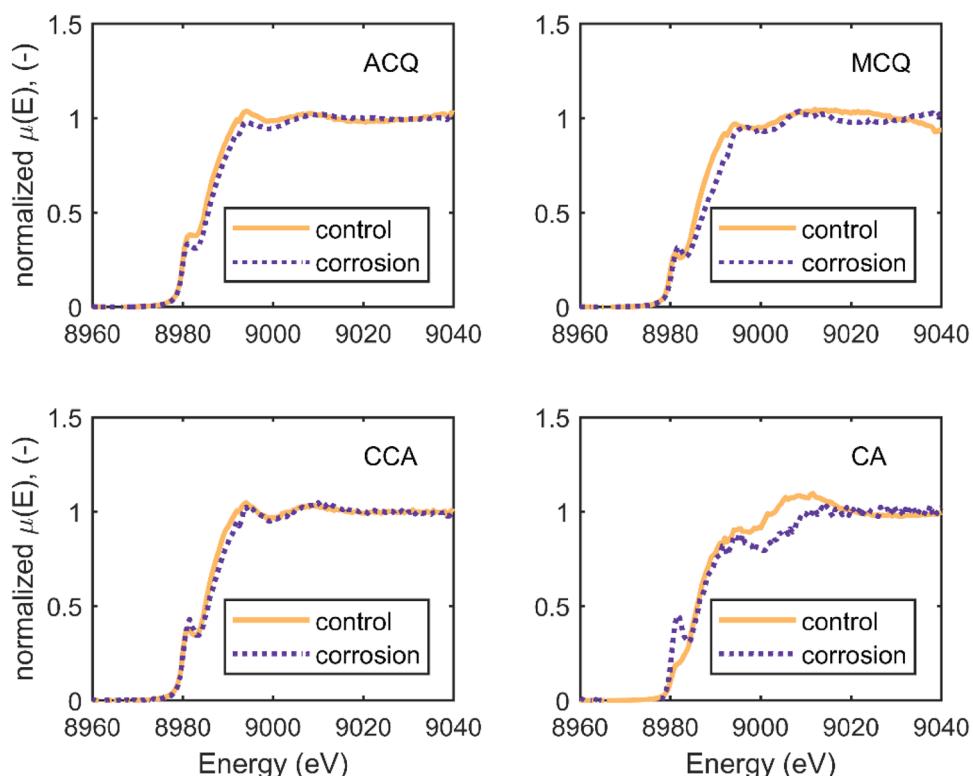
**Fig. 2** XANES spectra collected in the wood cell walls adjacent to the steel fasteners

Previous research had hypothesized that copper from the wood preservatives was either reduced in the cell walls near the fastener surface or migrated to the fastener surface where it was reduced. The first hypothesis was tested with XANES. Figure 2 shows the results of the XANES scans in the wood cell walls exposed to steel fasteners; Fig. 3 presents the corresponding results from the cell walls near galvanized fasteners. The subpanels represent the results from different wood treatments. The “control” data were taken from cell walls far from the fastener surface where no iron or zinc was detected in the XFM maps and the “corrosion” data were collected in cells that contained iron or zinc. While in many cases the cells in the “corrosion” zone were depleted in copper, there was enough copper signal to collect a XANES spectrum. It can be seen in Figs. 2 and 3 that in all but one case (CA, steel), the curves lie on top of each other. Importantly, the pre-edge peak (around 8982 eV) does not change in energy or amplitude, which implies that the oxidation state did not change. These figures show that for the most part, the corrosion mechanism does not involve *in situ* reduction of copper from the wood preservative in the wood cell walls.

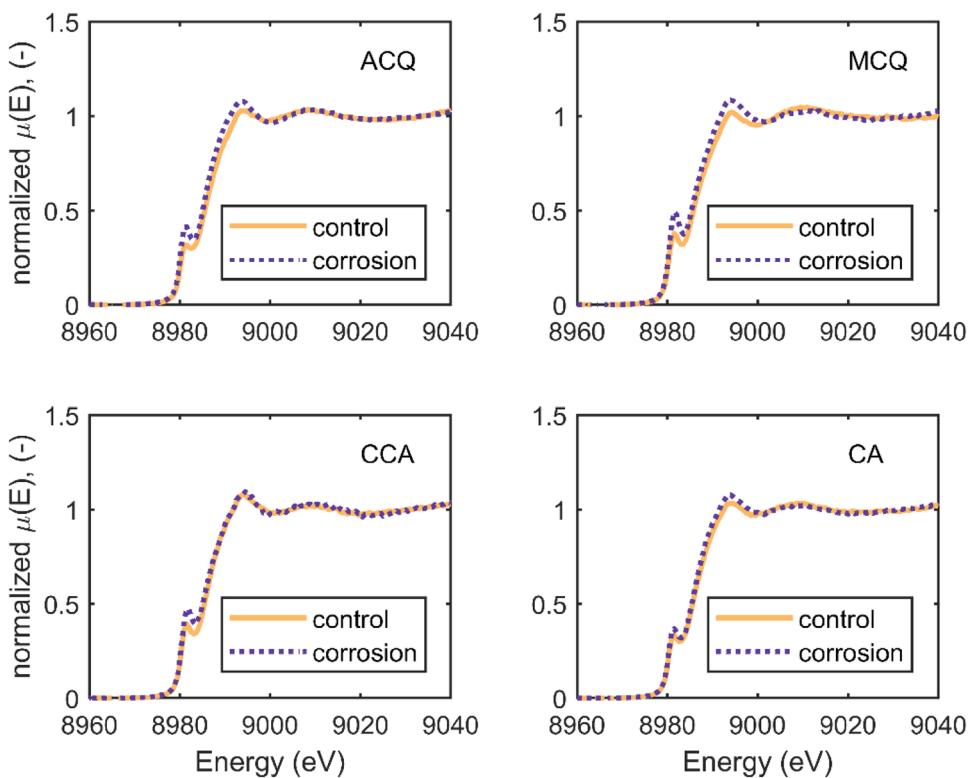
**Fig. 3** XANES spectra collected in the wood cell walls adjacent to the galvanized fasteners

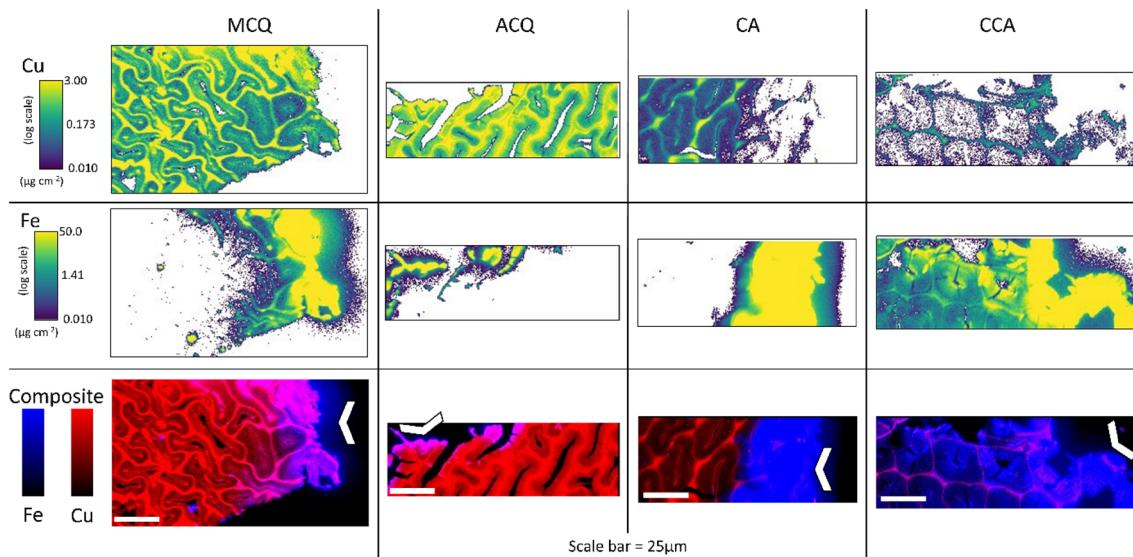
**Fig. 4** XFM maps of the wood cell walls near the fastener surface of steel fasteners in 4 different treatments. The top map shows the distribution of copper and the middle map shows the concentration of iron. The bottom map shows a composite image where the

copper distribution is shown in red and the iron distribution in blue; the intensity of each color is proportional to its concentration. Chevron denotes location of the fastener during exposure

XFM gives information about the spatial location of copper, iron, and zinc in the wood cell walls near the fastener surface. Figure 4 presents XFM maps collected in wood sections cut near the interface with steel fasteners.

Three different XFM maps are presented for each wood preservative: copper, iron, and a composite image where the copper and iron maps are plotted on top of each other with different colors (copper = red, iron = blue). The white chevron in the image indicates the approximate location of the fastener with respect to the wood section. The iron corrosion products can be seen in the cell walls of all four wood treatments, however, the depth to which the iron diffused varied across the treatments.

A range of behaviors can be observed across the different wood preservatives. The interaction of iron and copper is easiest to observe from the composite image. For example, the MCQ sample has red, purple, and blue regions. The cells in the red region show the copper in the cell walls from the preservative treatment. In the purple region, these cells still have most or all of the copper from the wood preservative, but iron from the fastener had diffused in as well. Finally, in the blue region, these cell walls are depleted in copper so only the iron signal is visible. While in the MCQ sample, all three regions are all visible, in the ACQ sample, however, the iron only appears in parts of the cell walls (less than 5  $\mu\text{m}$  from the edge). The majority of this iron rich region also contains copper but there is a small zone on the very edge of the cells that is depleted in copper. For the CA treatment, there is a large copper depleted and iron rich region; there does not appear to be an appreciable overlap between the iron and copper rich regions. For the CCA sample, there

While Figs. 4 and 5 are helpful in visualizing the interplay between the corrosion products in the wood cell wall and the copper concentration from the preservative in the corrosion affected zone, they have several limitations. Firstly, the sections were cut from the wood near the fastener after a corrosion test after the fasteners had been removed. While every effort was made to preserve the wood surface directly adjacent to the fastener, some cells may have been removed during fastener extraction or sectioning of the wood for the microscopy. Because of this, it is impossible to say how far any given image was from the fastener surface and whether differences in copper concentration between treatments represent a quantitative difference between the treatments or whether it was related to from where the sections were cut. These sample preparation issues are in part caused by the fact that the

Even with these limitations, Figs. 4 and 5 give an idea of the range of copper and iron interactions that are happening near the fastener surface. In all cases, iron and zinc corrosion products diffused into the wood cell walls. The range of diffusion distances ranged from as small as approximately 10  $\mu\text{m}$  for ACQ treated wood, to over 100  $\mu\text{m}$  in CCA treated wood. Furthermore, in nearly every case, there was a region near the fastener surface that was depleted in copper and these cells were only visible in the XFM maps of iron or zinc. The depth of this copper depleted zone again had a range of observed behaviors from less than or equal to 1  $\mu\text{m}$  in ACQ treated wood to as much as 50  $\mu\text{m}$  for CA treated wood.

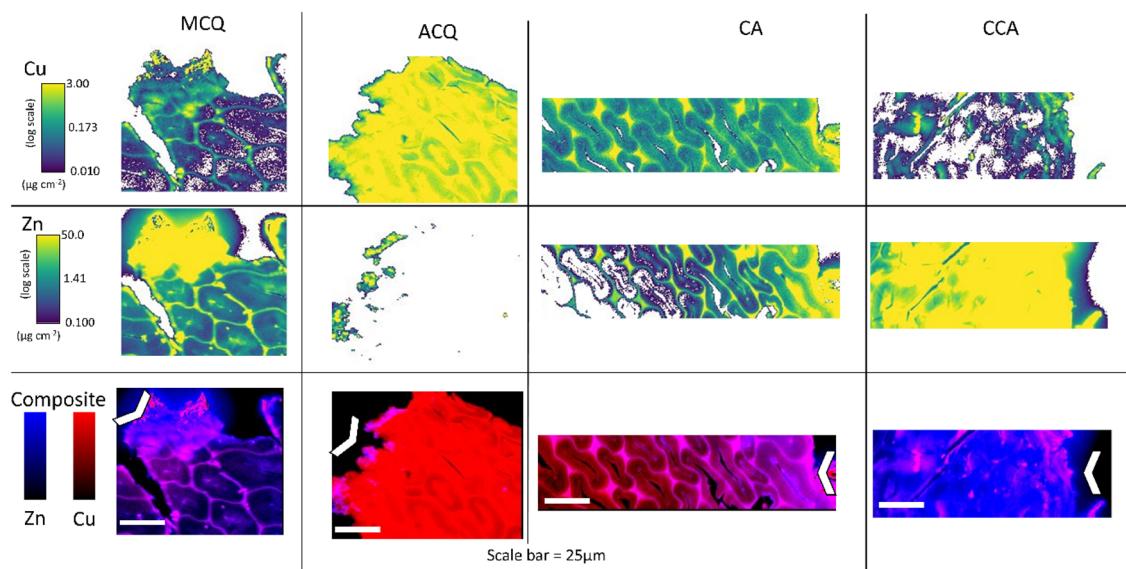
**Fig. 5** XFM maps of the wood cell walls near the fastener surface of hot dip galvanized steel fasteners in 4 different treatments. The top map shows the distribution of copper and the middle map shows the concentration of zinc. The bottom map shows a composite

image where the copper distribution is shown in red and the iron distribution in blue; the intensity of each color is proportional to its concentration. Chevron denotes location of the fastener during exposure

Figure 5 is an analogous figure containing XFM maps taken from cell wall material directly adjacent to galvanized steel fasteners. Similar to Fig. 4, the top image shows the distribution of copper within the cell wall, the middle image shows the zinc concentration and the composite image on the bottom is an overlay of the two previous maps with copper in red and zinc in blue. Although the sections in Fig. 5 came from different blocks of wood that were surrounding different fasteners from Fig. 4, it is instructive to make comparisons across how the various metal fasteners performed. It appears for all treatments, there is a higher concentration of zinc in the cell walls and that the zinc has diffused farther into the cell walls when compared to the steel fasteners in Fig. 4. This should not be surprising as the measured corrosion rates of the zinc galvanized fasteners were higher than those of the steel fasteners [18]. The MCQ and ACQ samples exhibit similar behavior to that shown in Fig. 4. For MCQ there is a region of zinc with no copper at the edge closest to the fastener with a zone where both copper and zinc are present behind this edge. The ACQ sample shows very little diffusion of the corrosion products into

the wood cell wall and almost no visible regions of the cell wall where only zinc is present by itself. Given that the ACQ sample had the highest corrosion rate, one would expect this sample to have a very high penetration of zinc into the cell wall and a high depletion of copper. It may be that the cells closest to where the fastener touched the wood were damaged or removed during sample preparation. The CA composite image in Fig. 5 has a large purple region where both zinc and copper are present, unlike the case for the steel fastener, there does not appear to be a large region of depleted copper. Finally for the CCA specimen, there are cells that have zinc but not copper near the fastener edge; the remainder of the sample has a very high concentration of zinc and a low concentration of copper.

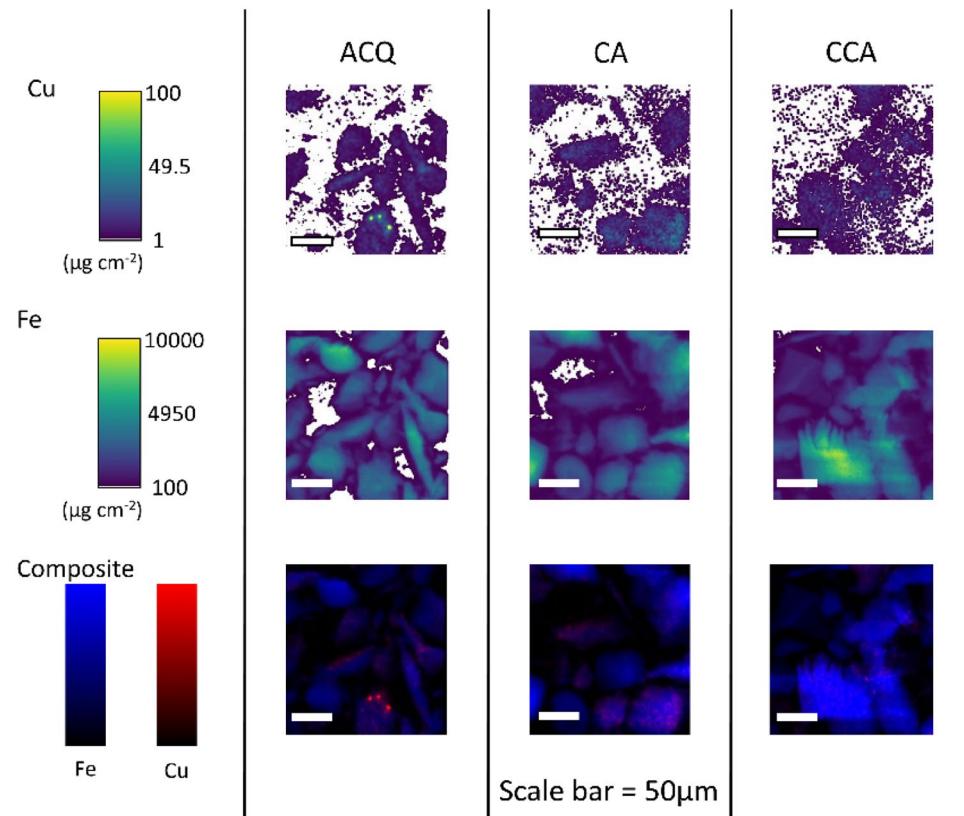
**Fig. 6** XFM maps of the corrosion products collected from the surface of steel fasteners embedded in treated wood; the different wood treatments are shown in adjacent columns. The distribution of copper is shown on the top row, iron on the second, and the third row presents a composite image where both the iron and copper distribution are shown as different colors

An attempt was made to see if XFM could detect copper in the corrosion products. The same corrosion products analyzed with EDS and powder XRD were analyzed at the same beamline used to collect the elemental maps shown in Fig. 6 for steel corrosion products and Fig. 7 for the

galvanized steel corrosion products. In Fig. 6 the corrosion product particles can be seen in the iron map. The copper map, also shows conglomerations of copper. However, the

copper appears in much lower quantities than iron in these maps; the scale is set to 1/1000th that of iron. The composite image in Fig. 6 is important for confirming that the copper is

co-located within the steel corrosion products and not separate particles or random noise. In the composite images, the regions of highest copper concentration can be observed as red/purple dots within the iron particles. This suggest that copper is indeed in the corrosion products, although in very small concentrations. This is consistent both with the proposed mechanism of corrosion that involves copper reduction and with the previous measurements where copper was not detected in the corrosion products, since the concentration is so low.

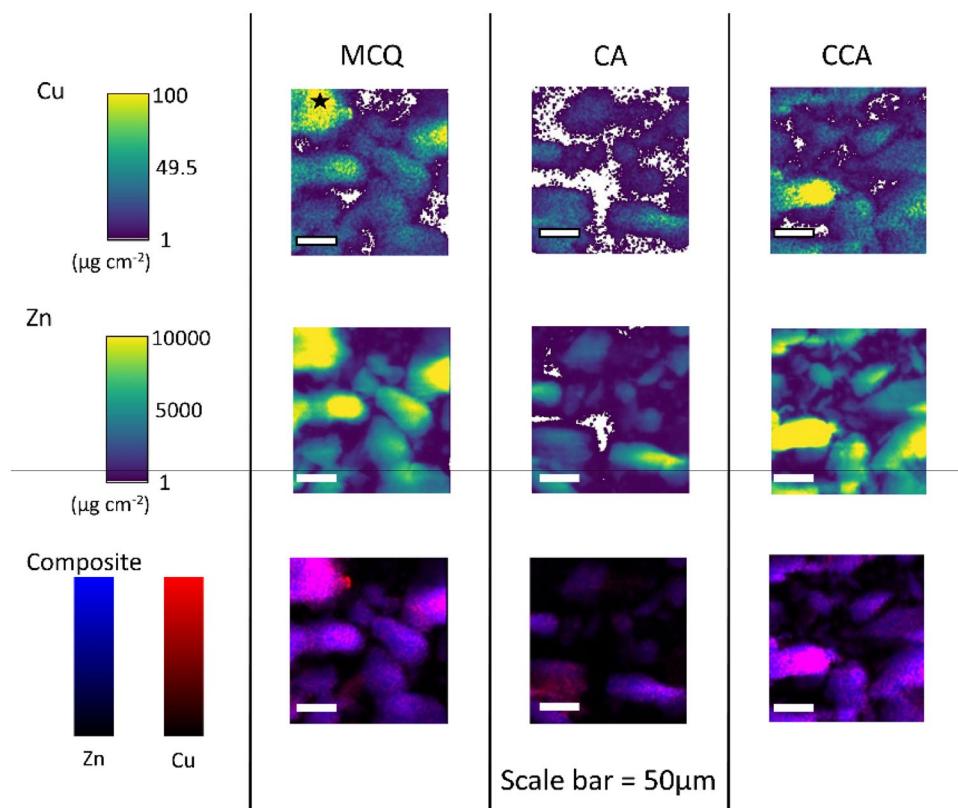
**Fig. 7** XFM maps of the corrosion products collected from the surface of hot dip galvanized steel fasteners embedded in treated wood; the different wood treatments are shown in adjacent columns. The distribution of copper is shown on the top row, zinc on the second, and the third row presents a composite image where the both the zinc and copper distribution are shown as different colors

Figure 7 shows the corrosion products from the galvanized fasteners; again, the shape of the particles can be easily seen from the zinc maps. In Fig. 7, the particles of corrosion products can most clearly be seen in the maps of zinc. Similar to Fig. 6, the scale for the map of copper is 1000 times smaller than that of the zinc concentration. However, in general, there appears to be more copper in the zinc corrosion products (Fig. 7) than in the steel corrosion products (Fig. 6). This can also be seen in the combined images in Fig. 7 where the corrosion products appear as purple objects, meaning that the copper is distributed throughout the zinc particles in the corrosion products.

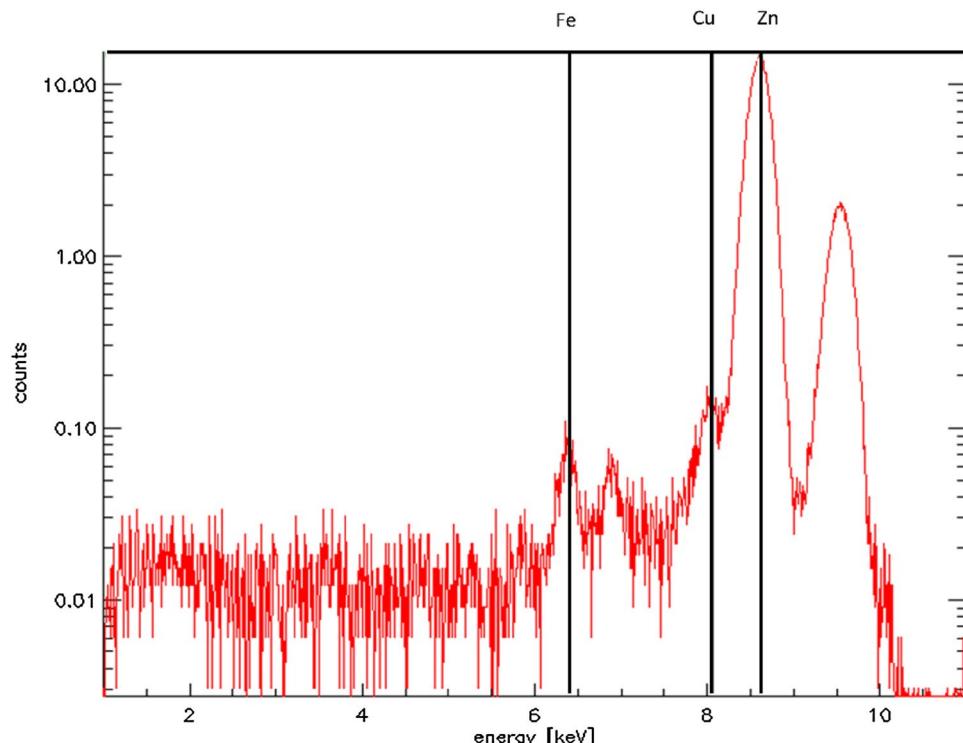
**Fig. 8** XRF spectra in the region of interest denoted by a star in Fig. 7. The  $K_{\alpha}$  peaks of Fe, Cu, and Zn, are highlighted by solid lines. Note that the Cu  $K_{\alpha}$  peak is distinct from that of Zn

Because the Ka peaks of copper (8.04 keV) and zinc (8.63 keV) are close, we further examined the spectra to make sure that the observed copper signal in the maps were indeed from copper and not from a wide zinc peak. The XFM spectra was examined in a region of interest with high copper concentration on the corrosion products collected from fasteners that had been in contact with MCQ treated wood. The region of interest is denoted with a star in Fig. 7. The corresponding spectra is presented in Fig. 8. In Fig. 8 the copper Ka peak can be found and is distinct from the zinc peak. We therefore conclude that there is indeed copper in the corrosion products of both steel and galvanized steel fasteners exposed to treated wood.
