# Quality of CAD-CAM inlays placed on aged resin-based composite restorations used as deep margin elevation: a laboratory study

**Objectives** To assess the impact of the age of resin-based composite (RBC) restorations used for deep margin elevation (DME) on the marginal quality and fracture resistance of inlays.

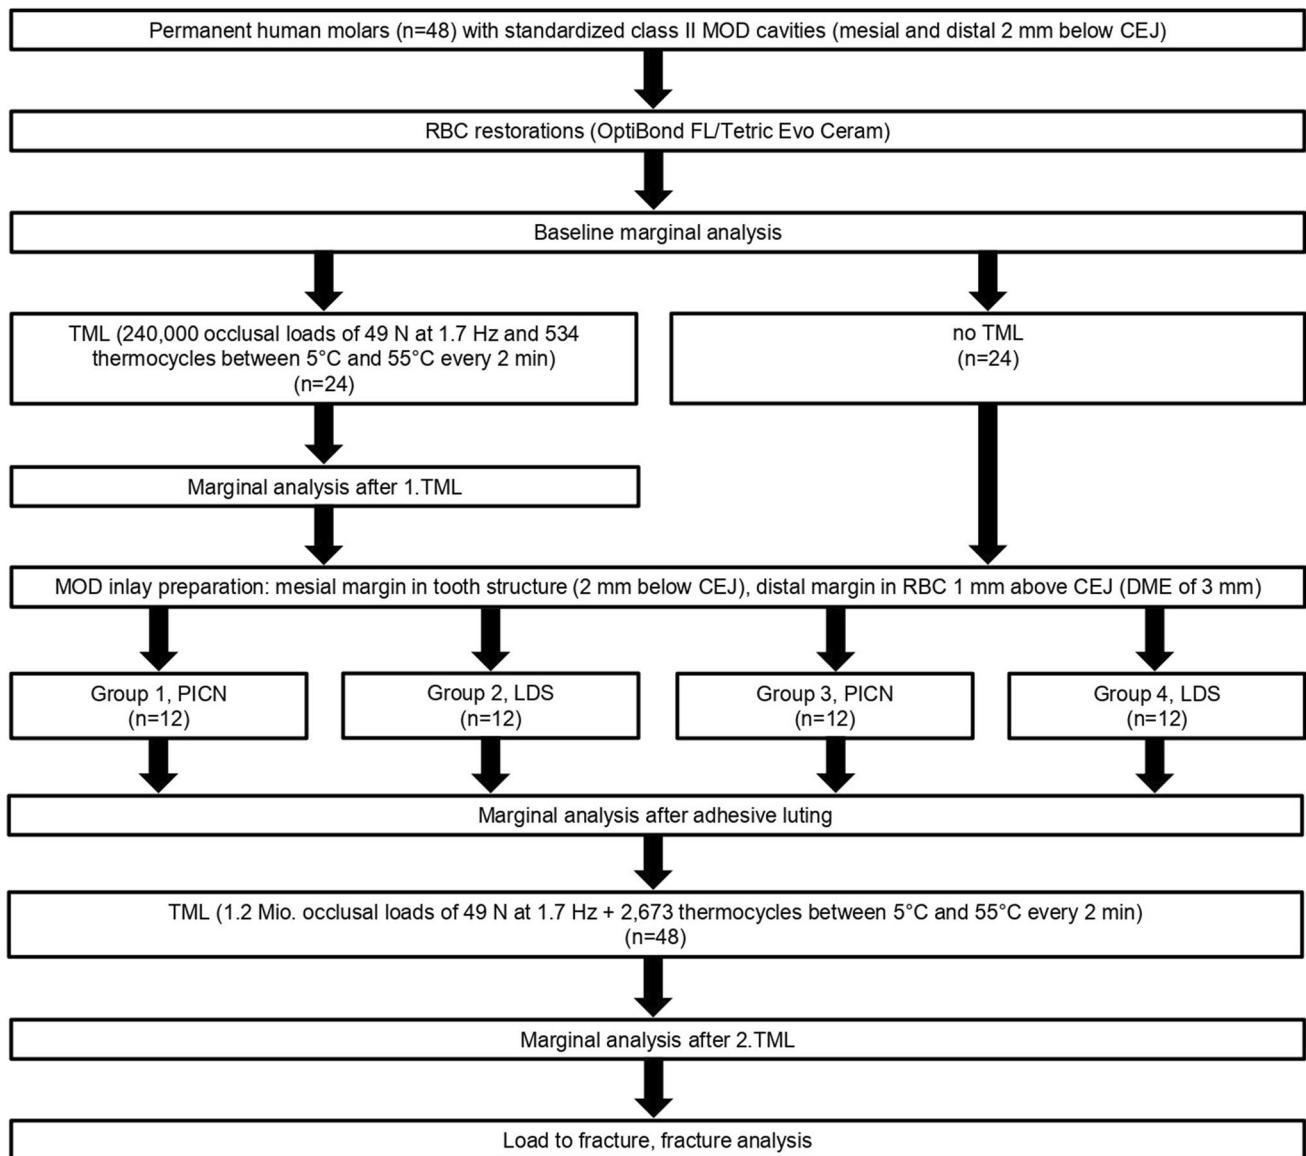
**Fig. 1** Flow chart with an overview of the study design

An overview of the study flow is shown in Fig. 1. Forty-eight permanent human molars of nearly equal size were cleaned after extraction with a universal curette and low-abrasive air polishing (Airflow Plus, E.M.S. Electro Medical Systems, Nyon, Switzerland). No effort was made to completely remove root cementum. The teeth, free of caries, restorations, craze lines, cracks, and significant signs of tooth wear, were stored in a 0.1% thymol solution until further processing.

The specimens were randomly allocated to four groups (G1 to G4), each comprising 12 specimens (Fig. 1). Specimens in groups G1 and G2 underwent artificial aging. In a custom, computer-controlled masticator, the specimens were exposed to mechanical and thermal stress for 240,000 occlusal load cycles with 49 N at 1.7 Hz. Zirconia spheres (Mühlmeier, Bärnau, Germany) with a diameter of 5 mm were used as antagonists. The specimens simultaneously underwent 534 thermocycles between of 5 °C and 55 °C with a 2-min dwell

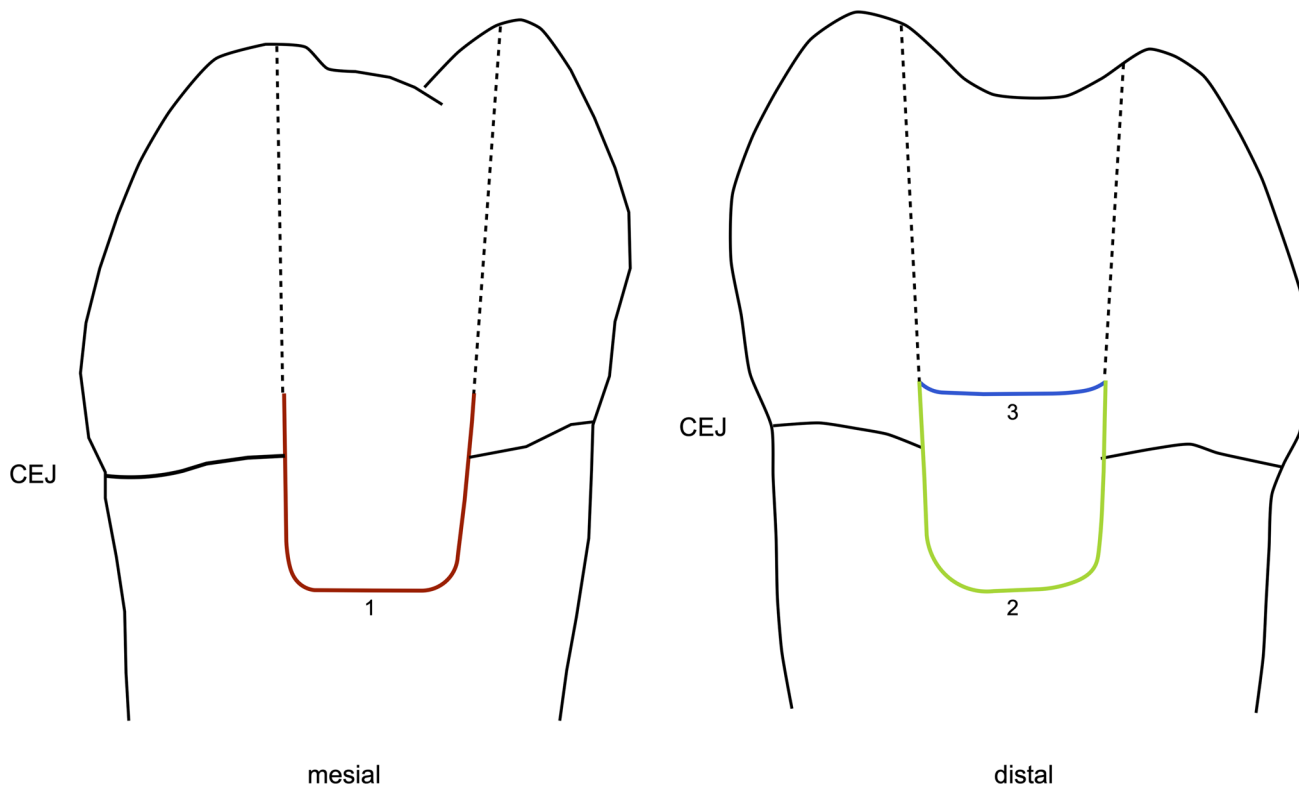
**Fig. 2** Schematic drawing of the proximal interfaces where the marginal integrity was assessed. The interface 1 (“tooth-inlay,” red line) was located on the mesial surface between the inlay and the tooth substance up to 1 mm above the CEJ. The interface 2 (“tooth-RBC,”

green line) was located on the distal surface between the RBC left as DME and the tooth substance. The interface 3 (“RBC-inlay,” blue line) was located on the distal surface between the RBC left as DME and the inlay

After insertion of the inlays, the marginal integrity was examined at a magnification of 20× at three different interfaces (Fig. 2) and assessed according to the protocol used at baseline.

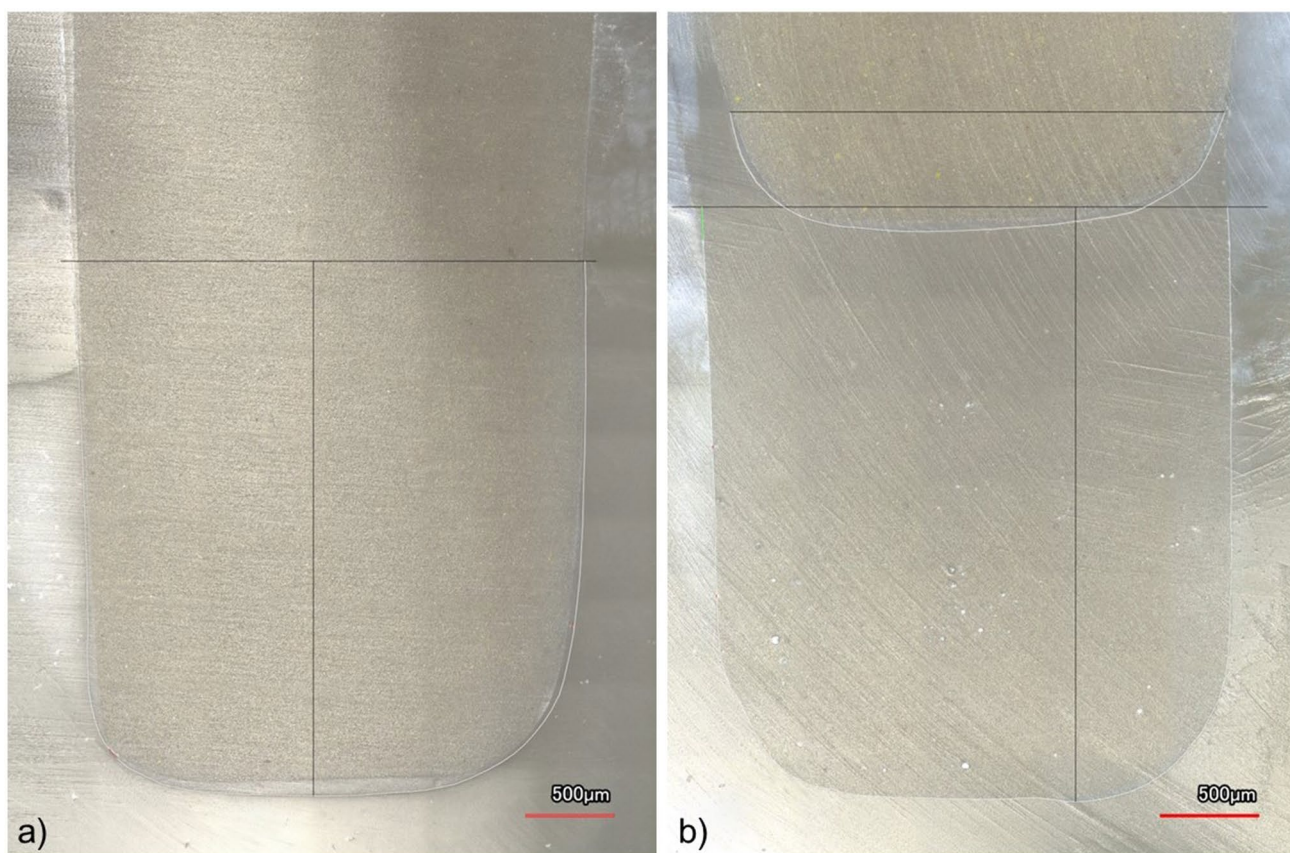
**Fig. 3** Laser microscope images of the mesial (a) and distal (b) surfaces of a specimen restored with a PICN inlay after the 2. TML. Standardized guides (black) were drawn in the image analysis software to mark the area in which quantitative analysis was performed. Interfaces 1 and 2 were drawn up to 3 mm from the lowest point of the margin (vertical and lower horizontal line). A fixed width of

2.5 mm (upper horizontal line) marked the ends of interface 3 at the intersection with the inlay margin. Measurement lines were drawn along the entire length of the interfaces, with white, green, and red lines indicating continuous, non-assessable, and non-continuous sections of the restoration margin, respectively

The final quantitative marginal analysis was conducted in the same manner as after the adhesive luting of the inlays. Figure 3, depicting representative images obtained with laser microscopy, describes the assessment method in finer detail.
