# Development of a Non-destructive Testing Method for Assessing Thermal Status of District Heating Pipes

H. P. Lidén<sup>1</sup> · B. Adl-Zarrabi<sup>1</sup>

Received: 4 September 2019 / Accepted: 10 February 2020 / Published online: 13 February 2020  
© The Author(s) 2020

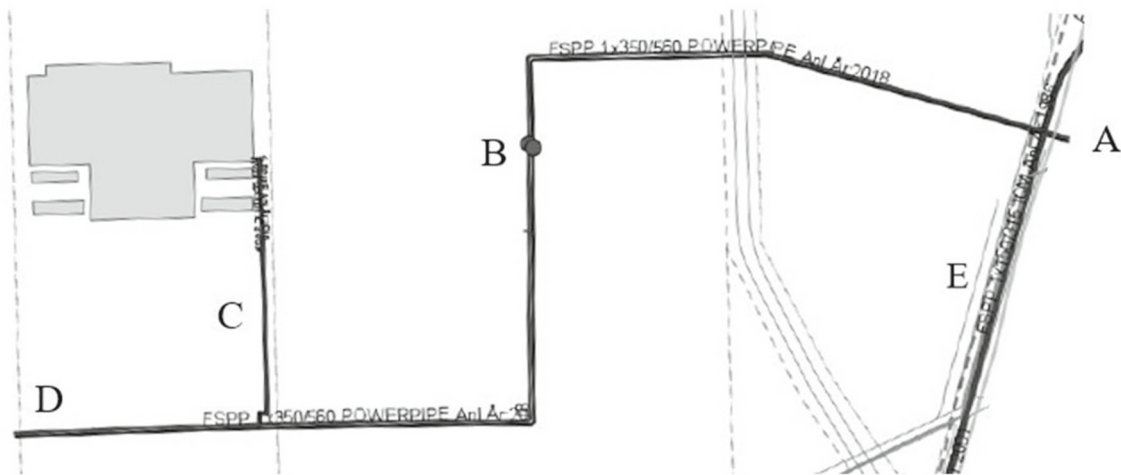
**Fig. 1** DH-network (A–D) for field experiment. Point A and B represent the position of valves, section C represents a smaller dimension of the pipe included in the experiment, point D is currently the end of the small network and E is a part of the larger main network

The measurement was carried out on a 496 m newly installed pipe network, which mainly consisted of dimension DN350/560 (350 mm in diameter of steel pipe/560 mm in diameter of casing pipe). The studied part of the DH-network (A–D) is presented in Fig. 1. Point A and B represent the position of the valves. The length of pipe section C is 55 m. The dimension of the pipe in the middle of section C was changed from DN125/450 to DN100/355. The copper wire length was 992 m ( $496 \times 2$ ) measured by an eco-pulse instrument. The network (A–D) was connected to the main network (E).

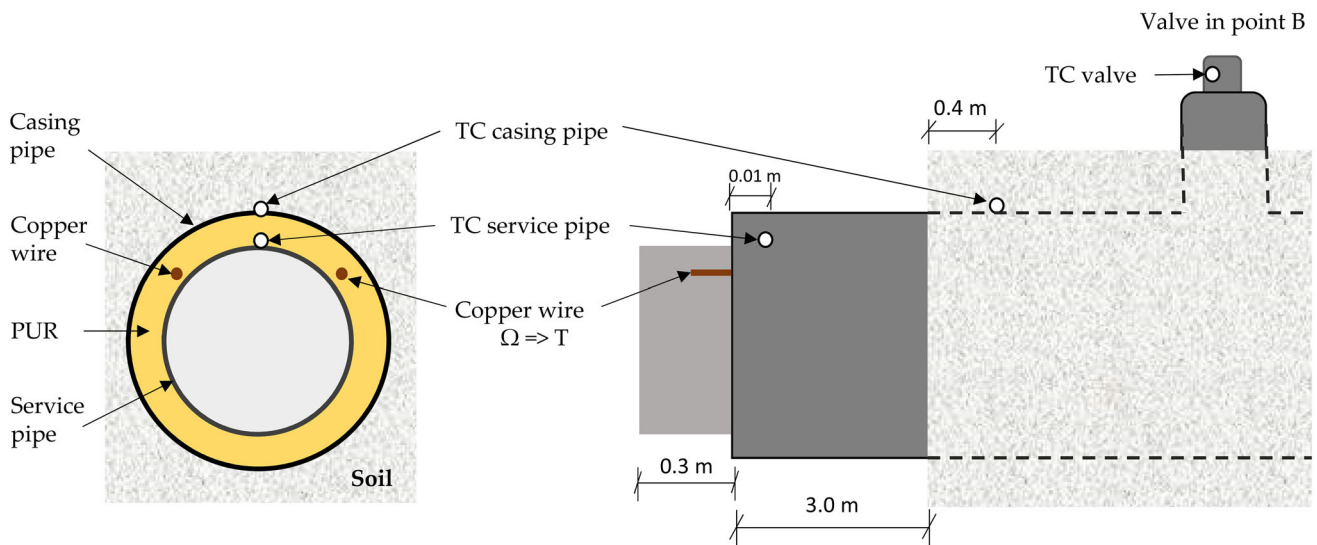
**Fig. 2** Illustration of measurement set-up at the excavation (point A in the network). The temperature measurements were conducted with thermocouples (type K), for service pipe (placed 0.01 m inside the PUR, on top of the service pipe), on the casing pipe under soil for sensitivity

analysis (inserted 0.4 m from the side), on the copper wire (indirectly by measurement of electrical resistance with a multimeter) and at a valve (point B in the network)

The temperature measurements were carried out at the excavation in the end of the network, point A, by type K thermocouples. The network (A–D) was located 0.51 m below ground surface, covered with soil. The soil material which covered the network was removed in position A for 3.0 m towards point B, see Fig. 2. The service pipe temperature was measured 0.01 m inside the PUR on top of the service

pipe. The temperature of the casing pipe was measured by a TC inserted in the soil 0.4 m along the casing. The temperature of a steel valve in point B was also measured (200 m from point A), by adding a TC directly on the lower parts of the steel and covering it with insulation. The electrical resistance of the copper wire was measured at the two wire ends in point A. The positions of all TCs are shown in Fig. 2.

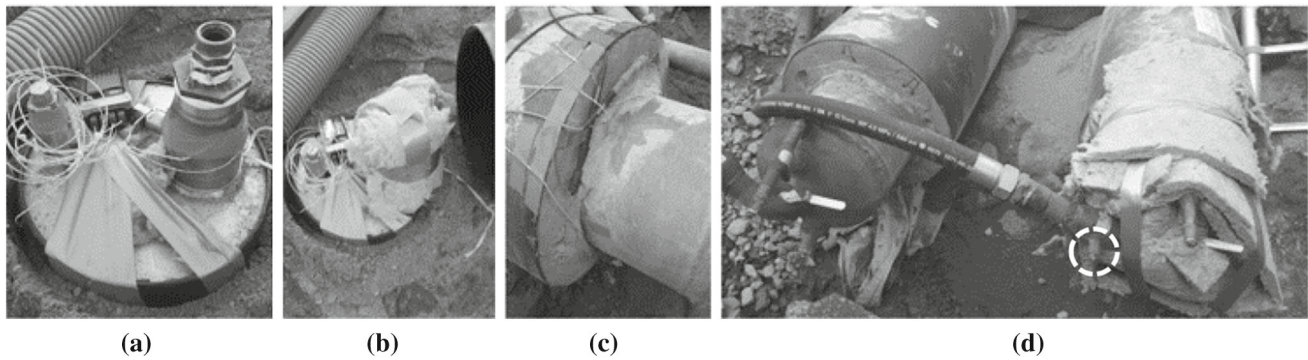
**Fig. 3** **a** Valve at point B with thermocouples; **b** the same valve after insulation with mineral wool; **c** the service pipe at the excavation with thermocouples and crocodile clamps on the ends of the copper wire,

connected to a multimeter; **d** the same pipe, to the right in photo, after insulation with mineral wool. White dotted circle shows the valve on the flexible pipe for shutdown

Figure 3 below presents photos (a, b) on the valve at point B and photos (c, d) shows the excavation at point A. Photo (d) also shows the flexible pipe that connected the pipe network (A–D) with the main network (E), a flexible pipe of approximately 20 m.

The power plant was located about 100 m from the excavation. The temperature decrease in DH-networks is normally 0.1–0.2 °C per kilometer. Thus, it was expected that the temperature of the service pipe in network (A–D) should be about 94 °C. However, the influence of a 20 m poorly insulated flexible pipe which connected the main supply pipe (E) to the network (A–D) should dominate the temperature difference between the main supply pipe (E) and the network (A–D). The cooling experiment took place on the 28th of February, the valve in point A (Fig. 3d, white dotted circle) was closed at 11:31 and reopened 14:26, thereby a shutdown of 175 min.

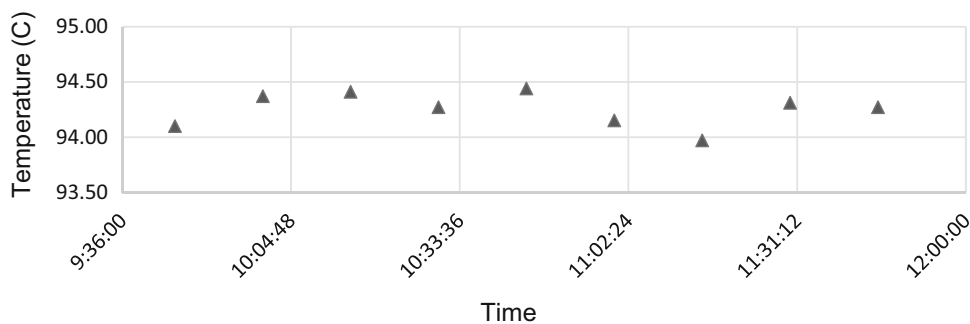
**Fig. 4** Temperature in main supply pipe (E) from power plant, two hours prior to shut down. Data received from power plant

The temperature distribution over the cross section of a pipe section should be in steady state condition prior to evaluation of a network. The main supply pipe (E) that served network (A–D) had a water temperature of approximately 94 °C, according to data collected by the energy company. Two hours of stable water temperature was enough to achieve a steady state condition prior to performing the cooling experiment. Temperature data for the main supply pipe (E) from the power plant is presented in Fig. 4.

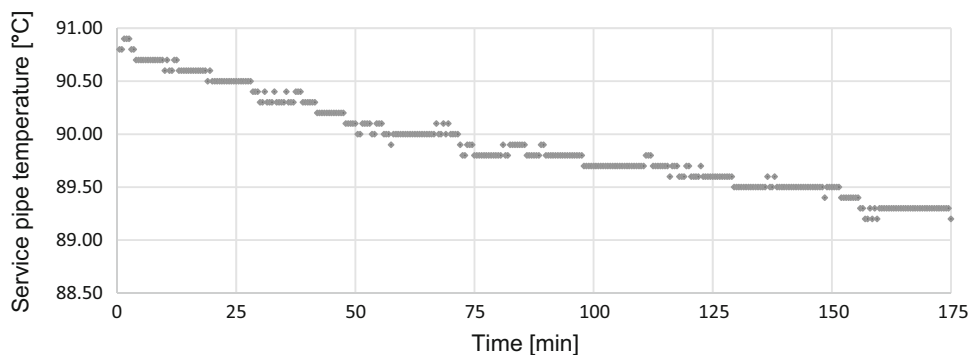
**Fig. 5** Measured temperature on the service pipe during cooling phase

The temperature of the service pipe in the network (A–D) during the cooling phase (175 min) is shown in Fig. 5. The measured temperature decrease was 1.55 °C (from 90.85 to 89.30 °C).

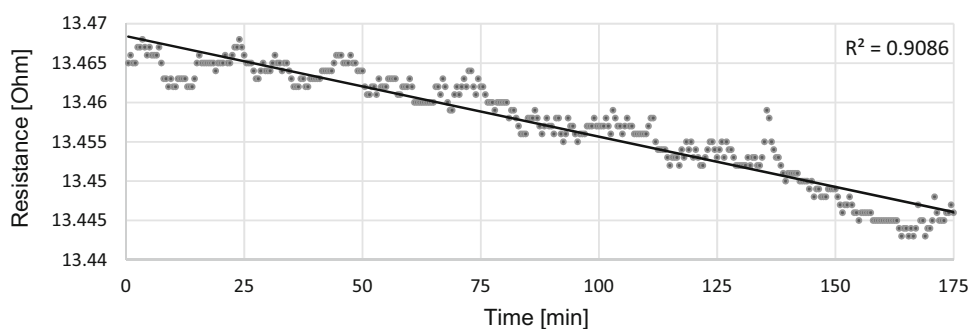
**Fig. 6** Decrease of electrical resistance in copper wire during cooling process

The electrical resistance of the copper wire was measured to 13.466 (Ohm) before start of the cooling phase, which decreased to 13.446 (Ohm) at the end of the cooling phase, see Fig. 6. The temperature at the position of copper wire was calculated by Eq. (5) to a decrease from 71.26 to 70.85 °C. Unlike the service pipe which is in direct contact with the water, the cooling of the copper wire did not start immediately when the valve was switched off.

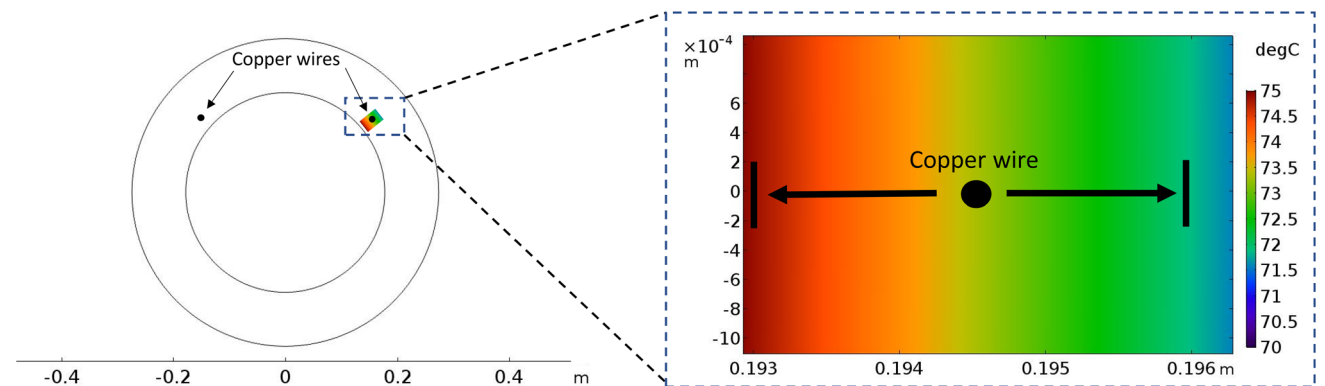
**Fig. 7** Calculated temperature profile for position of the copper wire (15–18 mm from the service pipe) when temperature of the service pipe was 90.85 °C and temperature of casing pipe was 6.6 °C. Black

dot represents the location of the copper wire at 16.5 mm (distance from the pipe center was 0.1945 m) from service pipe, with a temperature of 73.50 °C at steady state condition

and the service pipe (90.85 °C) as the boundary condition. The calculated temperature was 73.50 °C at the copper wire position, approximately 2.2 °C higher than measured

(71.26 °C). Assuming the maximum possible distance of the copper wire from the steel service pipe (18 mm), the copper wire temperature was calculated to 71, 80 °C, see Fig. 7.

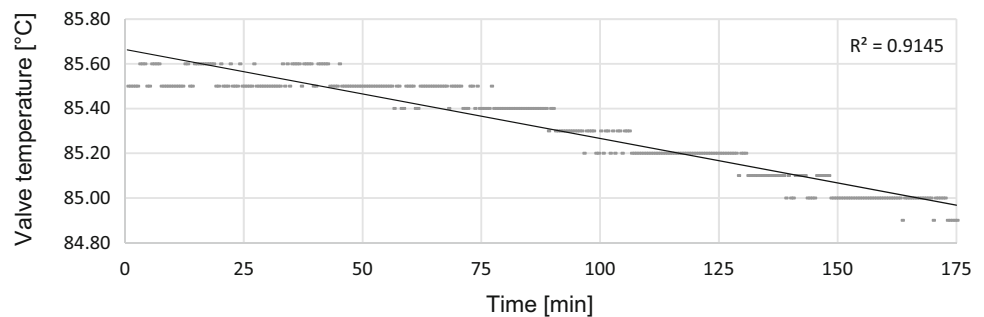
**Fig. 8** Temperature measurement on valve (representing service pipe) during cooling process

The absolute temperature for the valve in point B decreased from 85.60 to 84.90 °C, a temperature difference of 0.70 °C, see Fig. 8. The thermal diffusivity of steel offsets the cooling phase for the valve by approximately 60 min.
