Surface Treatment of Powder-Bed Fusion Additive Manufactured Metals for Improved Fatigue Life

David B. Witkin, Dhruv N. Patel, Henry Helvajian, Lee Steffeney, and Agustin Diaz

(Submitted March 23, 2018; in revised form August 16, 2018; published online November 19, 2018)

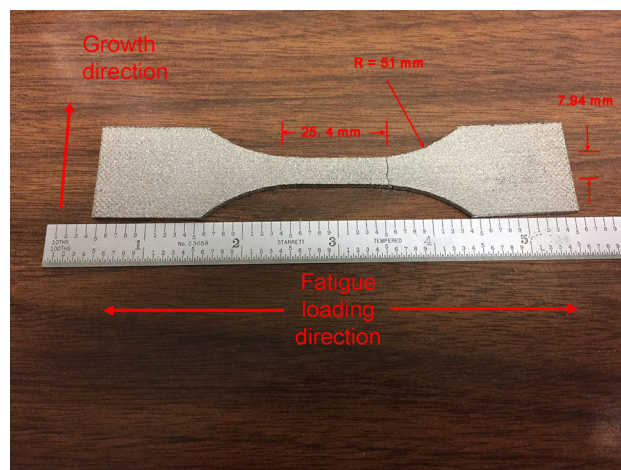
Fig. 1 Photograph of EBM Ti-6Al-4V flat dog bone specimen, with EBM growth and fatigue loading directions indicated

7.94 mm wide and 2.38 mm thick. Transition regions between the gauge and grip sections had a radius of 51 mm. One design consideration was that specimens be fabricated in a horizontal orientation as shown in Fig. 1 without use of build supports, so that testing in the as-built condition could be performed without alteration of the as-produced surface on any face or edge of the test specimen.

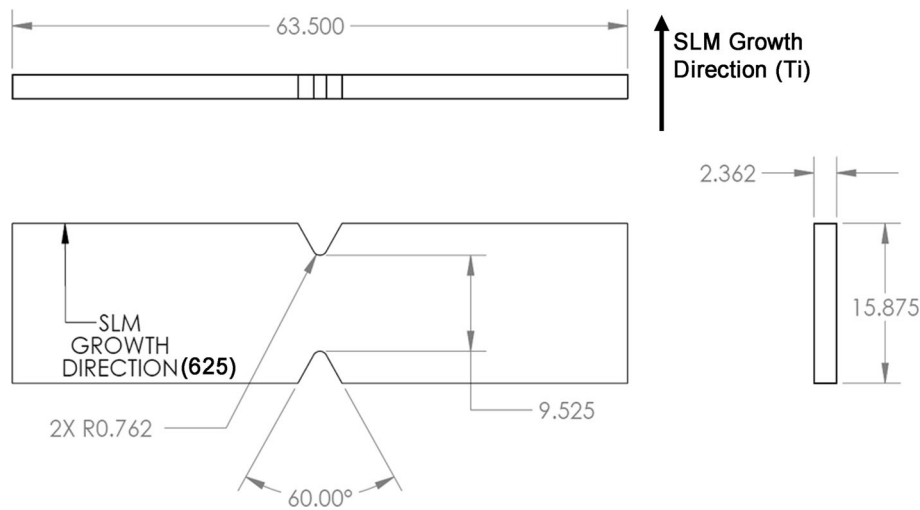
Fig. 2 Design of the notched fatigue specimen with $K_t = 3$ that was used to build SLM Ti-6Al-4V and Inconel 625 specimens (All values are in mm)

SLM test specimens were produced as flat notched specimens ($K_t \sim 3$) as shown in Fig. 2. The main intent of using a notched specimen was to limit the total surface area that needed to be treated with a laser. The Inconel 625 specimens were built at Stratasys Direct Manufacturing (Austin, TX), on edge as shown in Fig. 2. This enabled both top and bottom notches to be built without supports, again allowing comparison of true as-produced surfaces to treated surfaces. The Ti-6Al-4V specimens were built at Incodema3D (Ithaca, New York), but were built flat on the build plate to reduce printing time and specimen cost. Consequently, one side of the specimen had a surface that had been altered by electrical discharge machining (EDM) to remove it from the build plate. In this case, however, the notch root was a vertically oriented wall so the EDM surface on one face is not expected to have significantly impacted fatigue behavior.

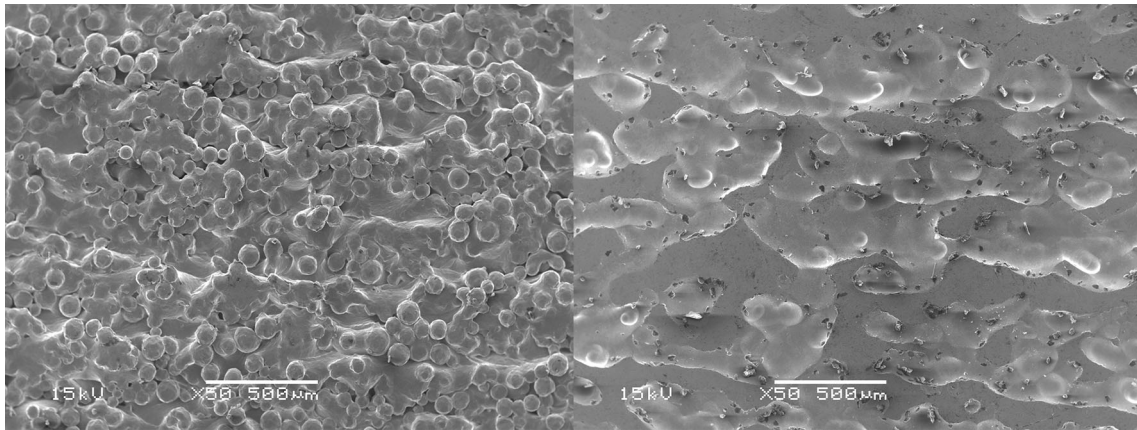
Fig. 3 Scanning electron micrographs of the surface (vertical wall) of EBM Ti-6Al-4V fatigue specimens in the as-built condition (left) and after CAVF treatment (right)

A qualitative means to assess the change in surface roughness is to look at micrographic images of the treated surface. In Fig. 3, a vertical wall of an EBM Ti-6Al-4V flat dog bone specimen is shown before (left) and after CAVF treatment (right). The as-built surface is characterized by nearly uniform coverage of the surface by semi-sintered or partially melted powder particles, along with horizontally oriented textures with spacing of several hundred micrometers, representing the individual melt layers. After CAVF treatment, the powder particles have been completely removed, but some surface topography remains. While the CAVF process is capable of rendering titanium surfaces smoother than that shown in Fig. 3, as previously discussed, a maximum removal depth was imposed to maintain integrity in comparing fatigue results. EBM equipment models developed subsequent to the S12 used to produce these materials may give different results for EBM Ti-6Al-4V surface roughness in both as-built and improved surfaces.

This approach provides some explanation of why the fatigue performance of the EBM Ti-6Al-4V improves even though there are still surface defects present, as shown in Fig. 3 and 11. The CAVF process may not reduce the deepest penetration of surface features, as seen in R_v , but the combination of mechanical and chemical polishing reduces the stress concentration associated with those defects. The same is true of the SLM Ti-6Al-4V. Although the EBM equipment used to produce these materials (Arcam S12) is no longer considered state of the art for electron beam powder-bed fusion, the general conclusions in terms of the CAVF process used with titanium would be applicable to different surface roughness conditions in more recent vintage equipment.

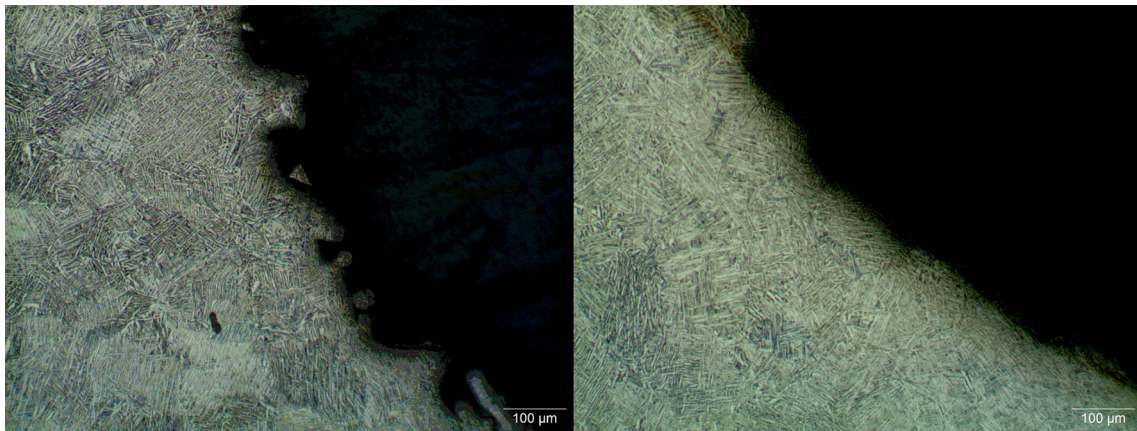
Fig. 4 Optical micrographs of polished and etched cross section of SLM Ti-6Al-4V notch root with as-built surface (left) and after CAVF (right)

For SLM Ti-6Al-4V, fatigue crack initiation occurs in the vicinity of the notch root. Notched Ti-6Al-4V samples were printed in a flat orientation, so the surface of interest is the vertical wall of the notch itself. Metallographic images in Fig. 4 show polished sections looking down the wall of the notch in tested specimens. Surface features on the as-built surface on the left-hand side are not present in the CAVF surface-treated specimen in the right-hand image.

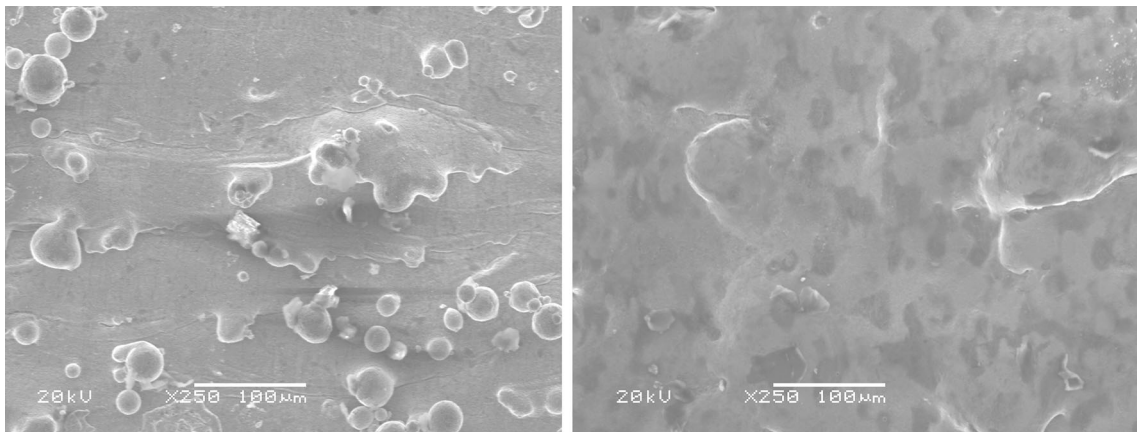
Fig. 5 Scanning electron micrographs of the surface (vertical wall) of SLM Inconel 625 notched fatigue specimen in the as-built condition (left) and after laser remelting (right)

Figures 5 and 6 show the result of laser remelting and abrasive polishing, respectively, of SLM Inconel 625. Powder particles have again been removed by both processes. The laser remelting process leaves some surface waviness, while the abrasive treatment leads to very smooth surfaces, although some surface depressions remain, as shown in the right-hand image of Fig. 6. A metallographic cross section of a laser remelted surface (Ref 20) (taken from a test article, not a fatigue specimen) is shown in Fig. 7. The remelted layer is characterized by a uniform melting depth and no apparent heat-affected zone in the parent material. Because the sample was HIP'ed prior to laser treatment, the remelted layer has a different microstructure that is characteristic of as-built SLM 625 with no subsequent thermal treatment.

The case of laser polished Inconel 625 is more complicated than that of Ti-6Al-4V. On the one hand, Fig. 5 shows that the surface roughness is decreased by the laser remelting, but that other surface topographic features or asperities are either not fully melted or not removed by the process. SEM images of fracture surfaces of as-built and laser remelted specimens

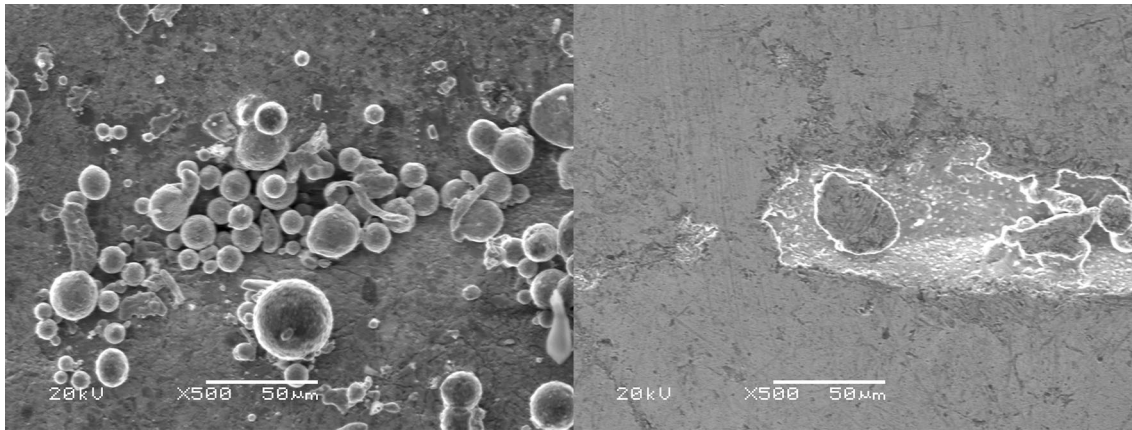
Fig. 6 Scanning electron micrographs of the surface (vertical wall) of SLM Inconel 625 notched fatigue specimen in the as-built condition (left) and after abrasive polishing (right)

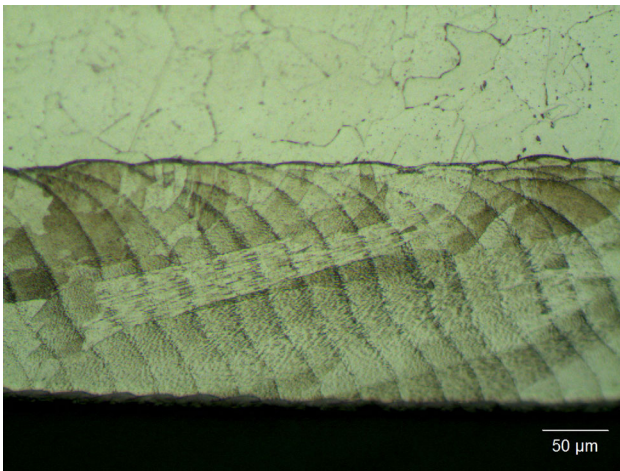
Fig. 7 Optical micrograph of a laser remelted layer on a SLM Inconel 625 parent material

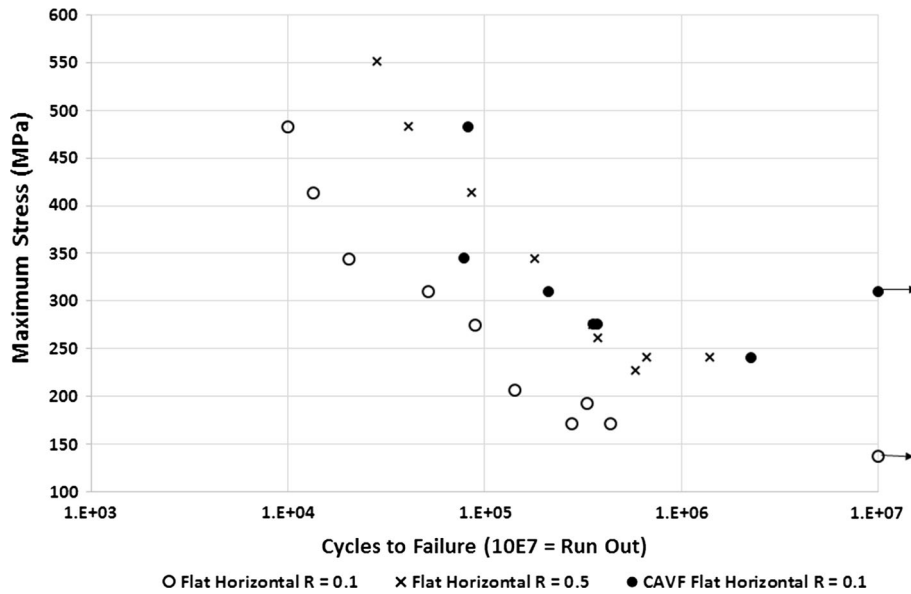
Fig. 8 S-N plot of fatigue results for EBM Ti-6Al-4V. Data points for suspended tests are marked by arrows

Fatigue results are presented as S–N plots. In Fig. 8, results are shown for flat EBM Ti-6Al-4V dog bones at $R = 0.1$ and 0.5 with as-produced surfaces and $R = 0.1$ for specimens treated by CAVF. In this plot, one CAVF-treated specimen

tested at a maximum stress of 310 Mpa ($R = 0.1$) did not fail after completing 10 M cycles. This was a much greater number of cycles than another specimen tested at 310 MPa, which failed after approximately 200 K cycles. The sample that did not fail at 310 MPa was retested at a maximum stress of 485 MPa, failing after 82 K cycles. Results at 310 and

485 MPa are seen to be somewhat greater than the rest of the trend described by the treated samples, and subsequent inspection of the fracture surfaces using SEM did not reveal any unusual features in comparison with other EBM Ti-6Al-4V samples that received the same surface treatment.

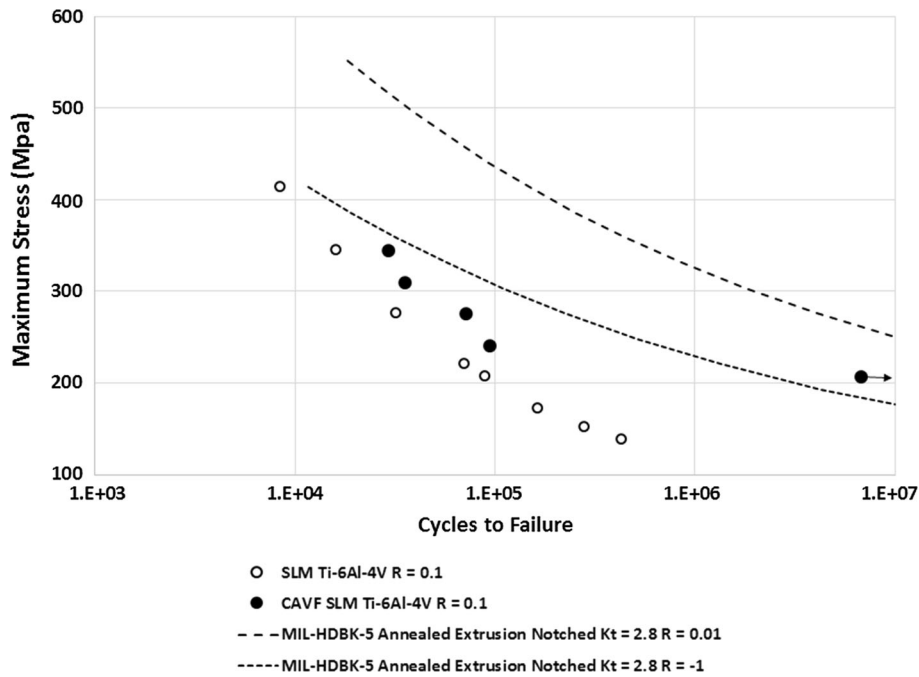
Fig. 9 S-N plot of fatigue results for SLM notched Ti-6Al-4V

S-N curves for notched specimens of Ti-6Al-4V made by SLM are shown in Fig. 9, along with models of notched fatigue ($K_t = 2.8$) for annealed Ti-6Al-4V extrusions from MIL-HDBK-5 for comparison. In this case, the CAVF treatment leads to approximate doubling of the number of cycles to failure at a given load. The test run at 205 MPa was halted after 6.7 M cycles. Based on the test results, 205 MPa is estimated as a practical endurance limit for the SLM material in the presence of a notch with $K_t \sim 3$ and $R = 0.1$ after CAVF treatment. The lowest test load for the untreated notched Ti-6Al-4V specimens was 138 MPa, which failed after 428 K cycles. This is too few cycles to estimate the endurance limit for this condition, but given typical characteristics of S-N curves for SLM, EBM and wrought Ti-6Al-4V materials, it is expected that the CAVF treatment would lead to an improvement in endurance limit of 50-100%, or from 100 to 140 MPa to the measured 205 MPa.

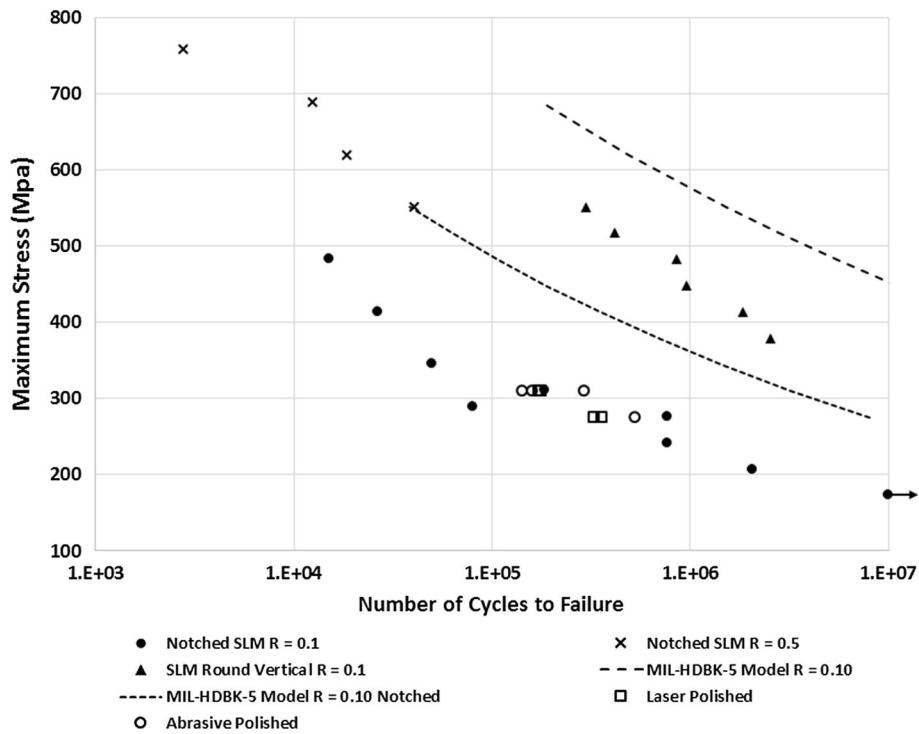
Fig. 10 S–N curve of fatigue results for SLM notched Inconel 625

The final set of fatigue results is for SLM Inconel 625, as shown in Fig. 10. Included in Fig. 10 are data for vertical round SLM alloy 625 specimens tested at $R = 0.1$ with as-produced surfaces (Ref 9), along with models based on MIL-HDBK-5 data for wrought annealed Inconel 625 tested at $R = 0.1$ for both notched ($K_t = 3$) and unnotched samples. The vertical SLM specimens' fatigue behavior in comparison with these two models was the basis for an estimate that the fatigue behavior of this alloy in SLM form with an as-produced surface could be conceived as roughly equivalent to a notched bar with K_t approximately 2.4-2.8 (Ref 9). The actual notched specimens that are plotted are for horizontally oriented samples with a notch elastic stress concentration factor of 3. The notched samples with as-produced surfaces have S-N curves that are offset from the wrought annealed model with $K_t = 3$ by roughly the same magnitude as the vertical samples are offset from the unnotched wrought annealed material. In this case, however, surface improvement did not lead to any apparent improvement in fatigue behavior. SLM 625 notched samples were split between abrasive surface polishing and laser remelting, and all such samples were tested at either 275 or 310 MPa maximum stress. The results in Fig. 10 for the surface-treated specimens are at best ambiguous, and unlike the results for Ti-6Al-4V, improvement in fatigue performance cannot be inferred.

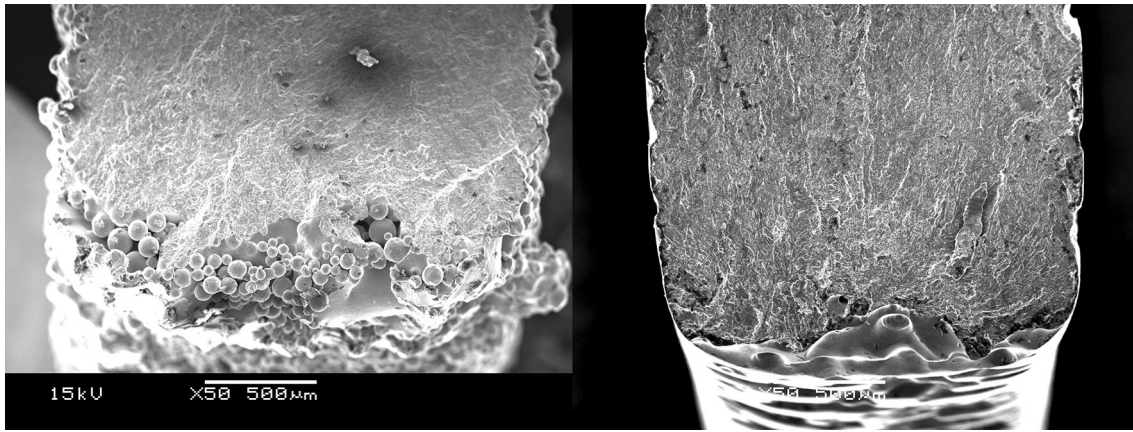
Fig. 11 Fracture surfaces of EBM Ti-6Al-4V fatigue specimens with as-built EBM surface (left) and after CAVF (right)

The surface features that contribute to reduced fatigue lifetimes or endurance limits in as-built specimens can be seen in fracture surfaces of tested fatigue specimens. Fracture surfaces for as-built and CAVF-treated EBM samples are shown in SEM images in Fig. 11. The orientation of the fracture surface in these images is identical to the orientation in which the specimens were printed. This perspective also shows some degree of rounding of the corners of the specimen after the CAVF process, an effect that would not have been accounted for in dimensional measurements, but would also tend to raise the actual stress in the test specimen due to slightly lower cross-sectional area compared to measuring width and thickness and assuming a rectangular cross section.

In all cases, the fatigue crack initiation occurred at the bottom surface of the EBM specimens. In the as-built specimen, the bottom surface is uneven, and unmelted regions can be seen penetrating upward approximately 500 μm into the net section. The surface treatment leads to a more even surface roughness, but as discussed previously by stopping the process after total material removal of 300–400 μm , some of the surface

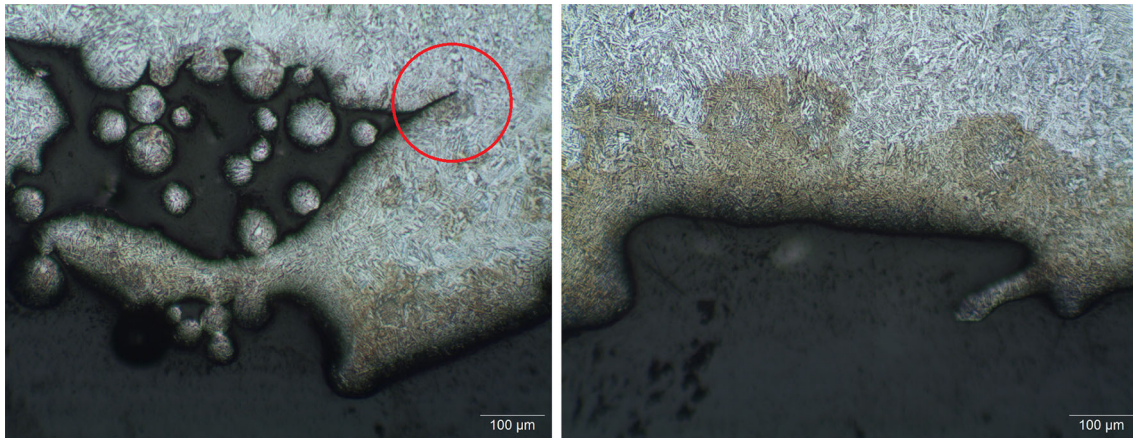
Fig. 12 Optical micrographs of polished and etched cross sections of EBM Ti-6Al-4V with as-built surface (left) and after CAVF (right). The surfaces shown correspond to unsupported horizontal surfaces facing downward in the vertical direction with respect to the EBM growth direction. The circled feature in the left-hand image is inferred to be typical of high stress concentration where fatigue cracks initiate, and is not present after CAVF treatment

defects are still present, and it is at these types of features where fatigue cracks initiate in the treated samples. It is notable, however, that the interior surface of these flaws has been smoothed and rounded relative to the starting condition. Considering the similarity in R_v for the as-built and treated EBM Ti-6Al-4V (although this was measured on vertical walls, not bottom edges of these samples), the CAVF process is eroding the surface of these surface defects, so the peak depth relative to the sample surface does not change, but the shape of the defect has changed. This is illustrated in metallographic cross sections from the bottom surface of a fatigue specimen in Fig. 12. The circled feature on the left-hand image is a crack-like feature that may have resulted from lack of fusion between adjacent electron beam passes or incomplete melting of powder particles. In the right-hand image, not only has the depth of the surface features been reduced, but this type of fatigue crack starter feature has been removed.

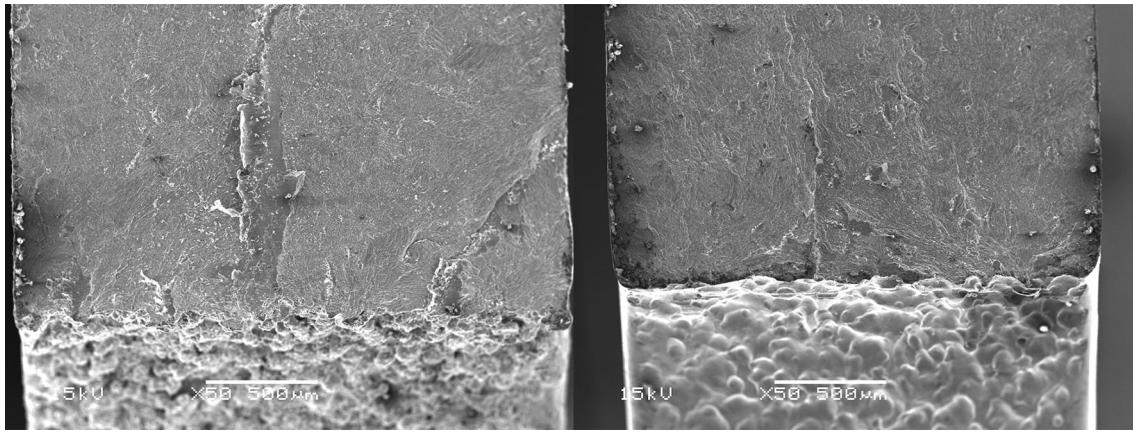
Fig. 13 Fracture surfaces of SLM Ti-6Al-4V fatigue specimens with as-built SLM surface (left) and after CAVF (right)

Fracture surfaces of the SLM samples are shown in Fig. 13. The edge of the specimen in the as-built tested specimen is much more even than the EBM Ti-6Al-4V specimen, not only due to intrinsic differences in the two processes but also because of the orientation of the specimens in the printer. In addition, the edge of the fracture surface in the treated specimen shows that defects penetrating the net section are rounder and

their interior surfaces are smoother in comparison with the as-built specimen.

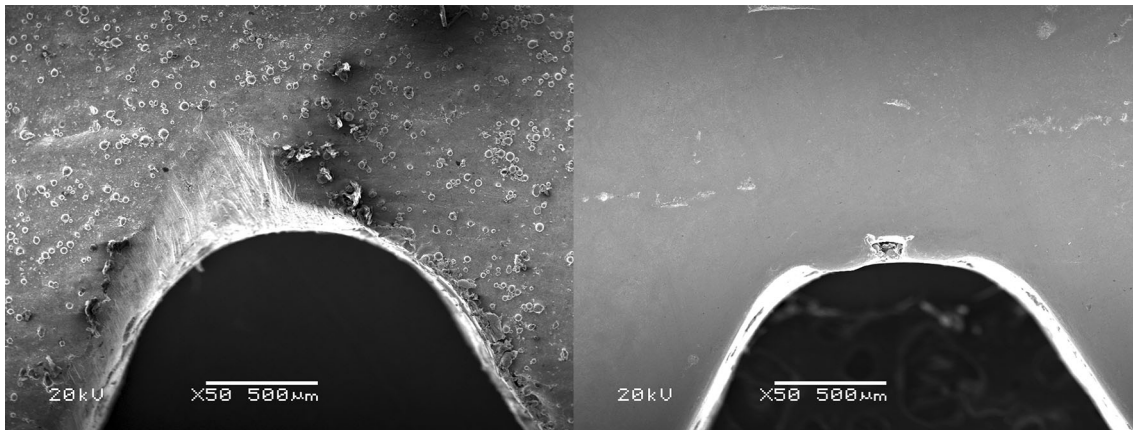
Fig. 14 Scanning electron micrographs of the notch in SLM Inconel 625 specimens in the as-built condition (left) and after abrasive polishing (right). Although the improvement in apparent surface roughness is obvious, the surface feature at the notch root likely responsible for lower fatigue performance compared to wrought or machined specimens is not removed by abrasive polishing

In the case of SLM Inconel 625, the shortcomings of the abrasive polishing from a fatigue perspective are illustrated by SEM images of the surfaces of notches in as-built and polished specimens that were facing downward vertically during printing

and built without supports (Fig. 14). Downward facing or highly inclined surfaces in powder-bed AM have higher surface roughness than vertical walls, so while the surface roughness of the vertical wall surrounding the notch has been smoothed to sub-micrometer R_a values, the notch root itself shows that a defect is still present. This is a similar outcome of abrasive polishing to that shown in Fig. 6 for a vertical wall, where the roughness due to the adhered powder particles has been removed, but surface defects remain even though measured surface roughness was greatly reduced. Unlike the reduced stress concentration due to CAVF in titanium, the results of abrasive polishing can be considered a reduction in the effective depth of a crack-like surface feature, but not a blunting of its tip. In the case of the elastic stress concentration of a surface notch, small changes in the depth of the notch due to material removal of the surface, while the radius of the notch root is left mostly unchanged, will not lead to significant reductions in K_t (Ref 26; see, for example, Table 6-1, Case 2a, p. 275).

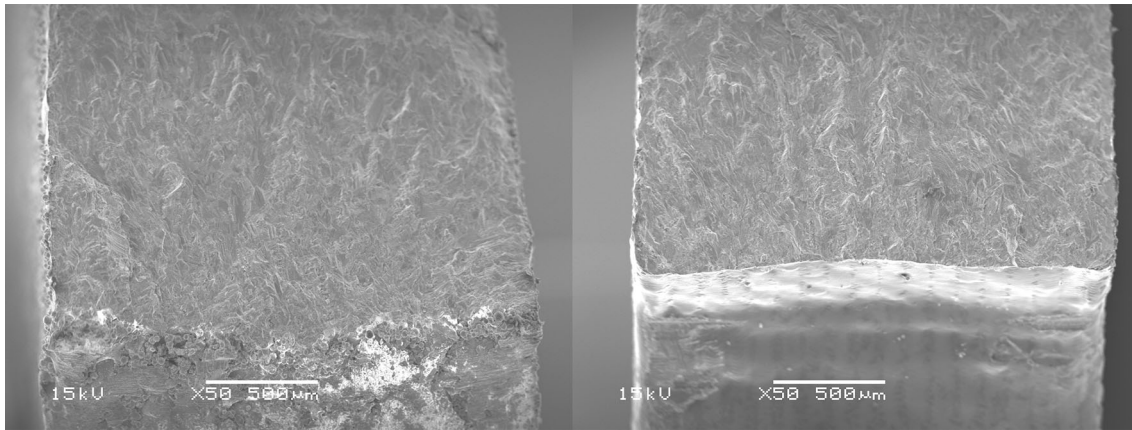
Fig. 15 Fracture surfaces of SLM Inconel 625 notched fatigue specimens with as-built SLM surface (left) and after laser remelting of the notch surface (right)

(Fig. 15) tested at the same stress levels (310 MPa) show considerable improvement in the smoothness of the edge of the notch where fracture initiated. At the same time, the remelted layer shown in Fig. 7 exhibits a rapidly solidified microstructure and an interface with the unmelted parent material, both of which may be more prone to crack initiation even though the outer surface is smoother. The transition from the laser remelted area to the parent material is not seen on fracture surfaces. It is thus not obvious whether the remelted layer is rapidly breached by a fatigue crack at the notch root, meaning that it plays no role in the fatigue of the specimen overall, or if it simply has a similar fatigue crack initiation behavior to the HIP'ed material with an as-produced surface, and is too thin to influence the number of cycles to failure even though its microstructure is different than the bulk material. While the authors are not aware of fatigue testing being performed on SLM specimens subjected to laser polishing, it is likely that a more appropriate approach to future testing will be to perform the polishing step on as-built material, and then HIP the samples so that the entire sample has a uniform microstructure to complement the smoother surface.
