Rain Erosion Maps for Wind Turbines Based on Geographical Locations: A Case Study in Ireland and Britain

Abstract

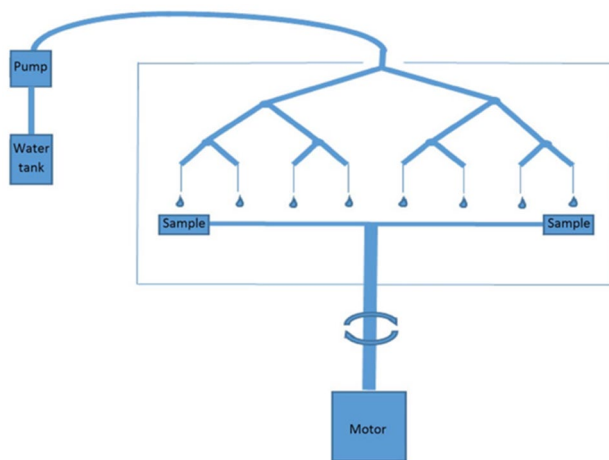
Fig. 2 Whirling arm schematic

Upon the completion of this map an experimental process in the Tribology laboratory at the University of Strathclyde was carried out to relate rainfall across the country to the degradation of wind turbine blades. There are many different ways to test for rain erosion [8]; however, the test method used for this case study is the whirling arm setup [9]. This consists of a large chamber with induced rainfall from hypodermic needles; in the centre of the chamber is a rotating arm which holds the material sample at the end. Adjusting the rotational speed of the spinning arm will adjust the impact velocity the sample encounters with the water droplet. The experimental setup can be seen in Fig. 1 and a schematic is shown in Fig. 2.

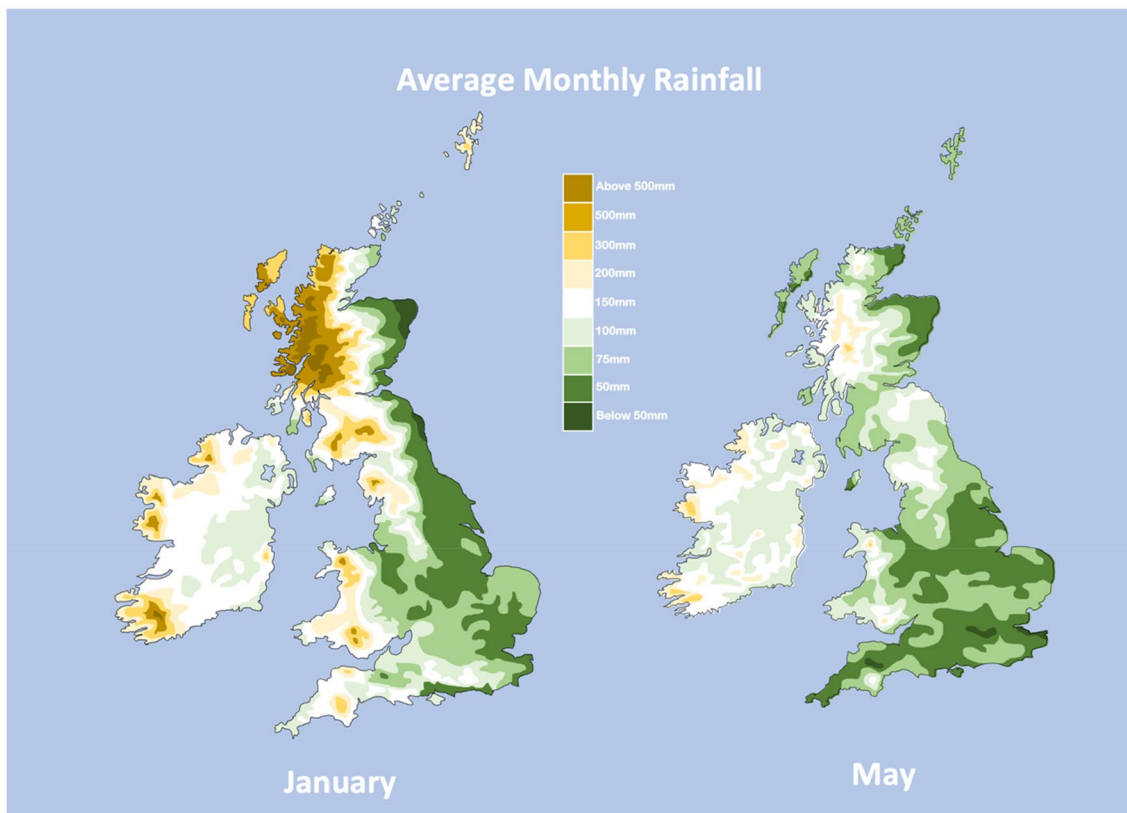
Fig. 3 The average rainfall in the months of January and May

allow for contrast to be observed between the 2 months. The result of this can be seen in Fig. 3.

The construction of the rainfall map (Fig. 3) allows the setup for the experiment to be finalised. The key to the map displays: Below 50 mm, 50 mm, 75 mm, 100 mm, 150 mm, 200 mm, 300 mm, 500 mm and above 500 mm. The rainfall rate of the whirling arm rig is 50 mm/h therefore for the time each sample exposed to rain erosion can be determined, this is.

The rainfall mostly averages between 50 and 500 mm of rain with some few areas showing more extreme rain. It is clear that the month of May experiences considerably less rain as it shows highs of 300 mm whereas this rate is fairly common in January. The areas of intensity are very similar in both months with the west coast of Scotland showing a high rainfall and also the west coast of Ireland, predominantly the south west coast of Ireland displaying very heavy rainfall. These are historically harsher climates due to the prominent westerly wind from the Atlantic [12]. This leads to further erosion as the largest windfarms are located in these areas due to the increased power output from the consistent wind [13]. This is a very common trade-off when building a windfarm as the conditions that yield the most power generation are also the conditions which deteriorate the turbine blades most rapidly, therefore the life of the turbine blade will be reduced [14].

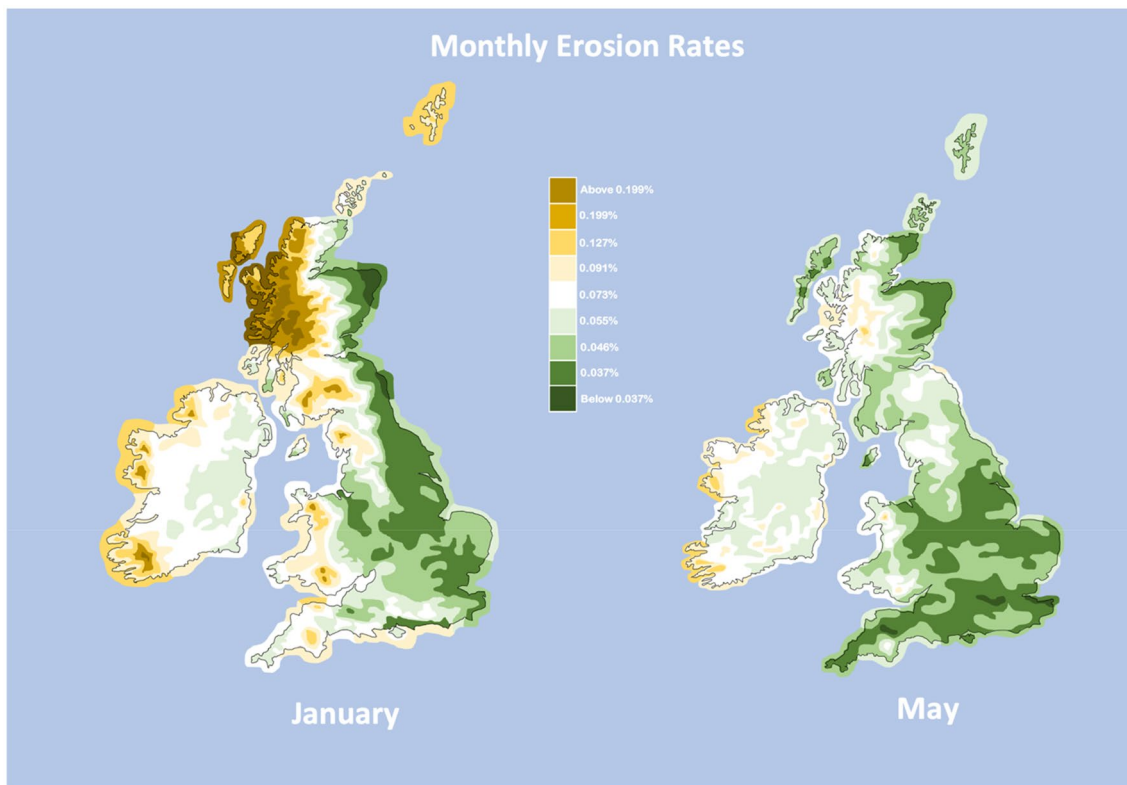
Fig. 4 The monthly erosion rates of the tip of a turbine blade along the leading edge in January and May

The results showed a maximum mass loss of 0.199% which relates to 500 mm of rainfall and a minimum mass loss of 0.037% which relates to 50 mm of rainfall. Although mass loss is not the most precise measurement for erosion when compared to imaging samples and identifying gauges, cracks and loss of material [18, 19]; it does allow for a broader comparison between samples.

The rainfall data is only available on land, therefore there was no offshore rain data to compare to the offshore erosion data. From the experiments using saltwater (3.5% saline solution) there was a higher mass loss at the higher exposure times compared to the neutral water tests. To compensate for this a border of approximately 10 miles was created offshore around the islands and assumed to be one grade above the adjacent onshore erosion rate. For example, the mainland of Shetland displayed an erosion of 0.046% mass loss therefore a 10-mile boundary off the coast of Shetland was created displaying the next grade up in the key which is an erosion of 0.055% mass loss. This is displayed in Fig. 4.

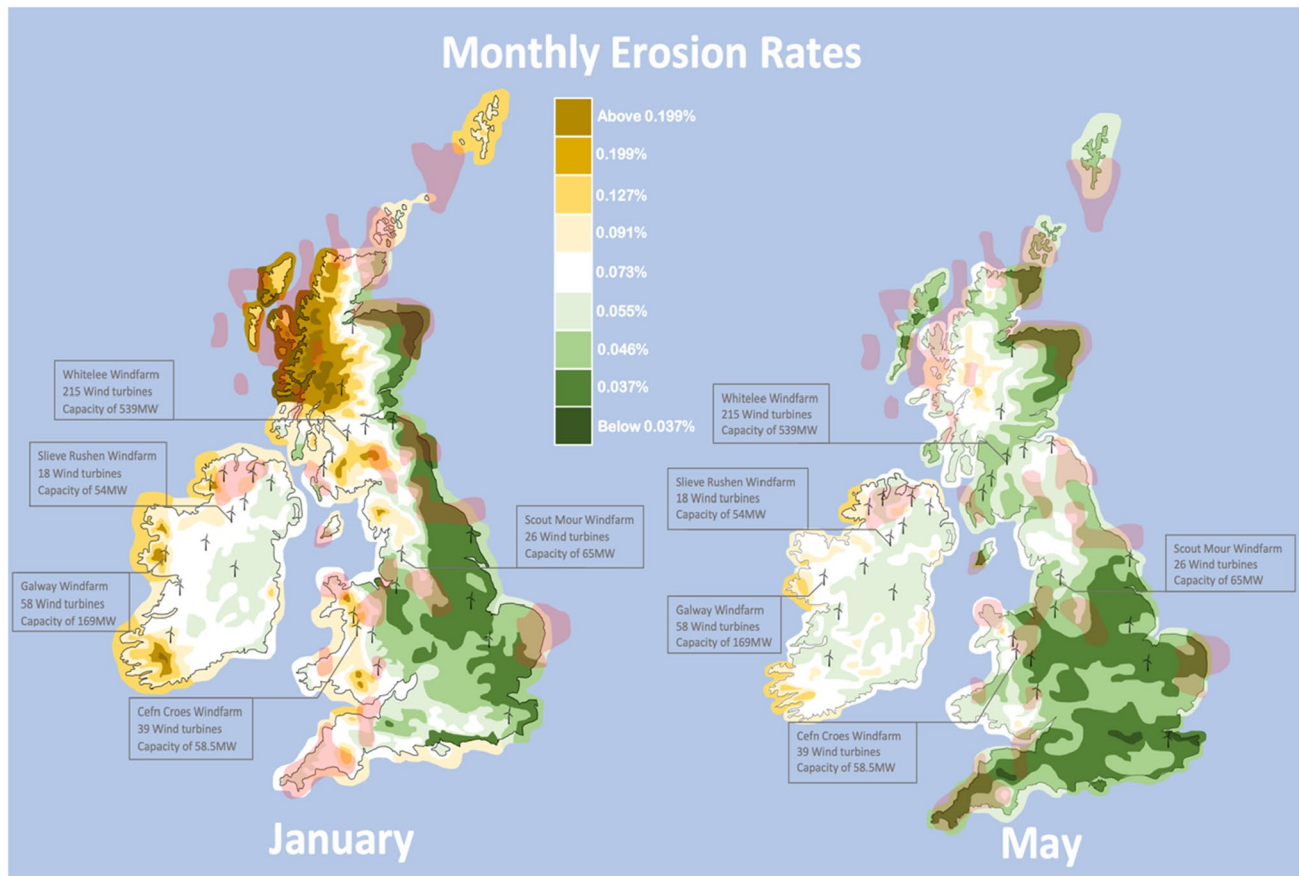
Fig. 5 The monthly erosion rates of the tip of a turbine blade along the leading edge in January and May with overlays of major wind turbine farms and areas of frequent hail

Construction of these maps now allows for further comparison to be made including locations of major wind farms and also areas of high hail rates which is displayed in Fig. 5. Even though the rainfall rate maps cover all precipitation, it is important to locate areas of high hail impact as these tribological actions can be detrimental to its structural integrity. Although the probability of hail striking wind turbine blades is very low and the damage would be difficult to ascertain, and it could possibly be masked as the outcome of heavy rainfall erosion, the implications of hail impacts have been proven experimentally to cause substantial damage. In a study looking into ballistic ice impacts, it was shown that the impact would delaminate and crack the composite material [24]. This would not only create a weak point in the blade structure itself but also create an initiation site for rain erosion to occur and for crack propagation into the structure of the blade. The areas of frequent hail are shown in Fig. 5 as the red overlay, and from the maps it is clear that the west coast is more adversely affected by hail. Unfortunately, there was limited data on hail in The Republic of Ireland; therefore, assumptions on this issue for this area of the map need to be treated with caution.

Also superimposed onto the map in Fig. 5 is the locations of some large wind farms and the largest in Scotland, England, Ireland, Wales, Northern Ireland and The Republic of Ireland have been labelled [25]. This not only allows for a comparison between the size of the various windfarms in each region but also how adversely affected each one is by the climate and the subsequent erosion. Most of the windfarms are in compromising locations but, as discussed previously, this is a trade-off between greater access to consistent wind to the lifetime of the blades.
